**HAZARDOUS MATERIAL SURVEY REPORT
FOR
PHASE 2 OAHU COMMUNITY CORRECTIONAL CENTER
HDOA ANIMAL QUARANTINE STATION
99-951 HALAWA VALLEY STREET
AIEA, ISLAND OF OAHU 96701**

**MNA PROJECT 02819_2
AHL PROJECT No. 6930.001
DAGS JOB No. 12-27-5713**

November 30, 2020

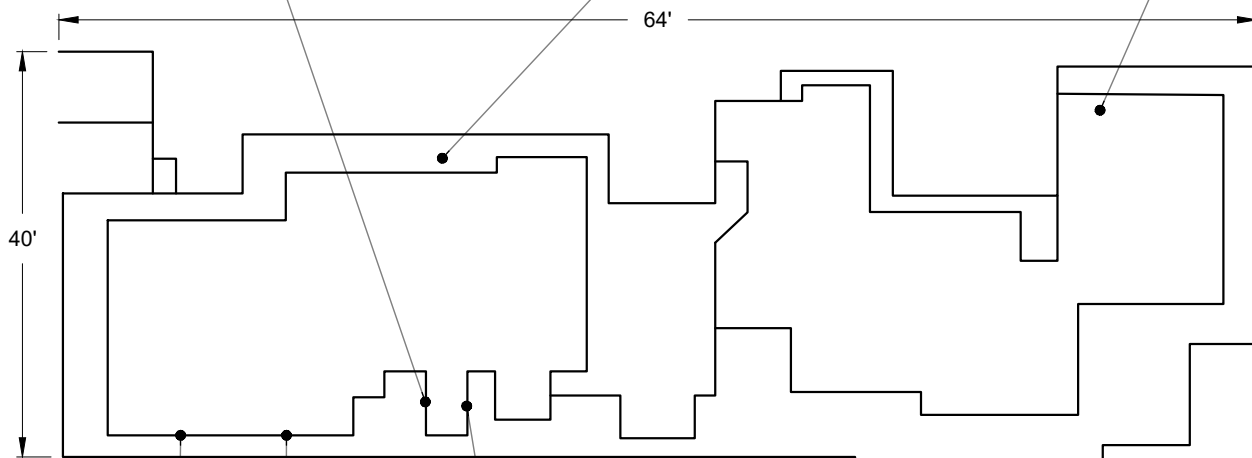
2819-B-A29A: ND
 2819-B-A29B: ND
 2819-B-A29C: ND
 HM ID: 29 (Black grout on concrete window frame)

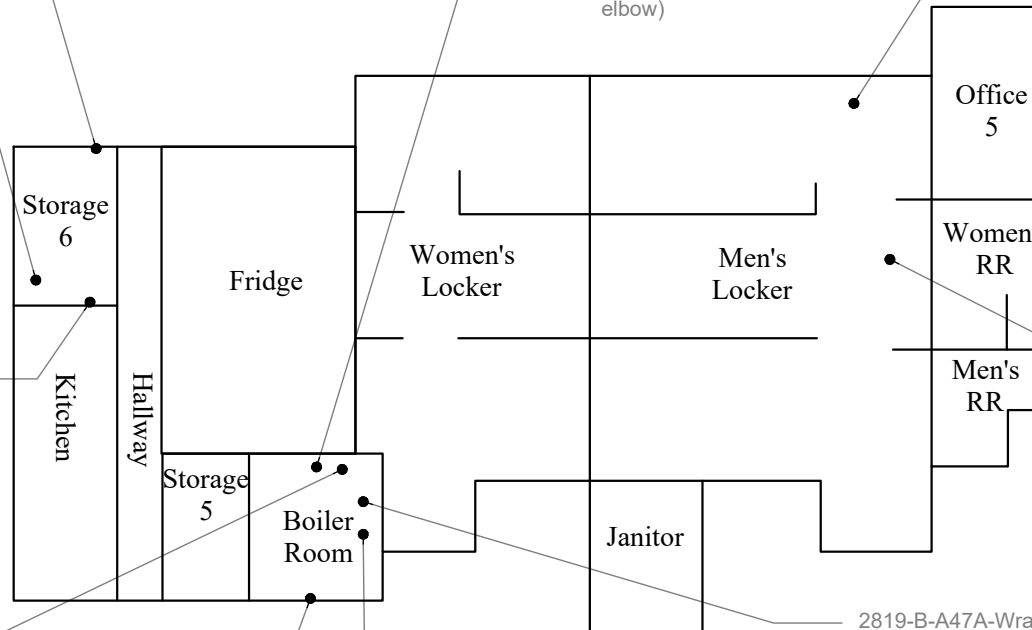
2819-B-A46A-Wrap: ND
 2819-B-A46A-Insulation: ND
 2819-B-A46B-Wrap: ND
 2819-B-A46B-Insulation: ND
 2819-B-A46C-Wrap: ND
 2819-B-A46C-Insulation: ND
 HM ID: 187 (White wrap and insulation on metal 4" pipe)

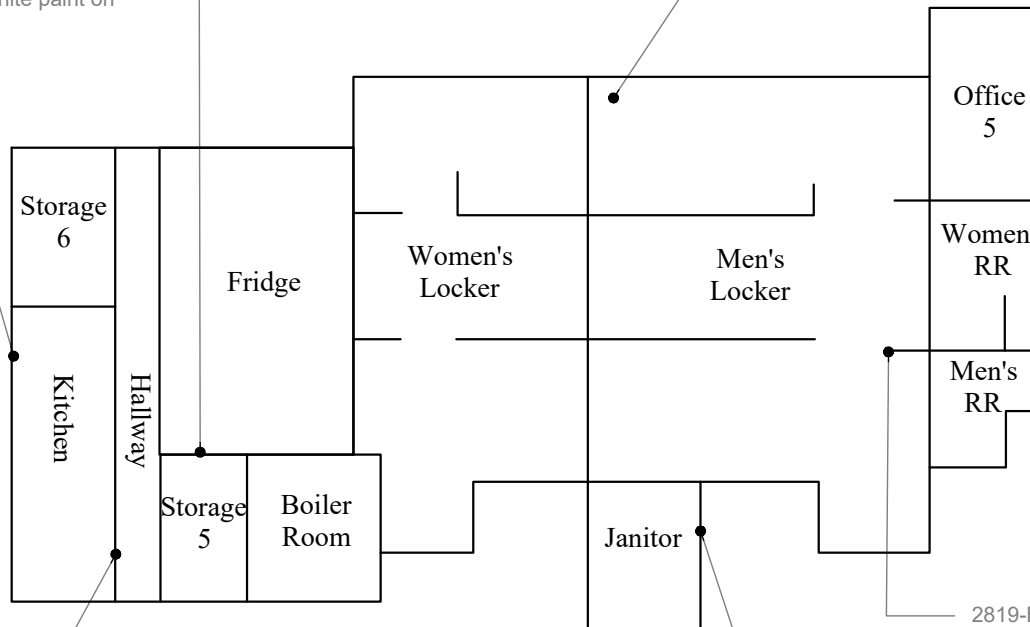
2819-B-P66A: <40 mg/kg
 2819-B-P66B: <40 mg/kg
 HM ID: 172 (White paint on concrete block wall)

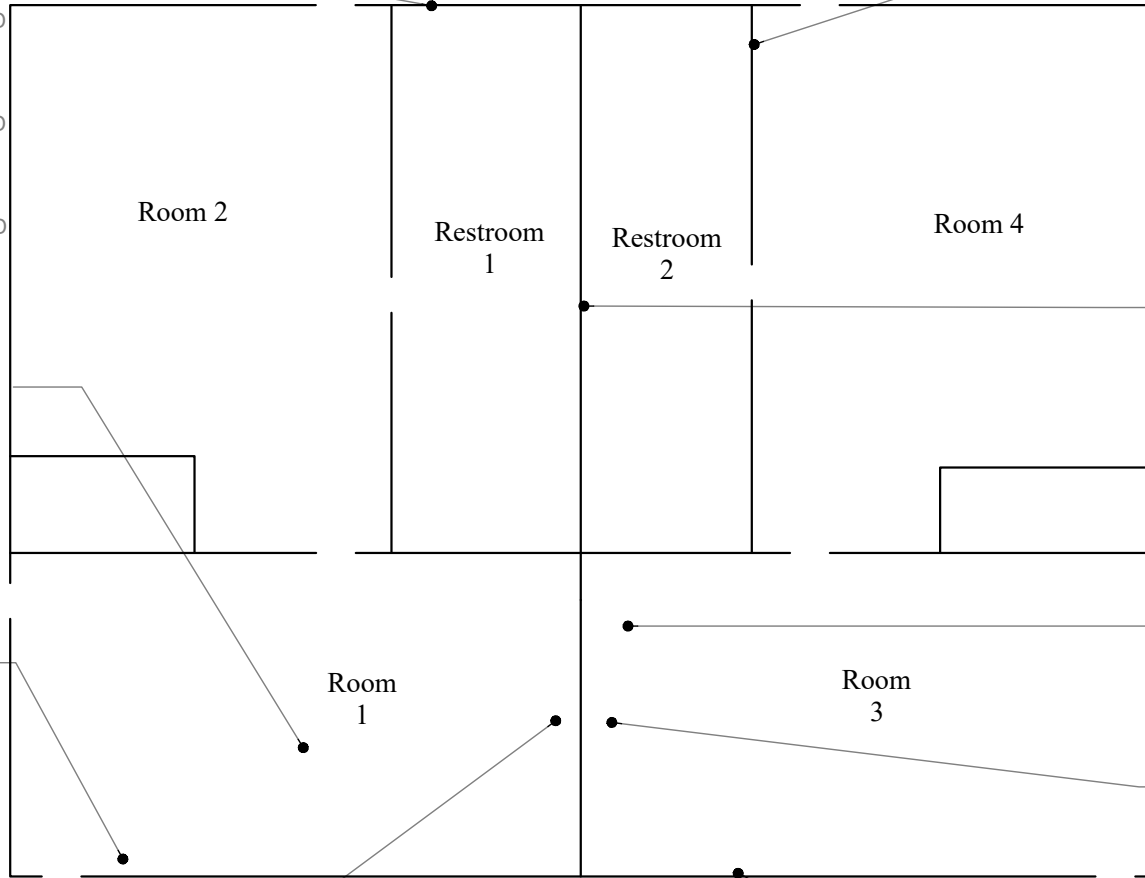
2819-A-A13A-Ceramic tile: ND
 2819-A-A13A-Grout: ND
 2819-A-A13A-Adhesive: ND
 2819-A-A13A-Joint compound: ND
 2819-A-A13B-Ceramic tile: ND
 2819-A-A13B-Grout: ND
 2819-A-A13B-Adhesive: ND
 2819-A-A13B-Joint compound: ND
 2819-A-A13C-Ceramic tile: ND
 2819-A-A13C-Grout: ND
 2819-A-A13C-Adhesive: ND
 2819-A-A13C-Joint compound: ND
 HM ID: 136 (Light gray 2" x 2" ceramic tile and grout on drywall wall)

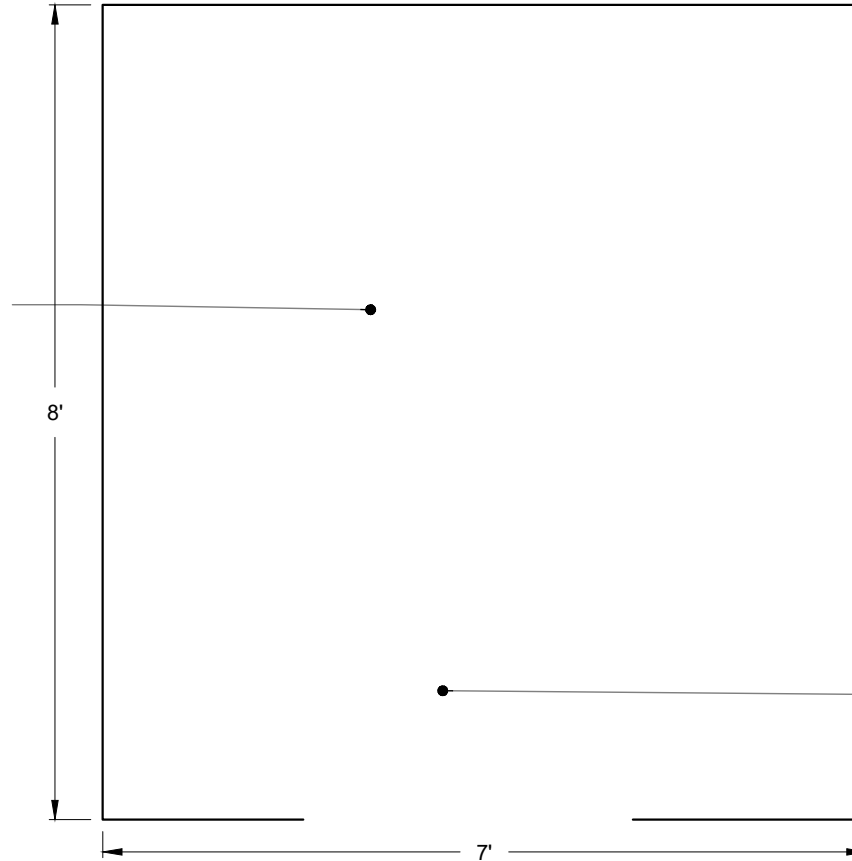
2819-A-A5A: ND
2819-A-A5B: ND
2819-A-A5C-Shingle: ND
2819-A-A5C-Tar: ND
HM ID: 114 (Black shingles and tar on wood roofing system)

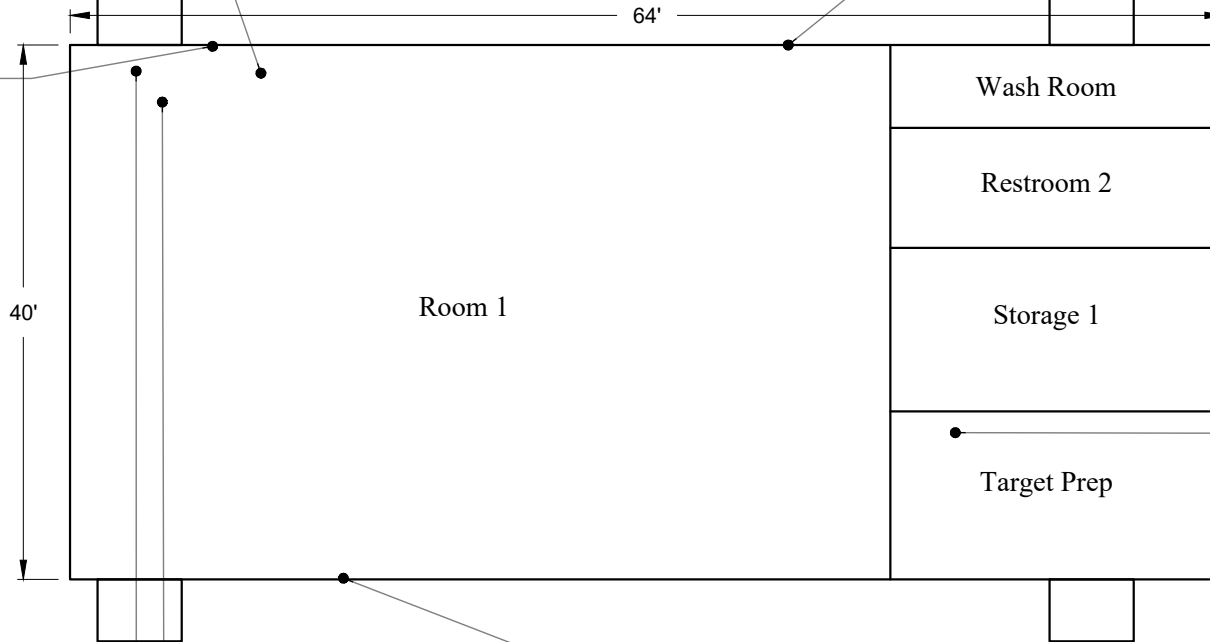
2819-A-A38A: ND
 2819-A-A38B: ND
 2819-A-A38C-Joint compound: ND
 HM ID: 241 (Beige on white drywall and joint compound on concrete block wall)

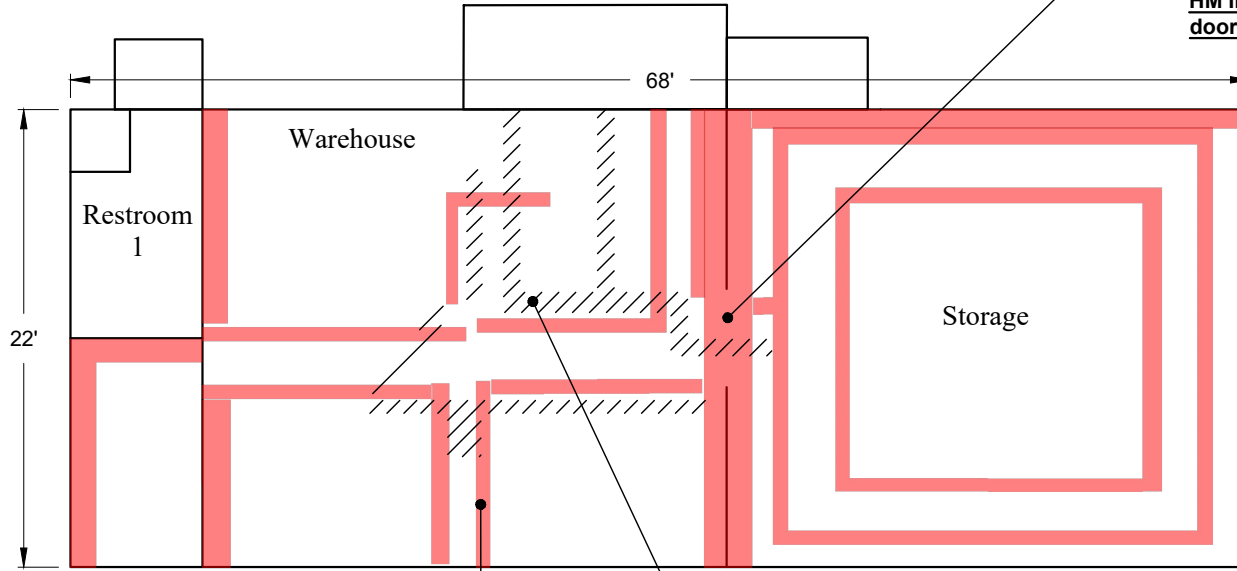
2819-A-P52A: LBP 39,000 mg/kg
2819-A-P52B: LBP 41,000 mg/kg
HM ID: 222 (Beige paint on metal door)
