**HAZARDOUS MATERIAL SURVEY REPORT
FOR
PHASE 2 ANIMAL QUARANTINE STATION RELOCATION
HALAWA VALLEY STREET
AIEA, ISLAND OF OAHU 96701**

MNA PROJECT 3048_2

October 6, 2021

MNA Environmental

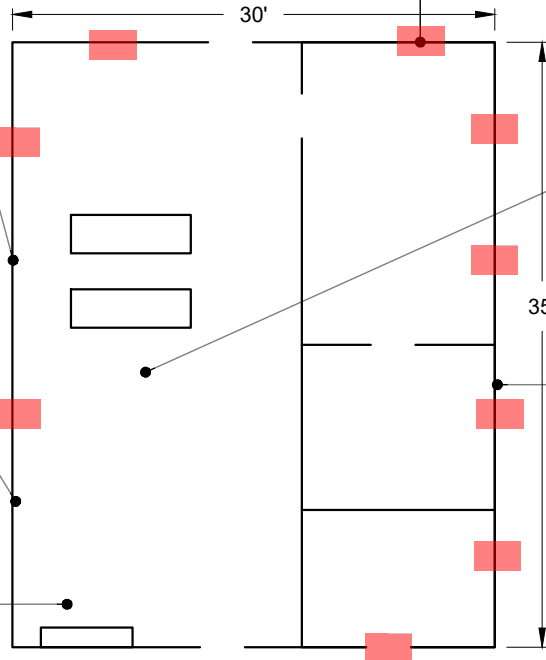
Asbestos Sample and Hazardous Material Locations
 Animal Quarantine Station Site
 Pretreatment Plant Interior and Exterior

3084-A3A: ACM 3%
 3084-A3B: Stop positive
 3084-A3C: Stop positive
HM ID: 23 (Off-white caulking on interior metal window frame)

3084-A8A: ND
 3084-A8B: ND
 3084-A8C: ND
 HM ID: 38 (Black built-up roofing on concrete roofing system)

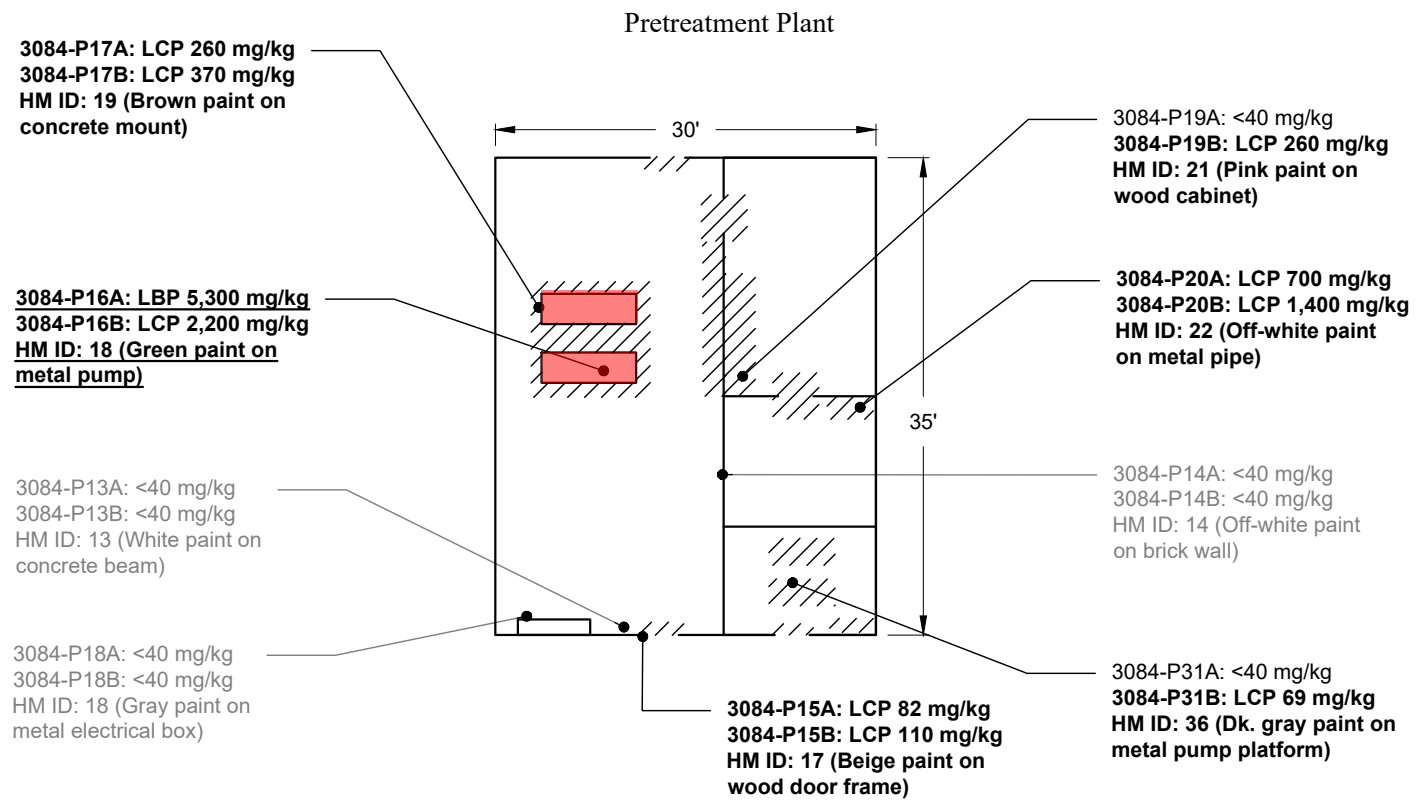
Lead Sample and Hazardous
Material Locations
Animal Quarantine Station Site
Pretreatment Plant Interior

HM ID	Location	Color	Substrate	Result (mg/kg)
17	Doors, door frames, window slats	Beige	Wood	LCP 82 - 110
18	Pipes, pumps	Green	Metal	LBP 2,200 - 5,300
19	Mounts	Brown	Concrete	LCP 260 - 370

HM ID	Location	Color	Substrate	Result (mg/kg)
21	Cabinets	Pink	Wood	LCP <40 - 260
22	Conduit, pipe	Off-white	Metal	LCP 700 - 1,400
36	Pump platform	Dk. gray		LCP <40 - 69

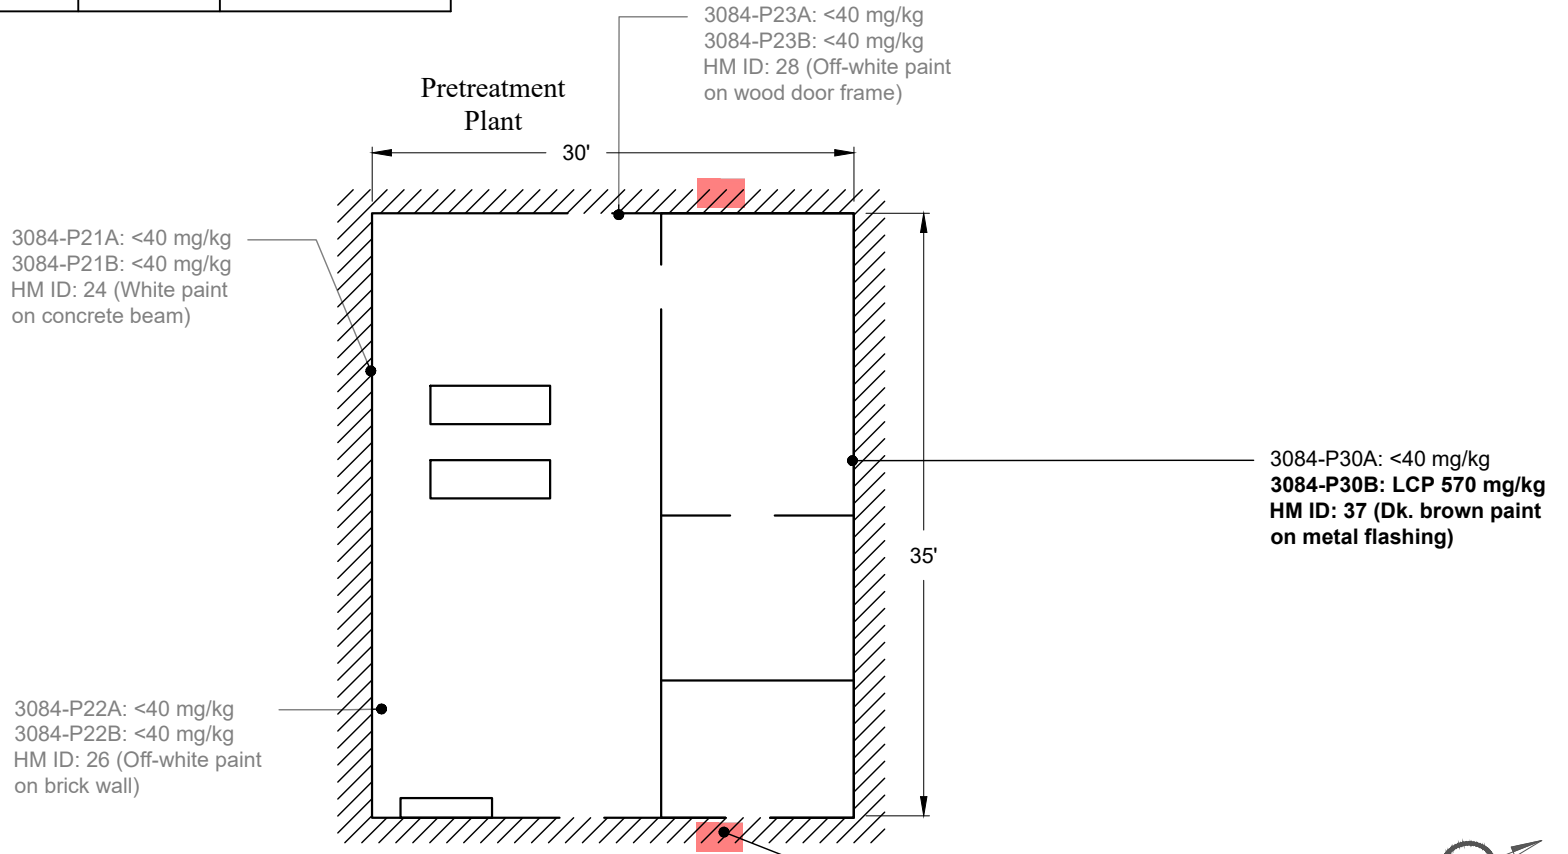
C - 7

HM ID	Location	Color	Substrate	Result (mg/kg)
29	Pipes	Off-white	Metal	LBP 3,600 - 53,000
37	Flashing	Dk. brown		LCP <40 - 570

3084-P24A: LCP 3,600 mg/kg
3084-P24B: LCP 52,000 mg/kg
HM ID: 29 (Off-white paint on metal pipe)

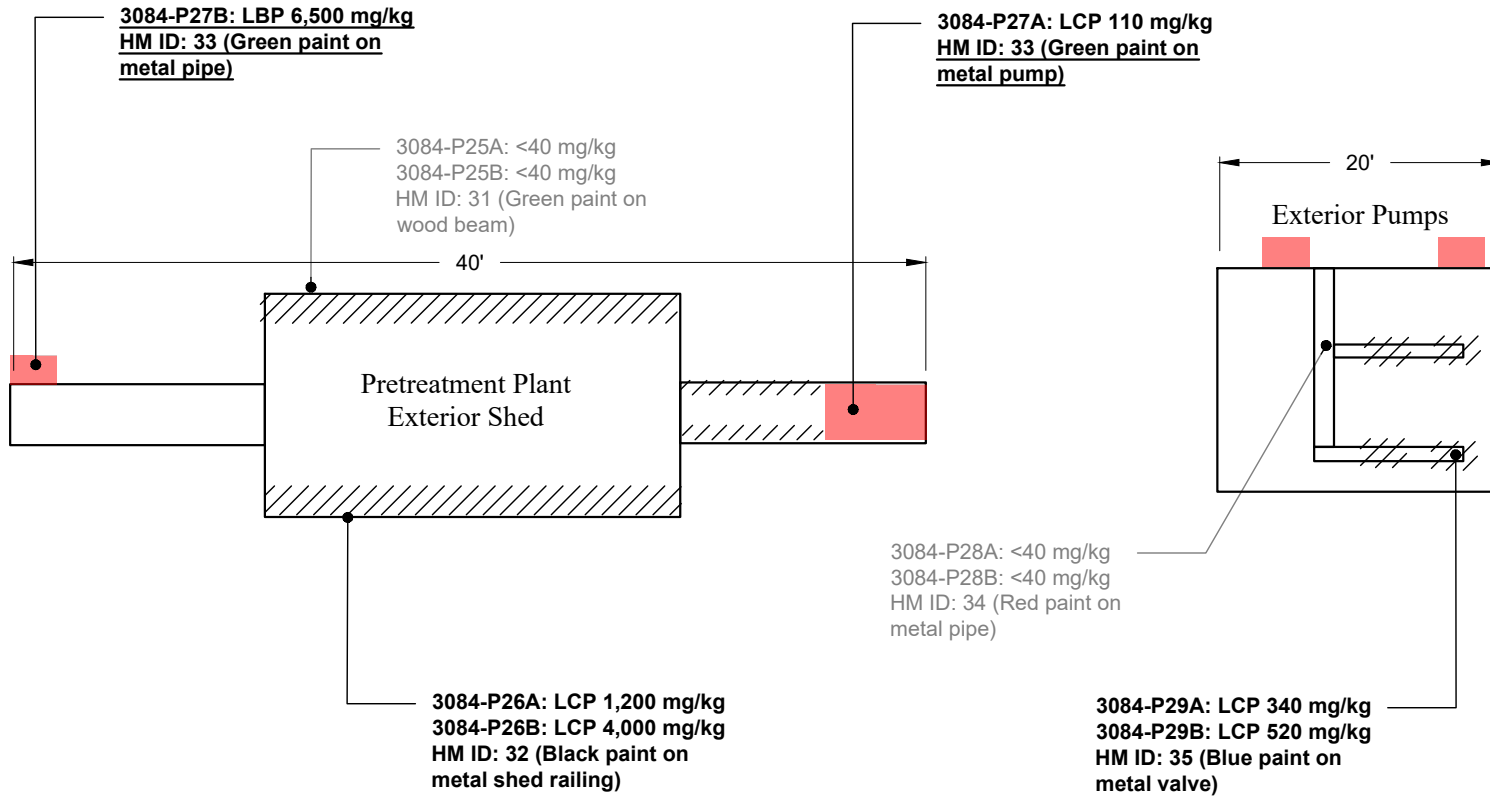
Sheet Number
C - 9

HM ID	Location	Color	Substrate	Result (mg/kg)
32	Shed railings	Black	Metal	LCP 1,200 - 4,000
33	Pipe, pumps	Green		LBP 110 - 6,500
35	Valves	Blue		LCP 340 - 520

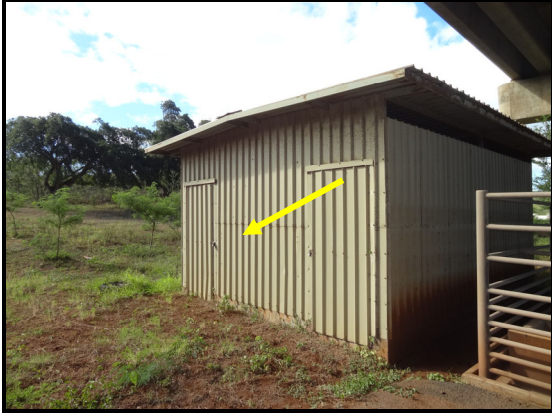
HM ID: 1
Sheds

Exterior
Beige paint on metal wall.

Non-LCP
3048-P1A: <37 mg/kg
3048-P1B: <35 mg/kg

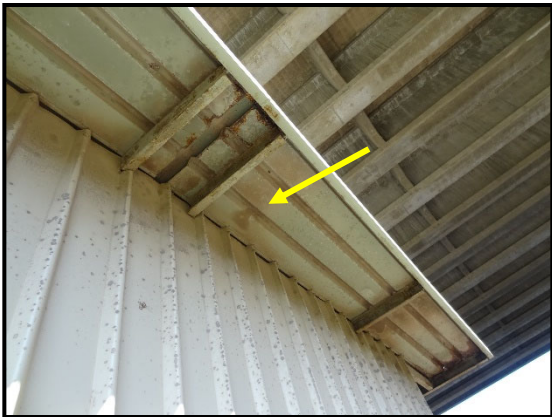
HM ID: 2
Sheds

Exterior
Green paint on metal ceiling/roof underside.

Non-LCP
3048-P2A: <35 mg/kg
3048-P2B: <33 mg/kg

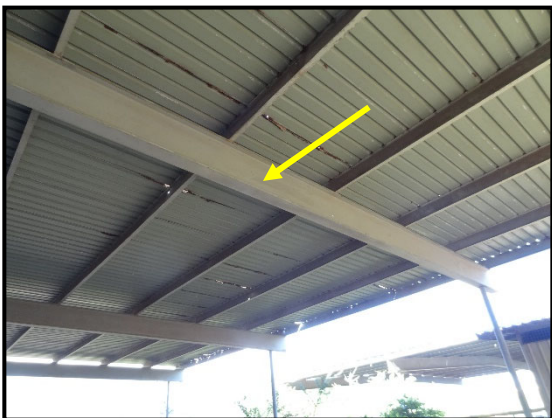
HM ID: 3
Large Canopies

Exterior
Beige paint on metal beam.

LCP
3048-P3A: <39 mg/kg
3048-P3B: 39 mg/kg

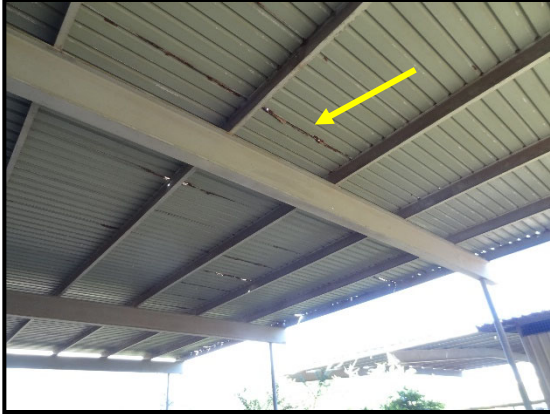
HM ID: 4
Large Canopies

Exterior
Green paint on metal ceiling/roof underside.

LCP
3048-P4A: <36 mg/kg
3048-P4B: 95 mg/kg

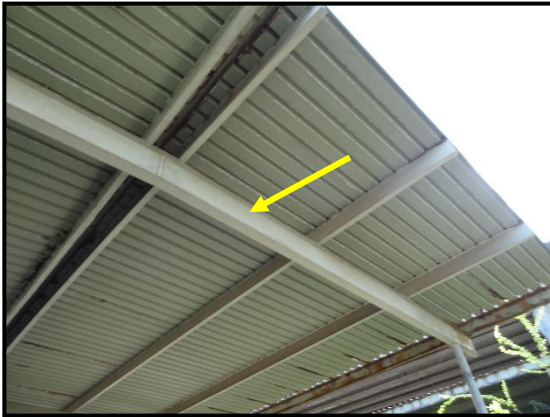
HM ID: 5
Canopies

Exterior
Beige paint on metal beam.

Non-LCP
3048-P5A: <39 mg/kg
3048-P5B: <38 mg/kg

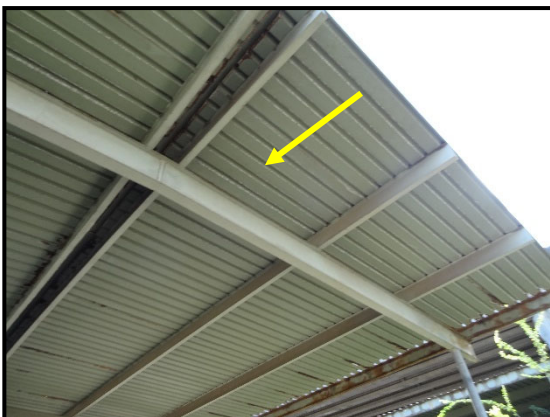
HM ID: 6
Canopies

Exterior
Green paint on metal ceiling/roof underside.

Non-LCP
3048-P6A: <36 mg/kg
3048-P6B: <35 mg/kg

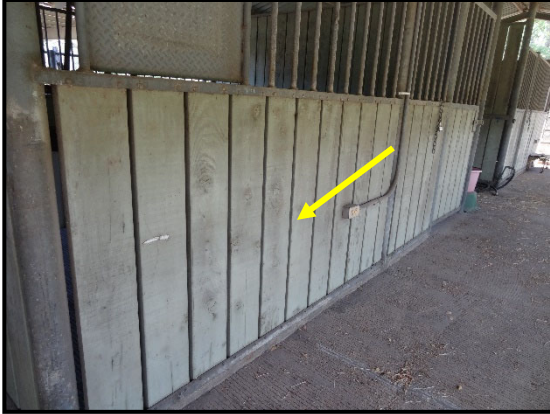
HM ID: 7
Kennel

Interior
Green paint on wood wall.

3048-P7A: <40 mg/kg

3048-P7B: <40 mg/kg

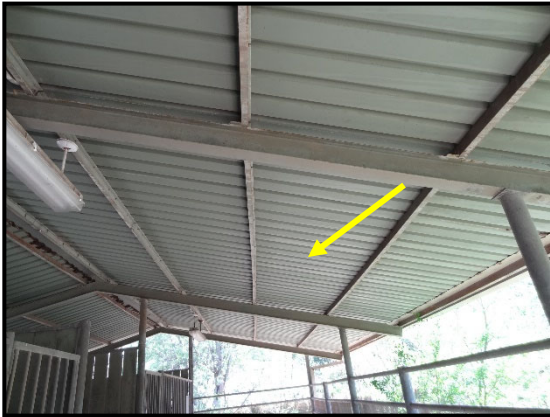
HM ID: 8
Kennel

Interior
Green paint on metal ceiling/roof underside.

3048-P8A: <37 mg/kg

3048-P8B: <40 mg/kg

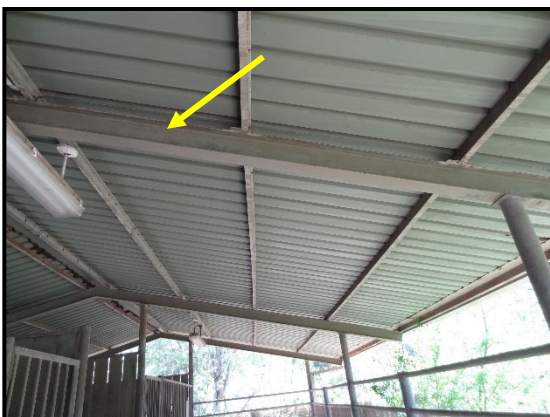
HM ID: 9
Kennel

Interior
Beige paint on metal beam.

3048-P9A: <36 mg/kg

3048-P9B: 55 mg/kg

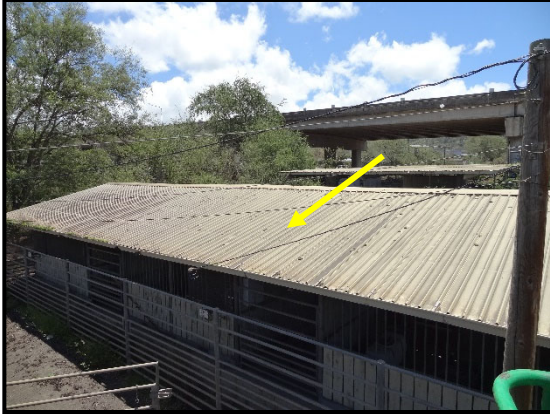
HM ID: 10
Kennel

Exterior
Beige paint on metal roof.

3048-P10A: 44 mg/kg

3048-P10B: <33 mg/kg

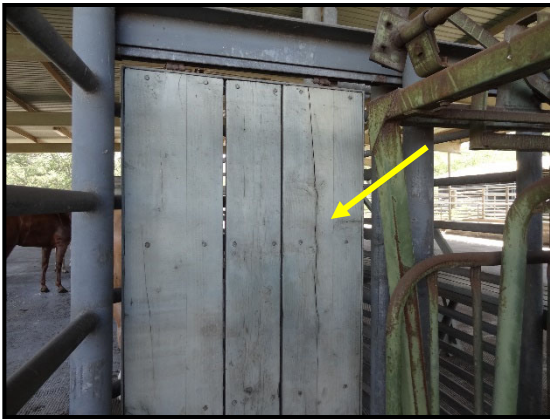
HM ID: 11
Large Canopies

Exterior
Green paint on wood wall.

3048-P11A: <40 mg/kg

3048-P11B: <40 mg/kg

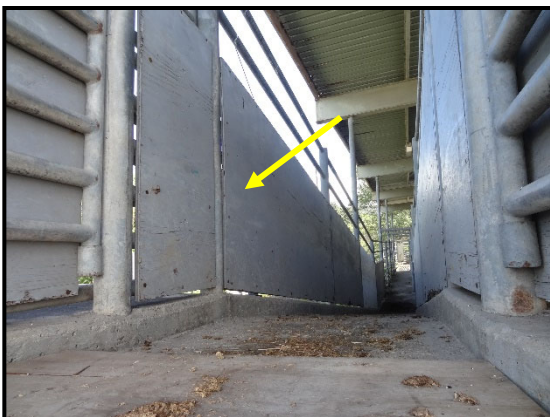
HM ID: 12
Large Canopies

Exterior
Gray paint on wood wall.

3048-P12A: <40 mg/kg

3048-P12B: <40 mg/kg

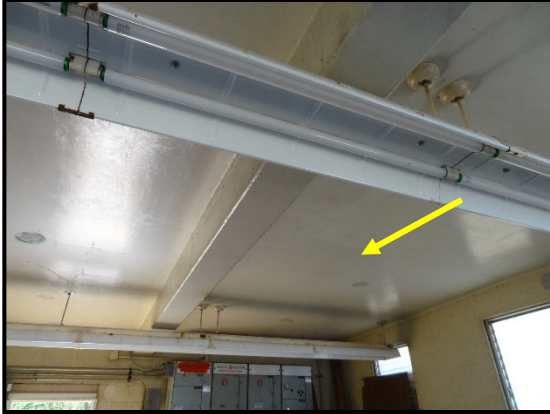
HM ID: 13
Pre-Treatment Plant

Interior
White paint on concrete ceiling.

Non-LCP
3048-P13A: <40 mg/kg
3048-P13B: <40 mg/kg

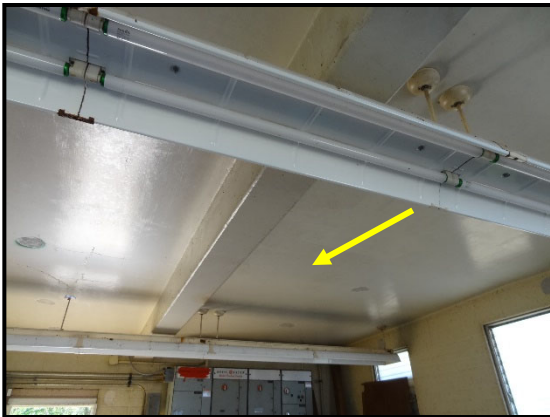
HM ID: 14
Pre-Treatment Plant

Interior
White textured paint and skim coat on concrete ceiling.

Non-ACM
3048-A1A-Textured paint: ND
3048-A1A-Skim coat: ND
3048-A1B-Textured paint: ND
3048-A1B-Skim coat: ND
3048-A1C-Textured paint: ND
3048-A1C-Skim coat: ND

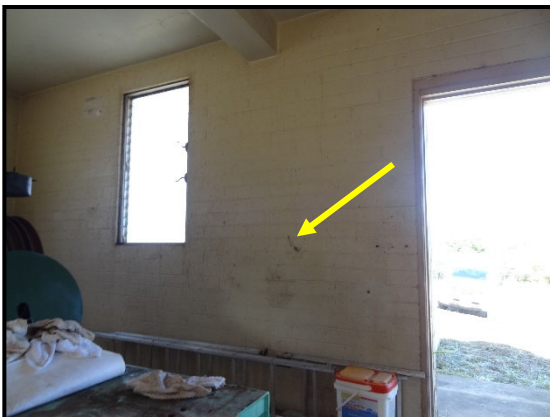
HM ID: 15
Pre-Treatment Plant

Interior
Off-white paint on brick wall.

Non-LCP
3048-P14A: <40 mg/kg
3048-P14B: <40 mg/kg

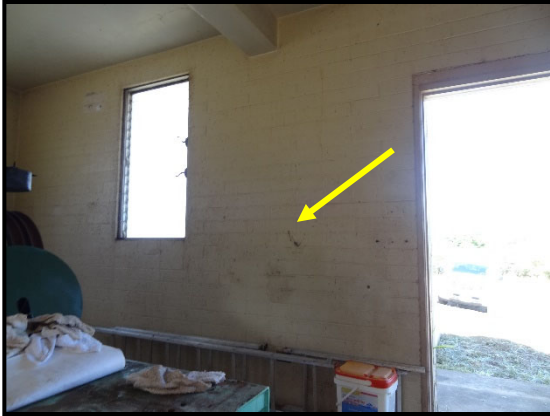
HM ID: 16
Pre-Treatment Plant

Interior
Off-white textured paint and skim coat on brick wall.

Non-ACM

3048-A2A-Paint/skim coat: ND
3048-A2B-Paint/skim coat: ND
3048-A2C-Textured Paint/skim coat: ND

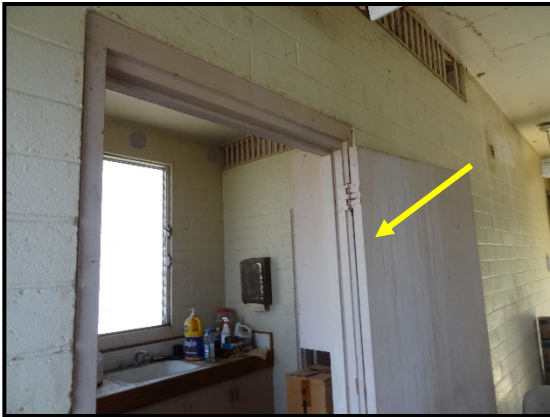
HM ID: 17
Pre-Treatment Plant

Interior
Beige paint on wood door.

LCP

3048-P15A: 110 mg/kg
3048-P15B: 82 mg/kg

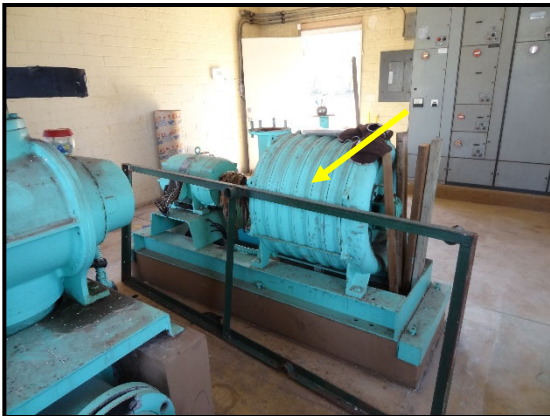
HM ID: 18
Pre-Treatment Plant

Interior
Green paint on metal pump.

LBP

3048-P16A: 5,300 mg/kg
3048-P16B: 2,200 mg/kg

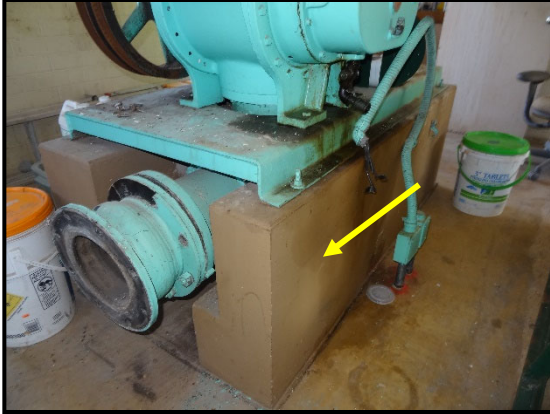
HM ID: 19
Pre-Treatment Plant

Interior
Brown paint on concrete mount.

LCP
3048-P17A: 370 mg/kg
3048-P17B: 260 mg/kg

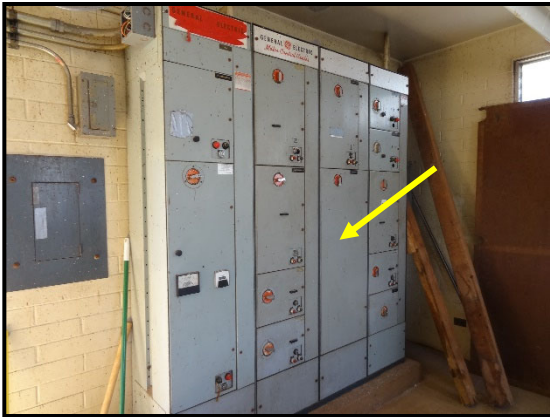
HM ID: 20
Pre-Treatment Plant

Interior
Gray paint on metal electrical box.

Non-LCP
3048-P18A: <40 mg/kg
3048-P18B: <40 mg/kg

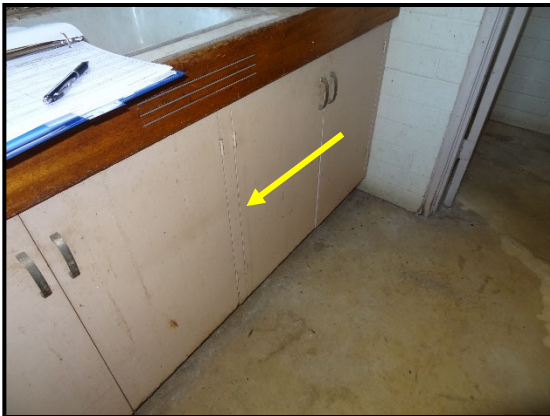
HM ID: 21
Pre-Treatment Plant

Interior
Pink paint on wood cabinet.

LCP
3048-P19A: <40 mg/kg
3048-P19B: 260 mg/kg

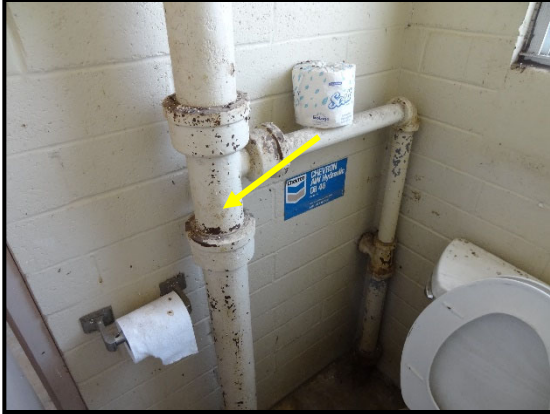
HM ID: 22
Pre-Treatment Plant

Interior
Off-white paint on metal pipe.

LCP
3048-P20A: 1,400 mg/kg
3048-P20B: 700 mg/kg

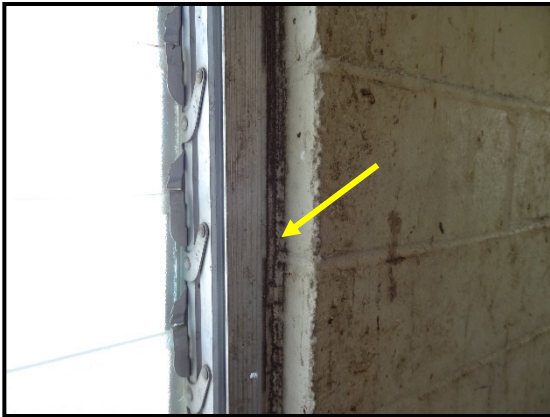
HM ID: 23
Pre-Treatment Plant

Interior
White caulking metal window frame.

ACM
3048-A3A: 3% Chrysotile
3048-A3B: Stop positive
3048-A3C: Stop positive

Employees involved in demolition and construction activities that disturb asbestos must conduct work in accordance with 29 CFR 1926.1101, the OSHA Asbestos Construction Standard. Work practices that would trigger these requirements include, but are not limited to, repair, maintenance, or renovation of structures containing asbestos, as well as removal or encapsulation of materials containing asbestos. For each project, the contractor must determine the appropriate safety measures based on the area to be disturbed, the type, volume, and condition of asbestos materials. Applicable work practice guidelines involving the disturbance of asbestos materials are summarized, but are not limited to:

- Waste and dust containing asbestos must be collected separately from other construction debris. Workers must conduct prompt and controlled clean up and disposal of asbestos wastes and debris in leak-tight containers.

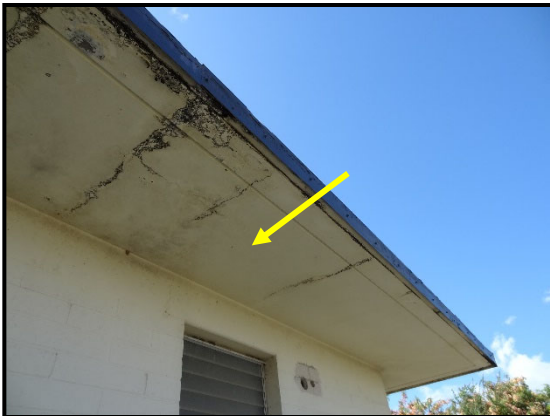
HM ID: 24
Pre-Treatment Plant

Exterior
White paint on concrete eave.

Non-LCP
3048-P21A: <40 mg/kg
3048-P21B: <40 mg/kg

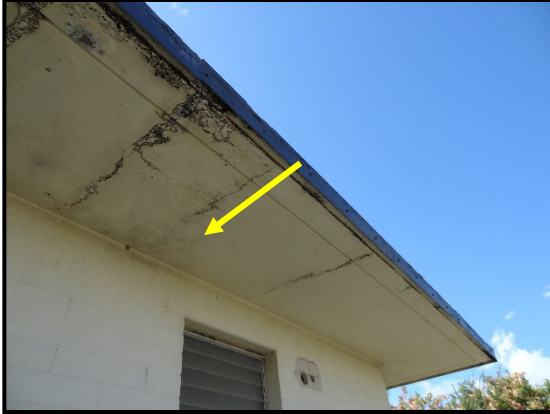
HM ID: 25
Pre-Treatment Plant

Exterior
White paint and skim coat on concrete eave.

Non-ACM

- 3048-A5A-Paint: ND
- 3048-A5A-Skim coat: ND
- 3048-A5B-Paint: ND
- 3048-A5B-Skim coat: ND
- 3048-A5C-Paint: ND
- 3048-A5C-Skim coat: ND

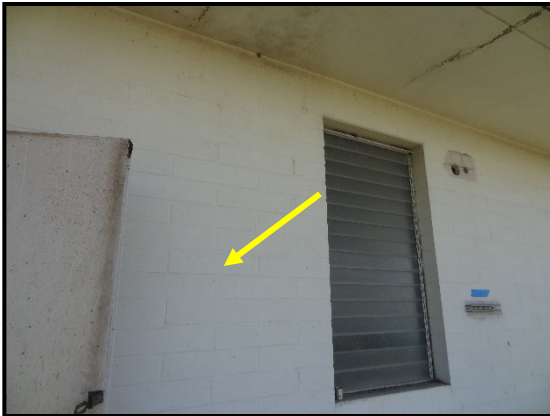
HM ID: 26
Pre-Treatment Plant

Exterior
Off-white paint on brick wall.

Non-LCP

- 3048-P22A: <40 mg/kg
- 3048-P22B: <40 mg/kg

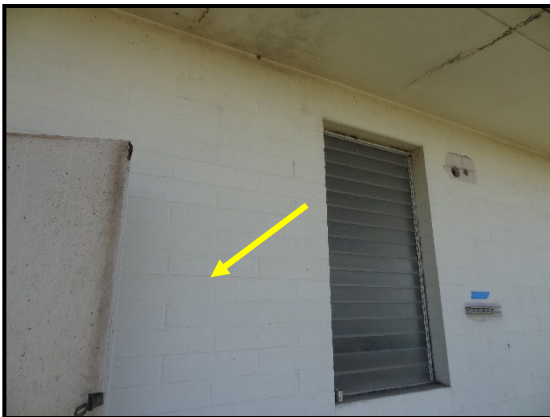
HM ID: 27
Pre-Treatment Plant

Exterior
Off-white paint and skim coat on brick wall.

Non-ACM

- 3048-A6A-Paint: ND
- 3048-A6A-Skim coat: ND
- 3048-A6B-Paint: ND
- 3048-A6B-Skim coat: ND
- 3048-A6C-Paint: ND
- 3048-A6C-Skim coat: ND

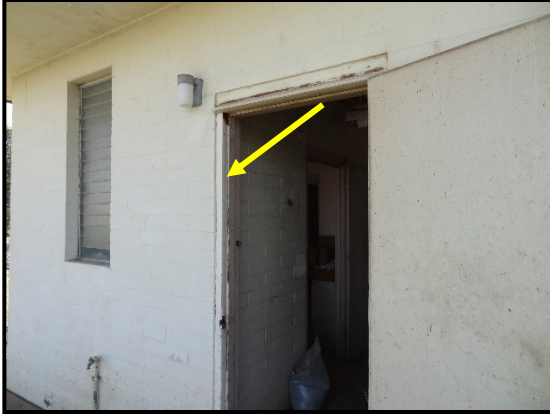
HM ID: 28
Pre-Treatment Plant

Exterior
Off-white paint on wood door frame.

Non-LCP
3048-P23A: <40 mg/kg
3048-P23B: <40 mg/kg

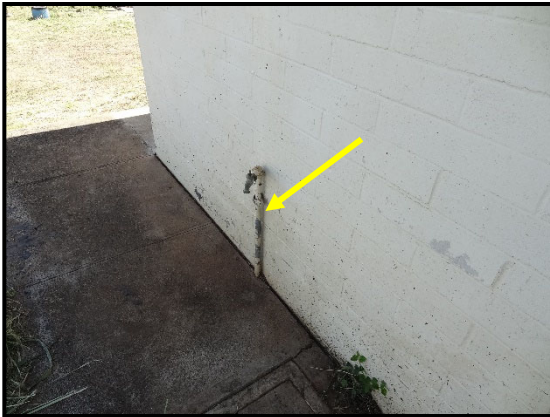
HM ID: 29
Pre-Treatment Plant

Exterior
Off-white paint on metal pipe.

LBP
3048-P24A: 53,000 mg/kg
3048-P24B: 3,600 mg/kg

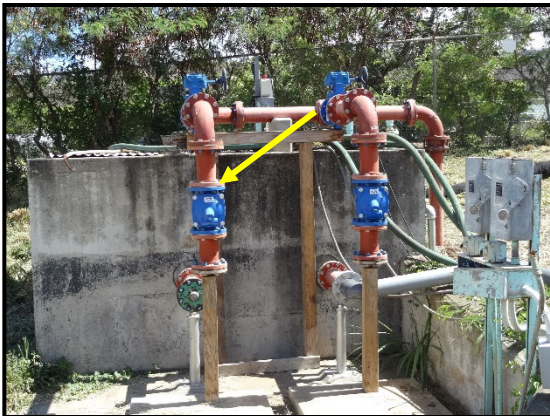
HM ID: 30
Pre-Treatment Plant

Exterior
Light green gasket on metal valve.

Non-ACM
3048-A7A: ND
3048-A7B: ND
3048-A7C: ND

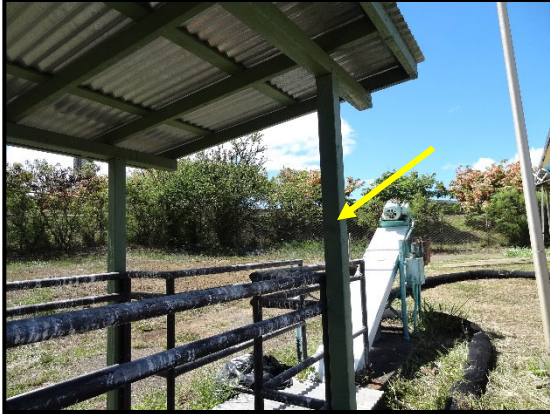
HM ID: 31
Pre-Treatment Plant

Shed
Green paint on wood post.

Non-LCP
3048-P25A: <40 mg/kg
3048-P25B: <40 mg/kg

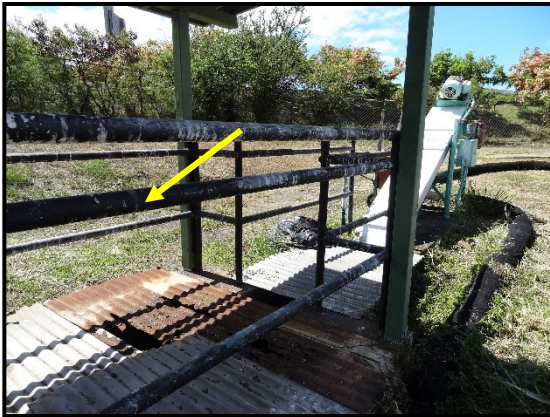
HM ID: 32
Pre-Treatment Plant

Shed
Black paint on metal railing.

LCP
3048-P26A: 4,000 mg/kg
3048-P26B: 1,200 mg/kg

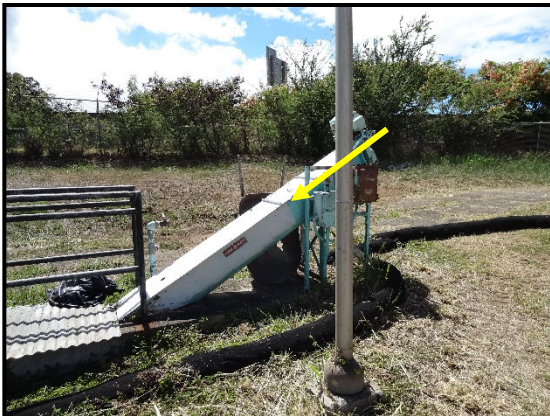
HM ID: 33
Pre-Treatment Plant

Shed
Green paint on metal pump.

LBP
3048-P27A: 6,500 mg/kg
3048-P27B: 110 mg/kg

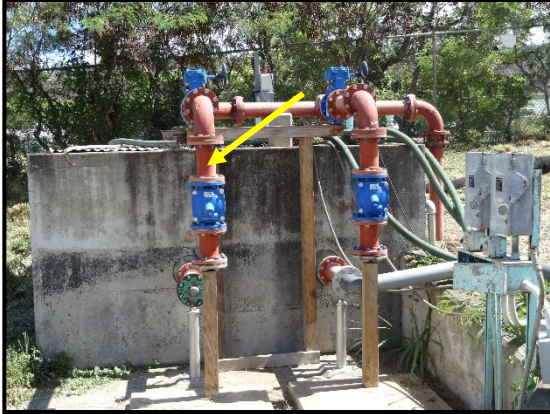
HM ID: 34
Pre-Treatment Plant

Exterior
Red paint on metal pipe.

Non-LCP
3048-P28A: <40 mg/kg
3048-P28B: <40 mg/kg

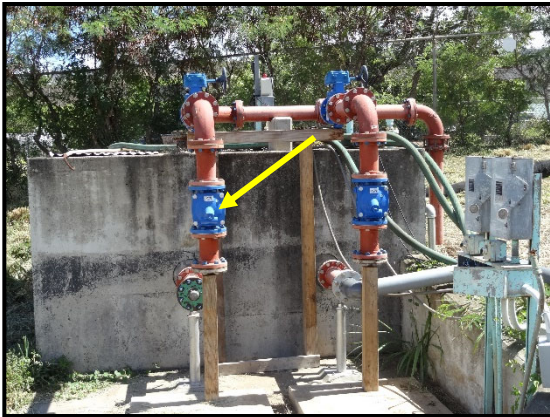
HM ID: 35
Pre-Treatment Plant

Exterior
Blue paint on metal valve.

LCP
3048-P29A: 520 mg/kg
3048-P29B: 340 mg/kg

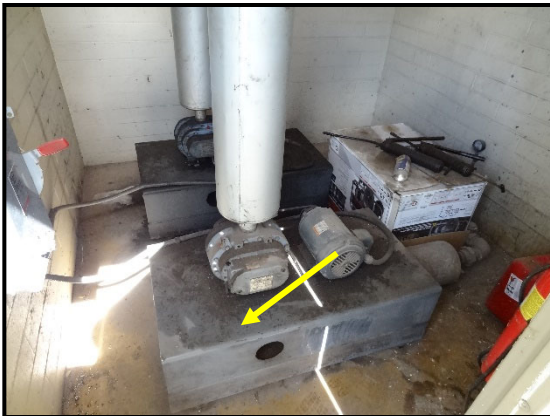
HM ID: 36
Pre-Treatment Plant

Interior
Dark gray paint on metal pump platform.

LCP
3048-P31A: 69 mg/kg
3048-P31B: <40 mg/kg

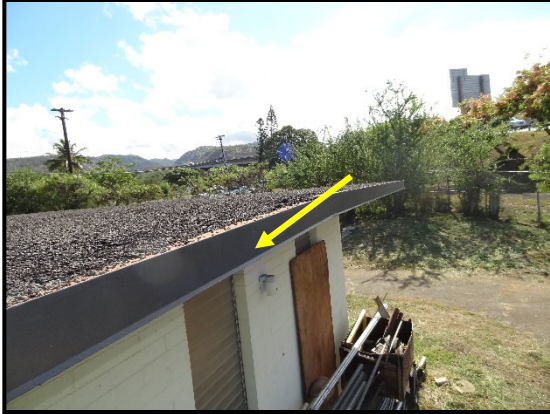
HM ID: 37
Pre-Treatment Plant

Exterior
Dark brown paint on metal flashing.

LCP
3048-P30A: 570 mg/kg
3048-P30B: <40 mg/kg

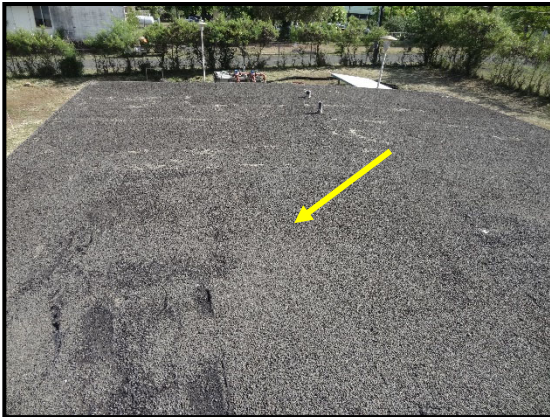
HM ID: 38
Pre-Treatment Plant

Exterior
Black built-up roofing on concrete roofing system.
