**HAZARDOUS MATERIAL SURVEY REPORT
FOR
PHASE 2 OAHU COMMUNITY CORRECTIONAL CENTER
HDOA ANIMAL QUARANTINE STATION
99-951 HALAWA VALLEY STREET
AIEA, ISLAND OF OAHU 96701**

**MNA PROJECT 02819_2
AHL PROJECT No. 6930.001
DAGS JOB No. 12-27-5713**

November 30, 2020

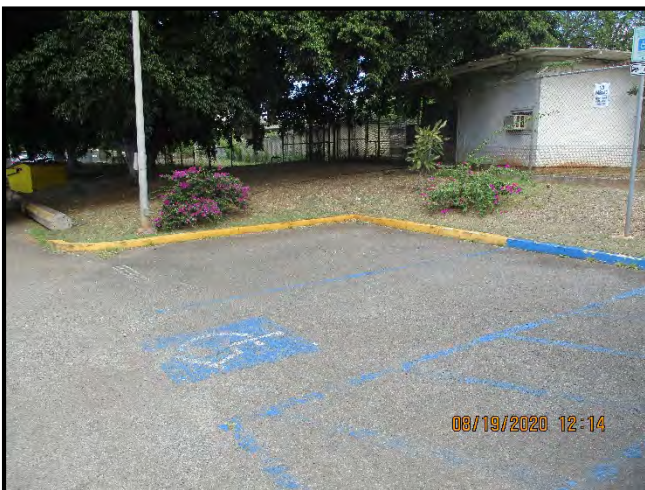
Parking Lot
August 2020

10. Parking Lot. Five paints suspected of containing lead were identified and sampled, generating 10 samples for analysis. One lead paint was found to be LBP, with results ranging from 19,000 mg/kg to 28,000 mg/kg.

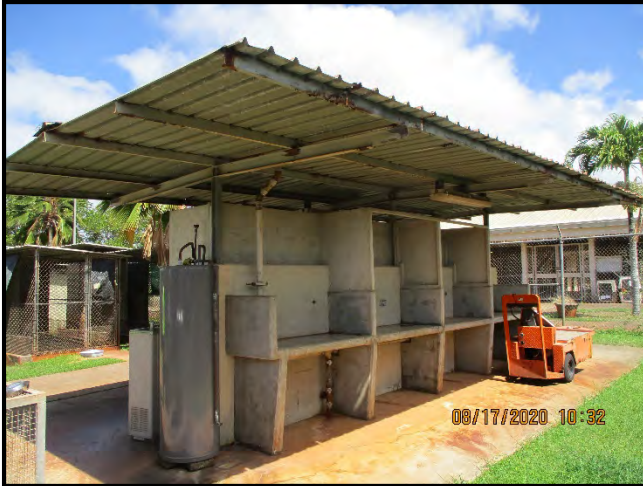
Wash Area Type 1
August 2020

12. Wash Areas Type 1. Five paints suspected of containing lead were identified and sampled, generating 10 samples for analysis. Two lead paints were confirmed, with results ranging from 91 mg/kg to 8,700 mg/kg. One of those paints was found to be LBP, with results of 8,700 mg/kg.

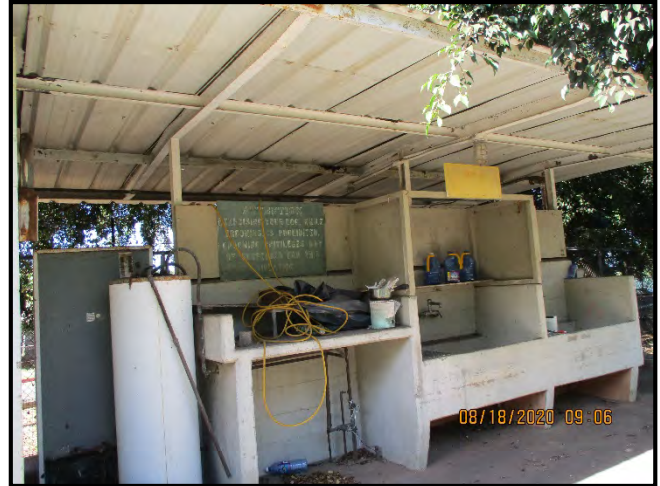
Wash Area Type 2
August 2020

13. Wash Areas Type 2. Three homogeneous materials suspected of containing asbestos were identified and sampled, generating nine samples for analysis. None of the samples contained 1% or greater asbestos by volume. Therefore, it is concluded that no ACM are present in the Wash Areas Type 2. All three materials, however, were found to contain less than 1% asbestos, and were therefore subjected to a point count analysis. The laboratory point count result indicated a trace amount of asbestos, 0.1 – 0.2% asbestos in paints/skim coats, specifically the brown paint/skim coat on concrete block walls, white paint/skim coat on concrete block walls, and white paint/skim coat on concrete walls.

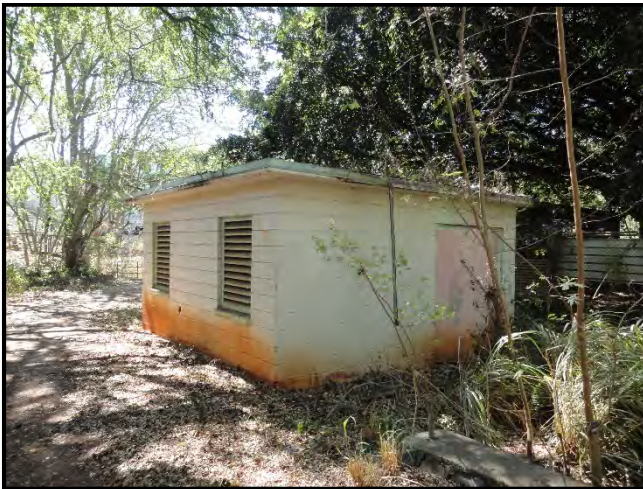
Water Shed
August 2020

14. Water Shed. Seven homogeneous materials suspected of containing asbestos were identified and sampled, generating twenty-one samples for analysis. None of the samples contained 1% or greater asbestos by volume. Therefore, it is concluded that no ACM are present in the Water Shed. Three materials, however, contained less than 1% asbestos, and were therefore subjected to a point count analysis. The laboratory point count result indicated a trace amount of asbestos, <0.1 – 0.1% asbestos in paints/skim coats and caulking, specifically white paint/skim coat on concrete block walls, white paint/skim coat on concrete ceilings, eaves, and walls, and white caulking on metal door and window frames.

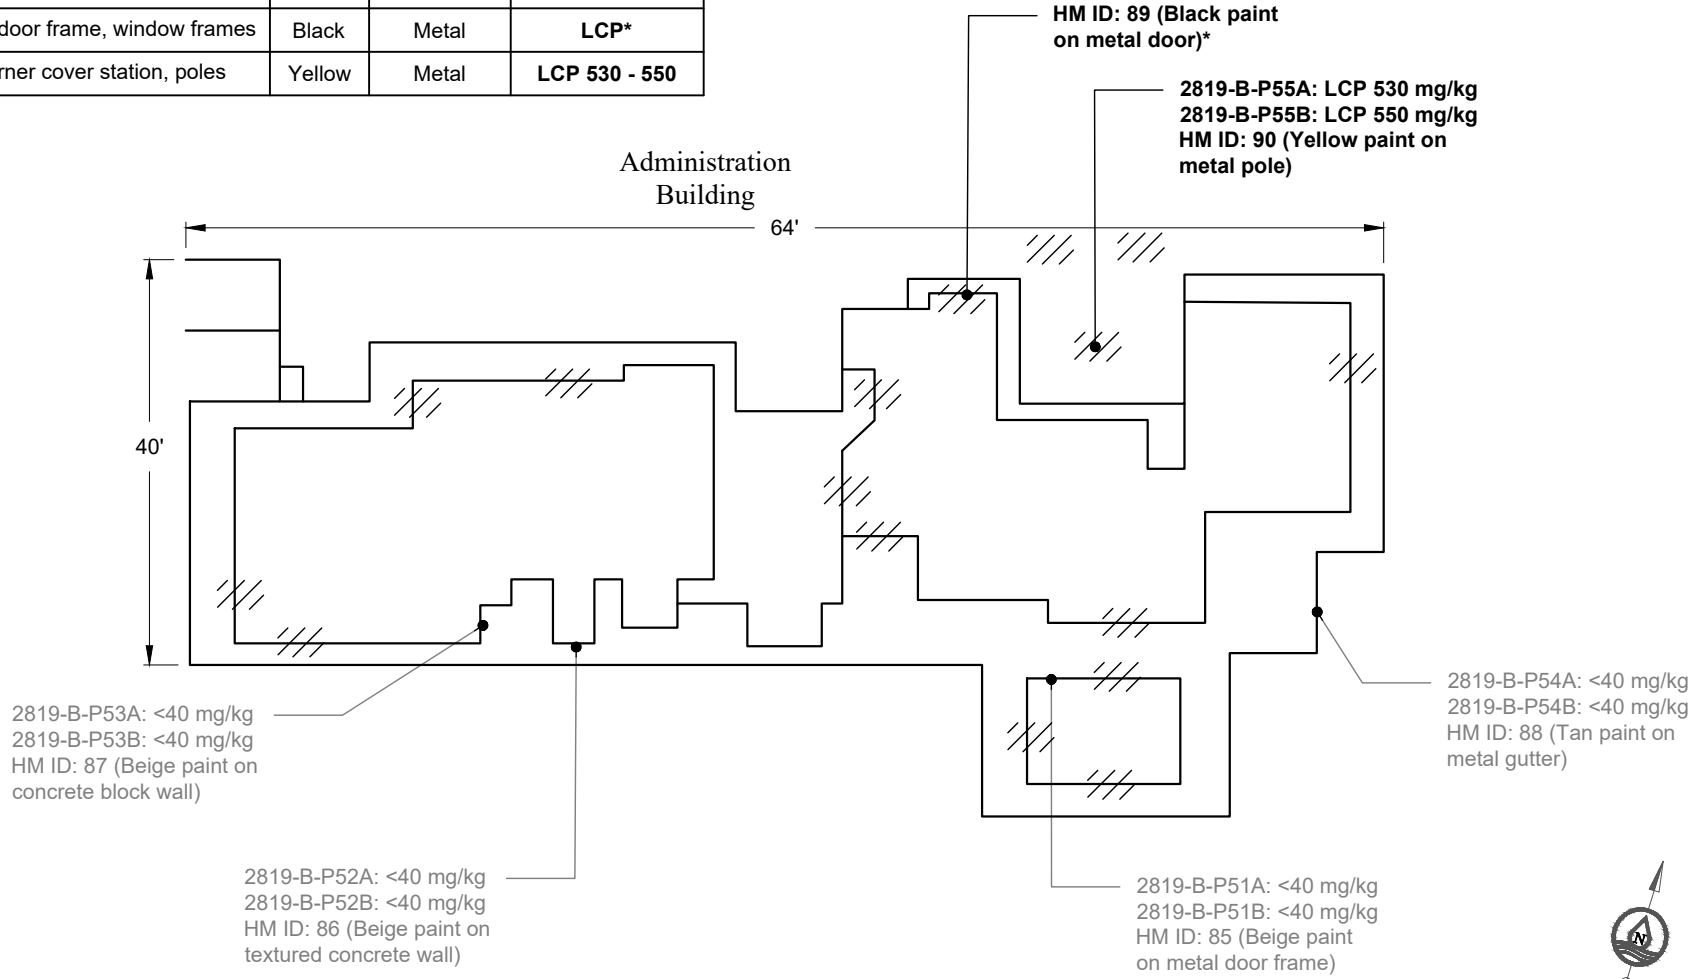
Lead Sample and Hazardous Material Locations
Animal Quarantine Station Site
Administration Building Exterior 1 of 2

HM ID	Locations	Color	Substrate	Results (mg/kg)
89	Door, door frame, window frames	Black	Metal	LCP*
90	Corner cover station, poles	Yellow	Metal	LCP 530 - 550

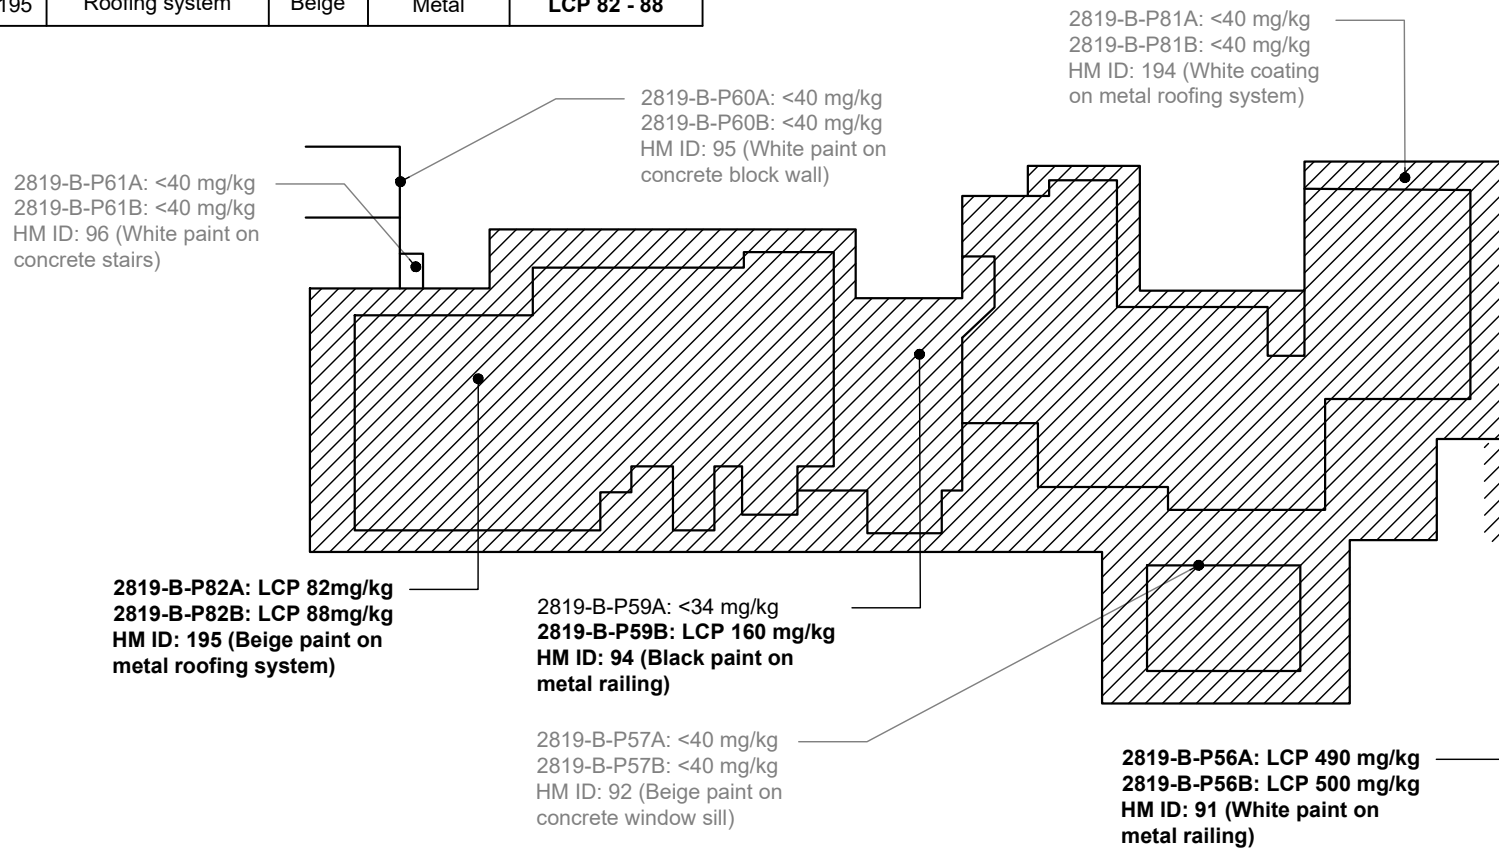
Lead Sample and Hazardous Material Locations
Animal Quarantine Station Site
Administration Building Exterior 2 of 2

HM ID	Locations	Color	Substrate	Results (mg/kg)
91	Railing	White	Metal	LCP 490 - 500
94	Railing	Black	Metal	LCP <34 - 160
195	Roofing system	Beige	Metal	LCP 82 - 88

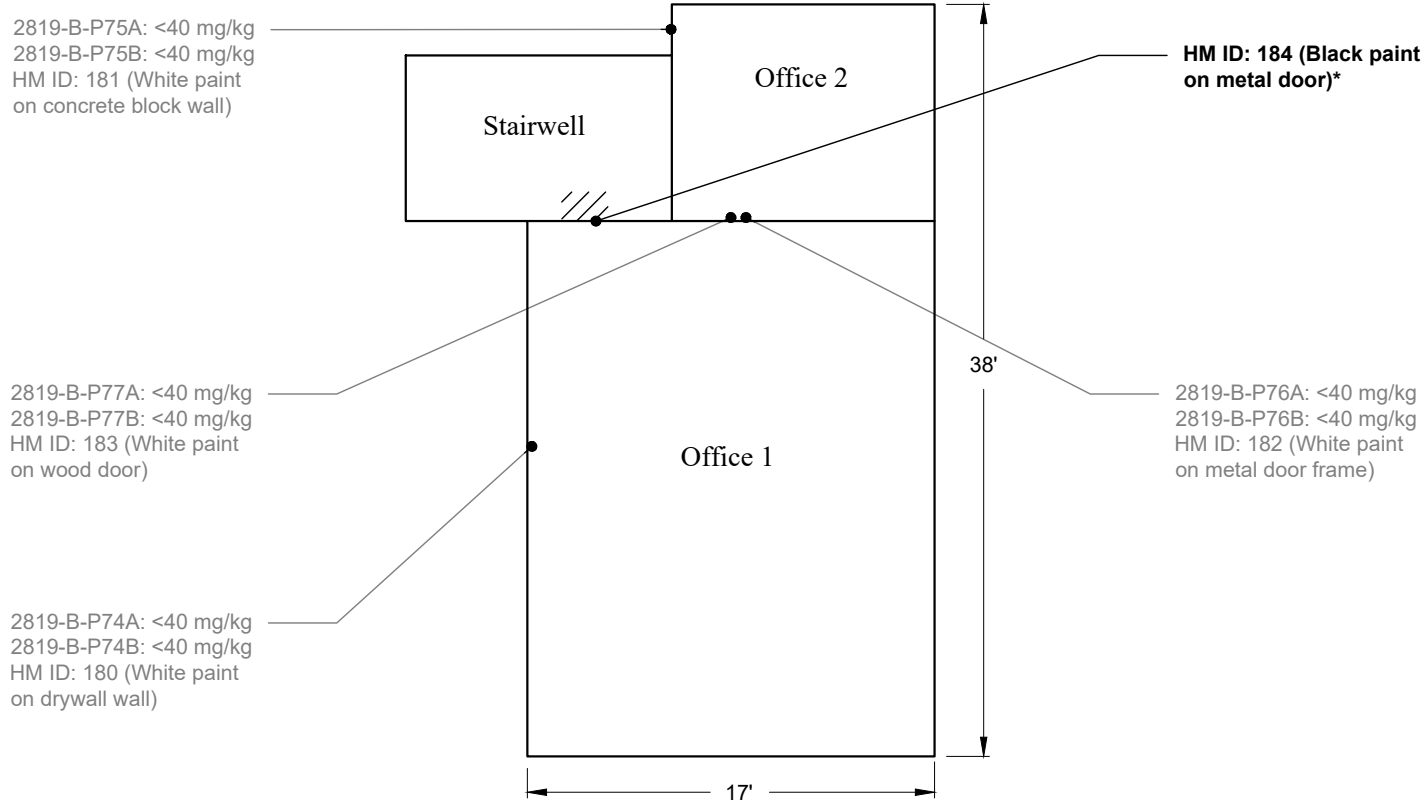
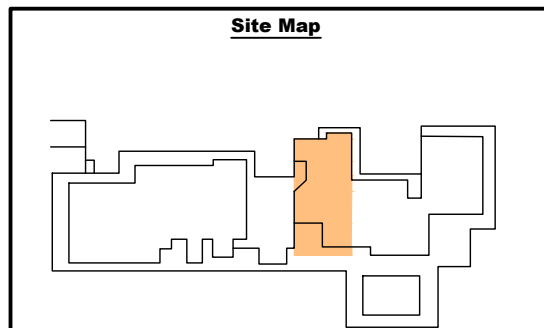
Sheet Number
D1 - 14

HM ID	Locations	Color	Substrate	Results (mg/kg)
184	Door	Black	Metal	LCP*

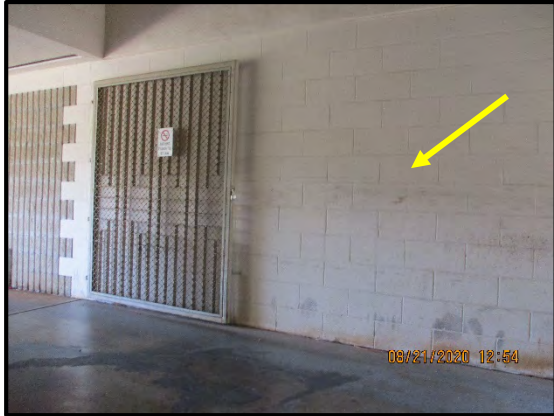
HM ID: 27
Admin Building
Floor 1

Exterior
Beige textured paint and skim coat on concrete block wall.

Non-ACM

2819-B-A27A-Texture paint: ND
2819-B-A27B-Texture paint: ND
2819-B-A27C-Texture paint: ND
2919-B-A27C-Skim coat: ND

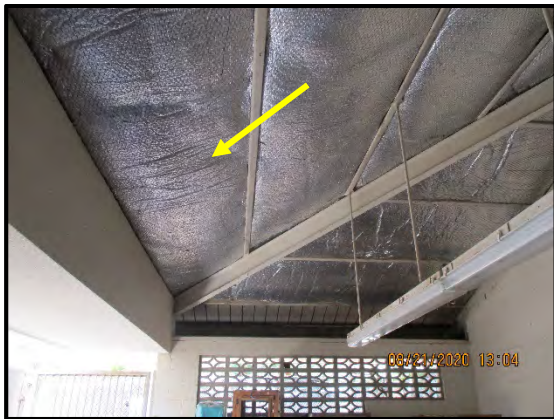
HM ID: 28
Admin Building
Floor 1

Exterior
Silver thermal system insulation on metal ceiling.

Non-ACM

2819-B-A28A-Wrap: ND
2819-B-A28A-Insulation: ND
2819-B-A28B-Wrap: ND
2819-B-A28B-Insulation: ND
2819-B-A28C-Wrap: ND
2819-B-A28C-Insulation: ND

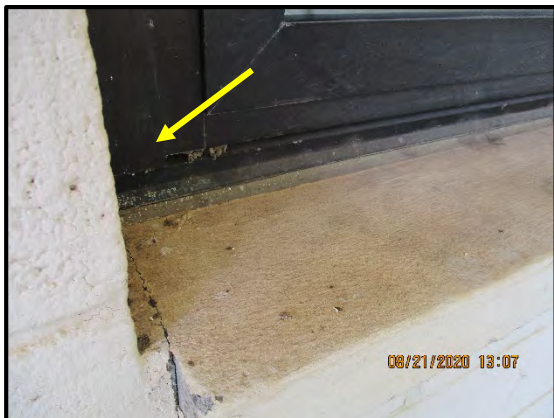
HM ID: 29
Admin Building
Floor 1

Exterior
Black grout on concrete window frame.

Non-ACM

2819-B-A29A: ND
2819-B-A29B: ND
2819-B-A29C: ND

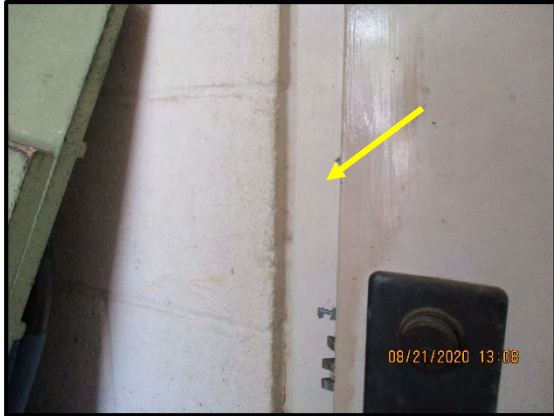
HM ID: 30
Admin Building
Floor 1

Exterior
White foam and caulking on concrete door frame.

Non-ACM

2819-B-A30A-Caulk like: ND
2819-B-A30A-Foam: ND
2819-B-A30B: ND
2819-B-A30C: ND

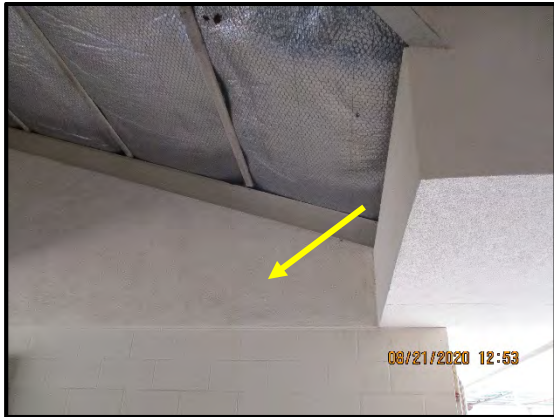
HM ID: 26
Admin Building
Floor 1

Exterior
Beige textured paint and skim coat on concrete ceiling.

Non-ACM

2819-B-A26A-Skim coat: ND
2819-B-A26A-Texture paint: ND
2819-B-A26B-Skim coat: ND
2819-B-A26B-Texture paint: ND
2819-B-A26C-Skim coat: ND

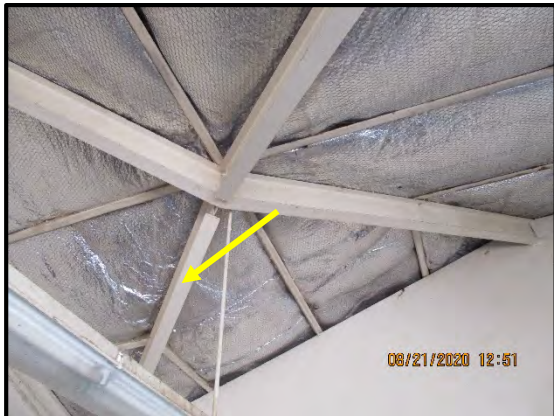
HM ID: 85
Admin Building
Floor 1

Exterior
Beige paint on metal beam.

2819-B-P51A: <40 mg/kg
2819-B-P51B: <40 mg/kg

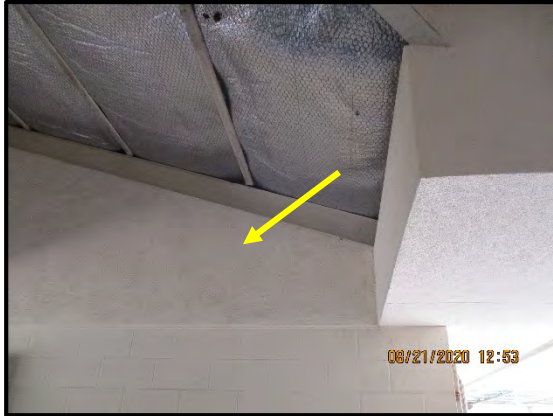
HM ID: 86
Admin Building
Floor 1

Exterior
Beige paint on textured concrete ceiling.

Non-LCP
2819-B-P52A: <40 mg/kg
2819-B-P52B: <40 mg/kg

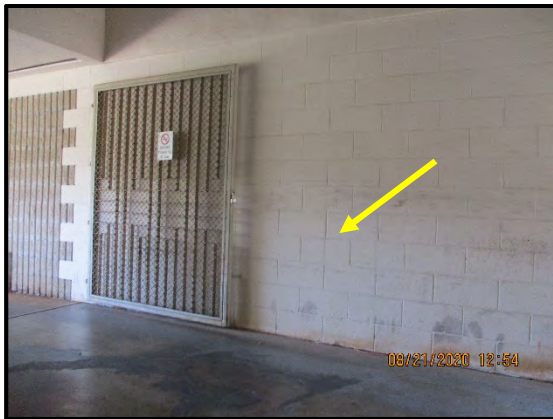
HM ID: 87
Admin Building
Floor 1

Exterior
Beige paint on concrete block wall.

Non-LCP
2819-B-P53A: <40 mg/kg
2819-B-P53B: <40 mg/kg

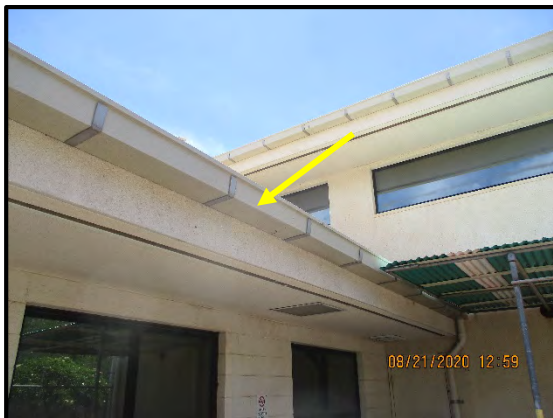
HM ID: 88
Admin Building
Floor 1

Exterior
Tan paint on metal gutter.

Non-LCP
2819-B-P54A: <33 mg/kg
2819-B-P54B: <55 mg/kg

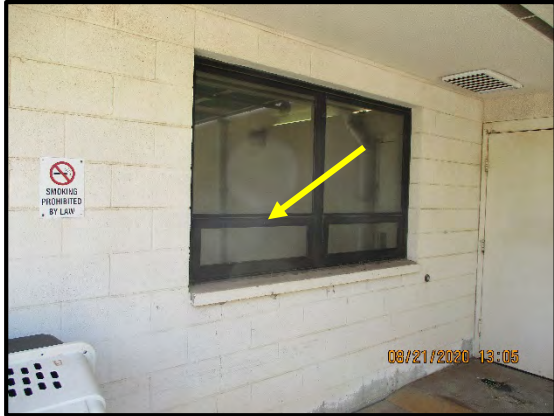
HM ID: 89
Admin Building
Floor 1
Exterior
Black paint on metal door.
**Assumed LCP
(Baked on paint)**

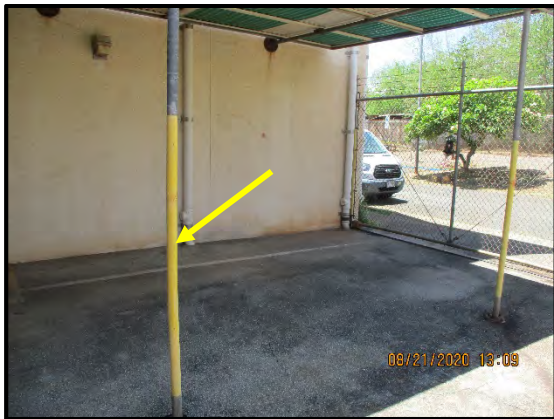
HM ID: 90
Admin Building
Floor 1
Exterior
Yellow paint on pole.
LCP
2819-B-P55A: 530 mg/kg
2819-B-P55B: 550 mg/kg

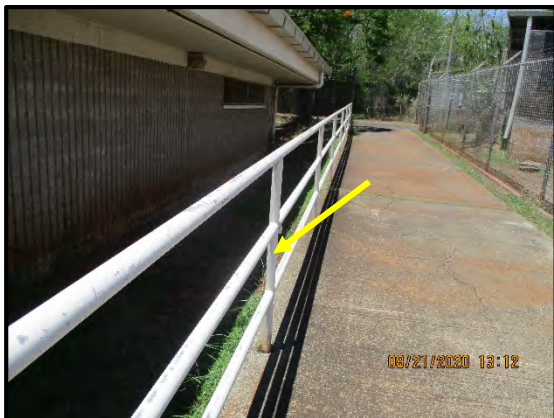
HM ID: 91
Admin Building
Floor 1
Exterior
White paint on metal railing.
LCP
2819-B-P56A: 490 mg/kg
2819-B-P56B: 500 mg/kg

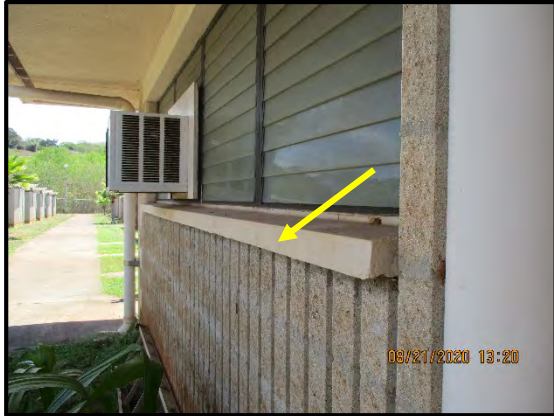
HM ID: 92
Admin Building
Floor 1

Exterior
Beige paint on concrete windowsill.

Non-LCP
2819-B-P57A: <40 mg/kg
2819-B-P57B: <40 mg/kg

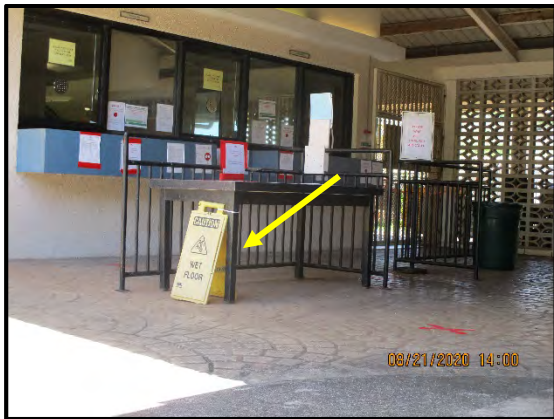
HM ID: 94
Admin Building
Floor 1

Exterior
Black paint on metal railing.

LCP
2819-B-P59A: 160 mg/kg
2819-B-P59B: <34 mg/kg

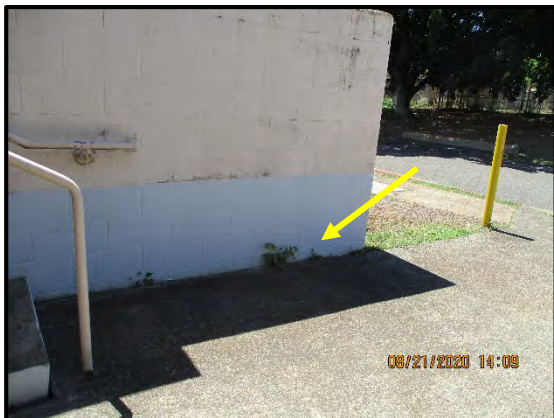
HM ID: 95
Admin Building
Floor 1

Exterior
White paint on concrete block wall.

Non-LCP
2819-B-P60A: <40 mg/kg
2819-B-P60B: <40 mg/kg

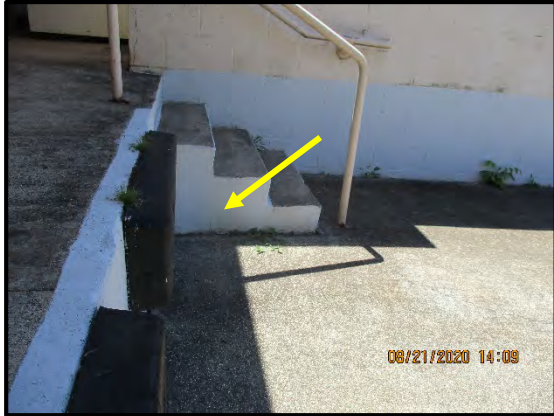
HM ID: 96
Admin Building
Floor 1

Exterior
White paint on concrete stairs.

Non-LCP
2819-B-P61A: <40 mg/kg
2819-B-P61B: <40 mg/kg

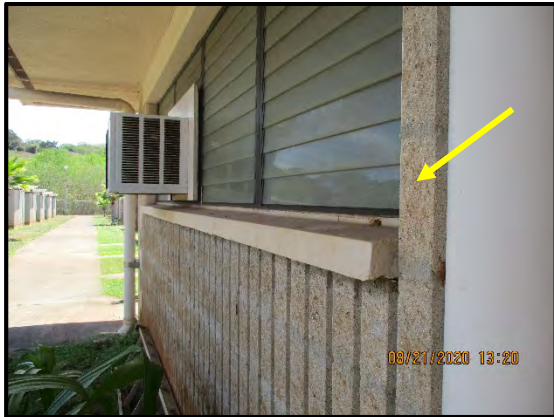
HM ID: 100
Admin Building
Floor 1

Exterior
Beige paint and skim coat on concrete windowsill.

Non-ACM
2819-B-A32A: ND
2819-B-A32B: ND
2819-B-A32C: ND

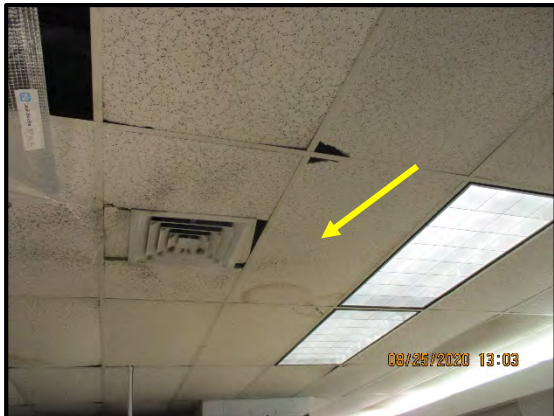
HM ID: 158
Admin Building
Floor 1

Kitchen
White 2' x 4' acoustic tile ceiling.

Non-ACM
2819-B-A32A: ND
2819-B-A32B: ND
2819-B-A32C: ND

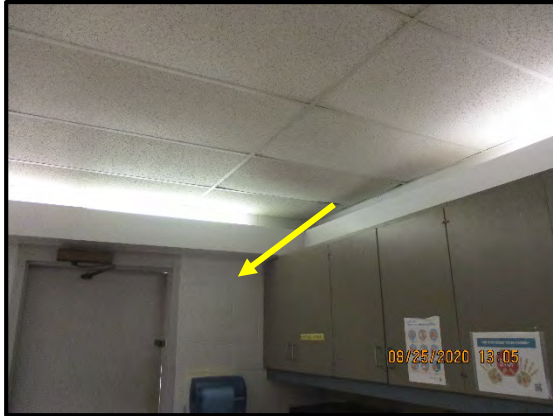
HM ID: 159
Admin Building
Floor 1

Break Room
White drywall wall.

Non-ACM

2819-B-A33A: ND
2819-B-A33B-Drywall: ND
2819-B-A33B-Joint Compound: ND
2819-B-A33C: ND

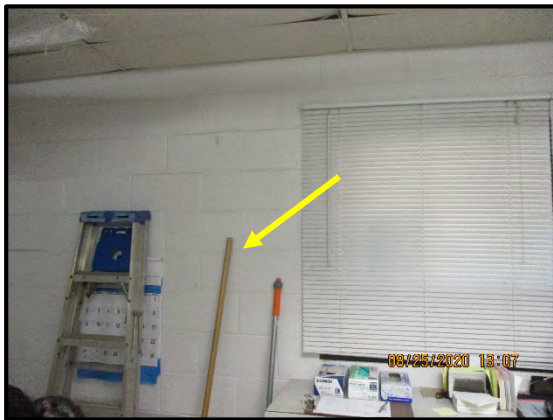
HM ID: 160
Admin Building
Floor 1

Kitchen
White paint and skim coat on concrete block wall.

Non-ACM

2819-B-A34A-Comp Texture paint/Skim coat: ND
2819-B-A34B-Comp Texture paint/Skim coat: ND
2819-B-A34C-Comp Texture paint/Skim coat: ND

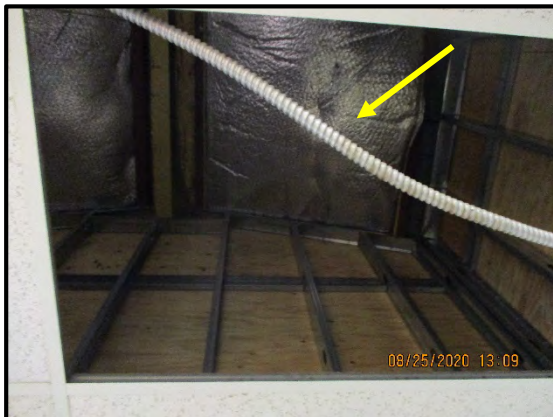
HM ID: 161
Admin Building
Floor 1

Plenum
Silver thermal system insulation on metal ceiling.

Non-ACM

2819-B-A35A-Wrap: ND
2819-B-A35A-Insulation: ND
2819-B-A35B-Wrap: ND
2819-B-A35B-Insulation: ND
2819-B-A35C-Wrap: ND
2819-B-A35C-Insulation: ND

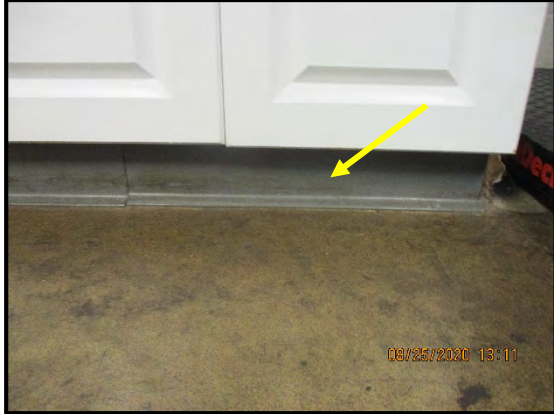
HM ID: 162
Admin Building
Floor 1

Break Room
Gray cove base on wood wall.

Non-ACM
2819-B-A36A-Cove base: ND
2819-B-A36A-Mastic: ND
2819-B-A36B-Cove base: ND
2819-B-A36B-Mastic: ND
2819-B-A36C-Cove base: ND
2819-B-A36C-Mastic: ND

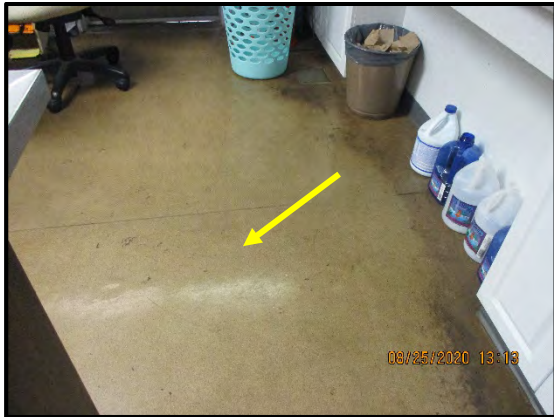
HM ID: 163
Admin Building
Floor 1

Dispensary
Tan linoleum and mastic on concrete floor.

Non-ACM
2819-B-A37A-Linoleum: ND
2819-B-A37A-Mastic: ND
2819-B-A37B-Linoleum: ND
2819-B-A37B-Mastic: ND
2819-B-A37C-Linoleum: ND
2819-B-A37C-Mastic: ND

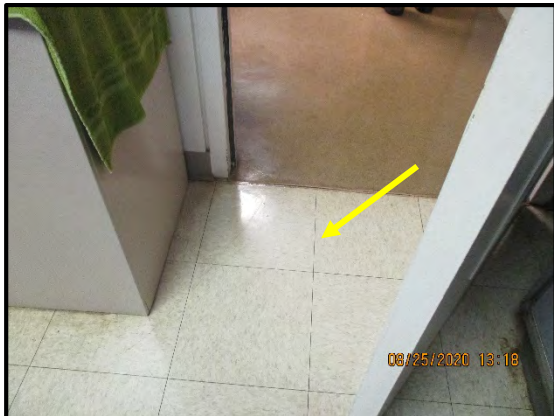
HM ID: 164
Admin Building
Floor 1

Break Room
Beige 12" x 12" vinyl tile and mastic on concrete floor.

Non-ACM
2819-B-A38A-Vinyl floor tile: ND
2819-B-A38A-Mastic: ND
2819-B-A38B-Vinyl floor tile: ND
2819-B-A38B-Mastic: ND
2819-B-A38C-Vinyl floor tile: ND
2819-B-A38C-Mastic: ND

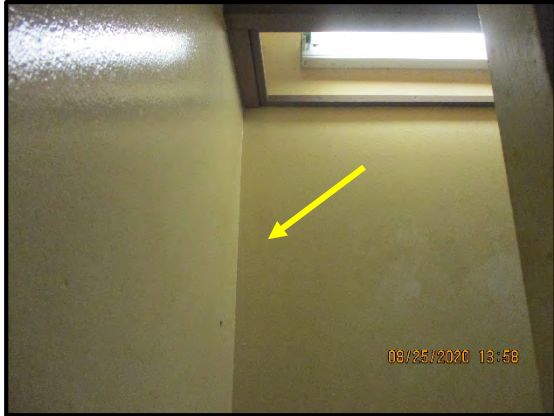
HM ID: 165
Admin Building
Floor 1

Storage Room 4
Beige drywall and joint compound on wall.

Non-ACM

2819-B-A39A: ND
2819-B-A39B-Drywall: ND
2819-B-A39B-Joint Compound: ND
2819-B-A39C-Drywall: ND
2819-B-A39C-Joint Compound: ND

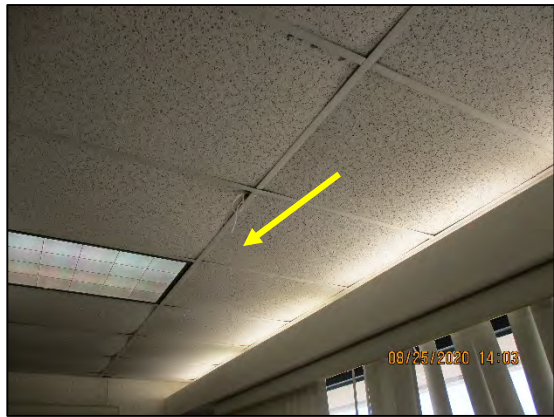
HM ID: 166
Admin Building
Floor 2

Office 1
White 2' x 4' acoustic tile ceiling.

Non-ACM

2819-B-A40A: ND
2819-B-A40B: ND
2819-B-A40C: ND

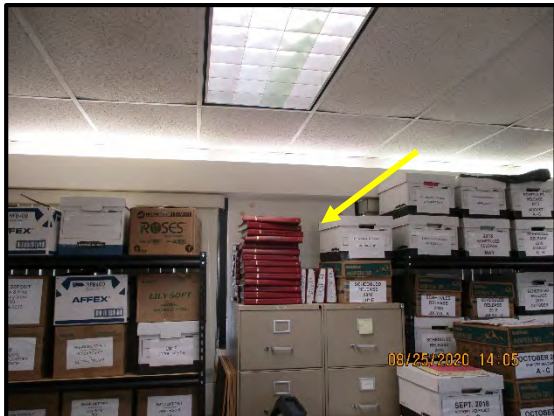
HM ID: 167
Admin Building
Floor 2

Office 1
White drywall and joint compound on wall.

2819-B-A41A-Drywall: ND
2819-B-A41A-Joint Compound: ND
2819-B-A41B-Drywall: ND
2819-B-A41B-Joint Compound: ND
2819-B-A41C-Drywall: ND
2819-B-A41C-Joint Compound: ND

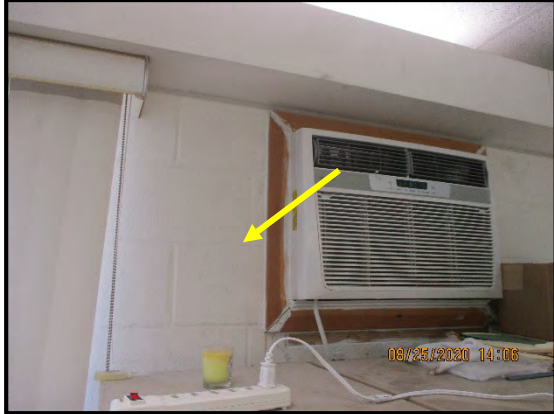
HM ID: 168
Admin Building
Floor 2

Office 1
White textured paint and skim coat on concrete block wall.

Non-ACM

2819-B-A42A-Texture paint: ND
2819-B-A42A-Skim coat: ND
2819-B-A42B-Texture paint: ND
2819-B-A42B-Skim coat: ND
2819-B-A42C-Comp Texture paint/Skim coat: ND

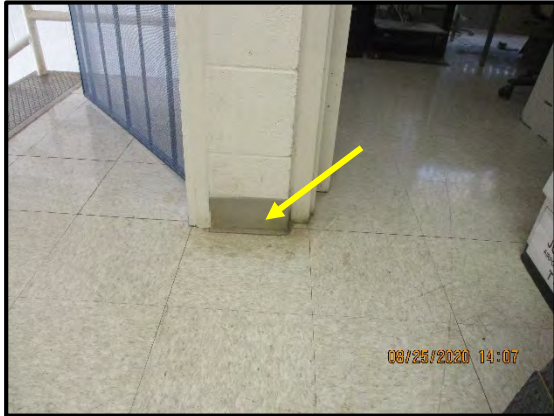
HM ID: 169
Admin Building
Floor 2

Office 1
Gray cove base and mastic on concrete wall.

Non-ACM

2819-B-A43A-Cove base: ND
2819-B-A43A-Mastic 1: ND
2819-B-A43A-Mastic 2: ND
2819-B-A43B-Cove base: ND
2819-B-A43B-Mastic: ND
2819-B-A43C-Cove base: ND
2819-B-A43C-Mastic: ND

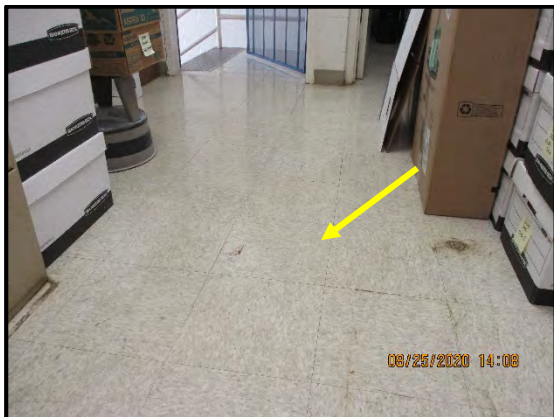
HM ID: 170
Admin Building
Floor 2

Office 1
Beige 12" x 12" vinyl tile and mastic on concrete floor.

2819-B-A44A-Vinyl floor tile: ND
2819-B-A44A-Mastic: ND
2819-B-A44B-Vinyl floor tile: ND
2819-B-A44B-Mastic: ND
2819-B-A44C-Vinyl floor tile: ND
2819-B-A44C-Mastic: ND

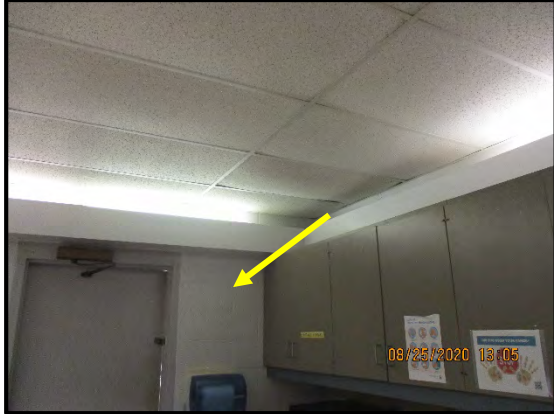
HM ID: 171
Admin Building
Floor 1

Break Room
White paint on drywall wall.

Non-LCP
2819-B-P65A: <40 mg/kg
2819-B-P65B: <40 mg/kg

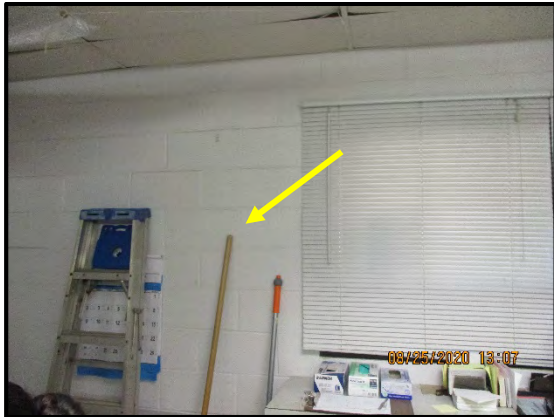
HM ID: 172
Admin Building
Floor 1

Boiler Room
White paint on concrete block wall.

Non-LCP
2819-B-P66A: <40 mg/kg
2819-B-P66B: <40 mg/kg

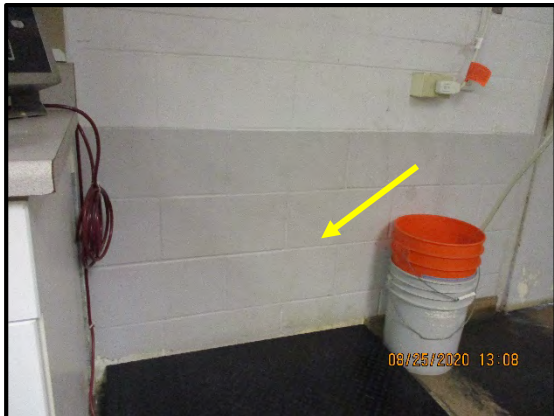
HM ID: 173
Admin Building
Floor 1

Dispensary
Gray paint on concrete block wall.

Non-LCP
2819-B-P67A: <40 mg/kg
2819-B-P67B: <40 mg/kg

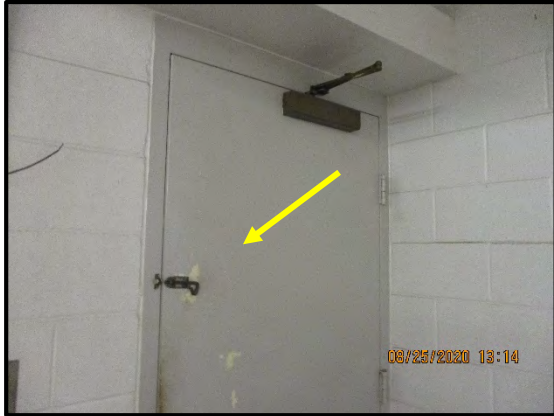
HM ID: 174
Admin Building
Floor 1

Dispensary
Gray paint on metal door.

Non-LCP
2819-B-P68A: <40 mg/kg
2819-B-P68B: <40 mg/kg

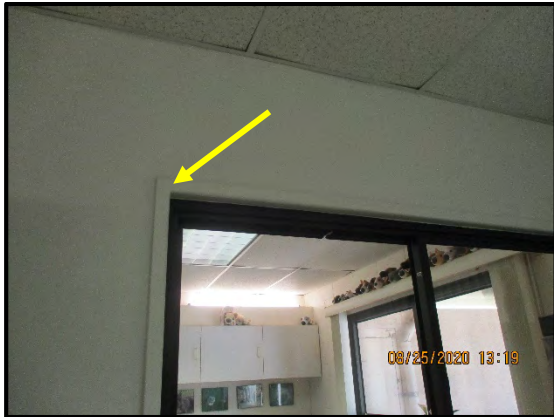
HM ID: 175
Admin Building
Floor 1

Office 1
White paint on wood window frame.

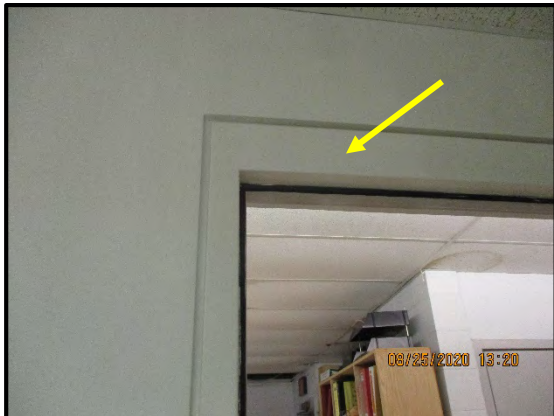
HM ID: 176
Admin Building
Floor 1

Men's Locker Room
White paint on metal door frame.

Non-LCP
2819-B-P70A: <40 mg/kg
2819-B-P70B: <40 mg/kg

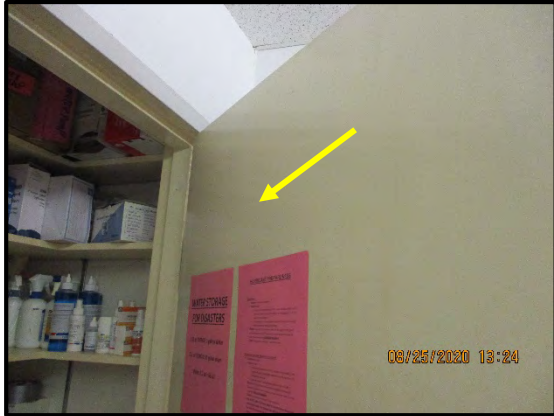
HM ID: 177
Admin Building
Floor 1
Break Room
Beige paint on metal door.
Non-LCP
2819-B-P71A: <40 mg/kg
2819-B-P71B: <40 mg/kg

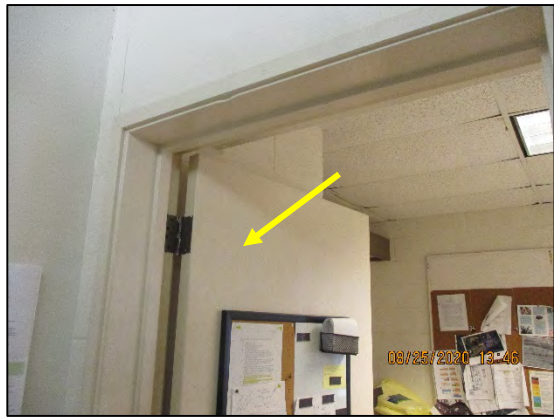
HM ID: 178
Admin Building
Floor 1
Hallway
Beige paint on wood door.
Non-LCP
2819-B-P72A: <40 mg/kg
2819-B-P72B: <40 mg/kg

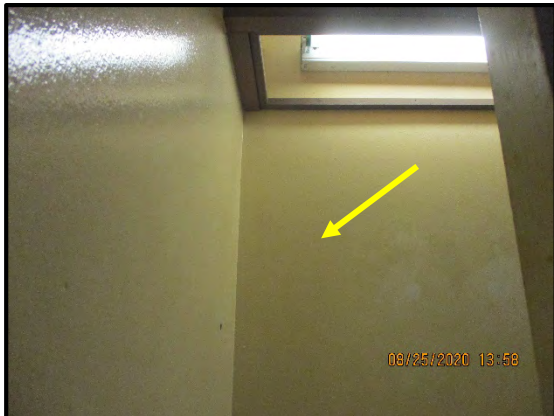
HM ID: 179
Admin Building
Floor 1
Storage Room 4
Beige paint on drywall wall.
Non-LCP
2819-B-P73A: <40 mg/kg
2819-B-P73B: <40 mg/kg

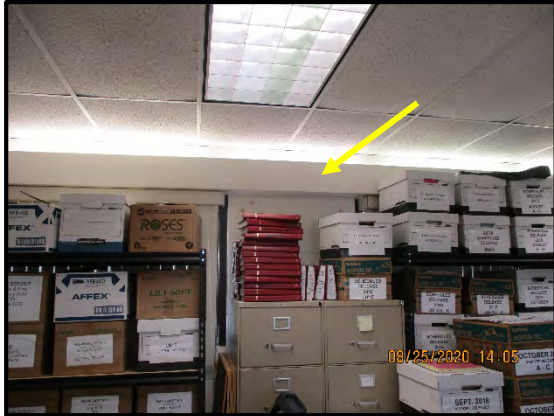
HM ID: 180
Admin Building
Floor 2
Office 1
White paint on drywall wall.
Non-LCP
2819-B-P74A: <40 mg/kg
2819-B-P74B: <40 mg/kg

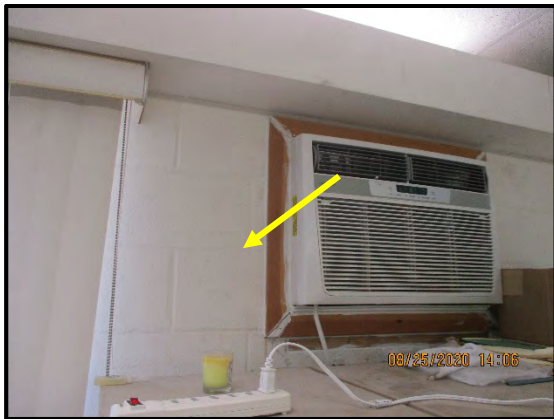
HM ID: 181
Admin Building
Floor 2
Office 1
White paint on concrete block wall.
Non-LCP
2819-B-P75A: <40 mg/kg
2819-B-P75B: <40 mg/kg

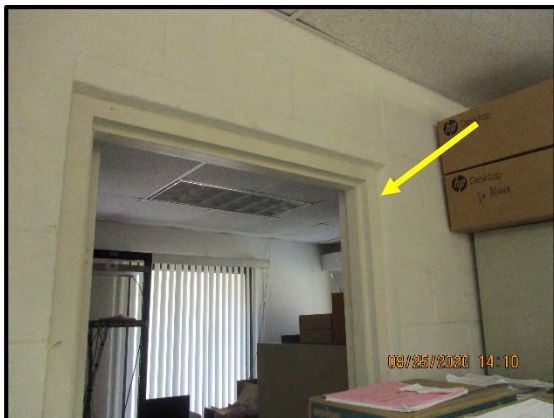
HM ID: 182
Admin Building
Floor 2
Office 1
White paint on metal door frame.
Non-LCP
2819-B-P76A: <40 mg/kg
2819-B-P76B: <40 mg/kg

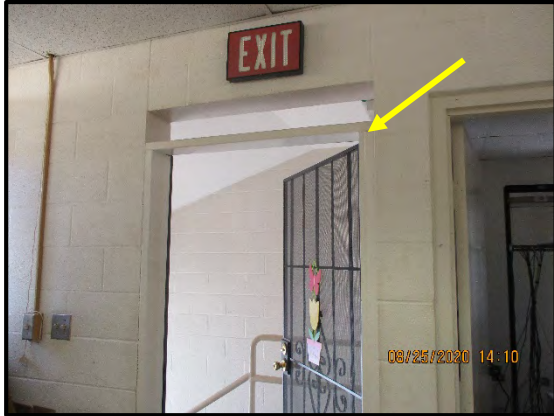
HM ID: 183
Admin Building
Floor 2

Office 1
White paint on wood door frame.

Non-LCP
2819-B-P77A: <40 mg/kg
2819-B-P77B: <40 mg/kg

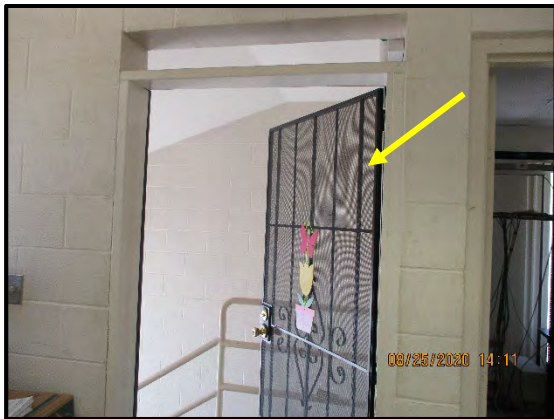
HM ID: 184
Admin Building
Floor 2

Office 1
Black paint on metal door.

**Assumed LCP
(Baked on paint)**

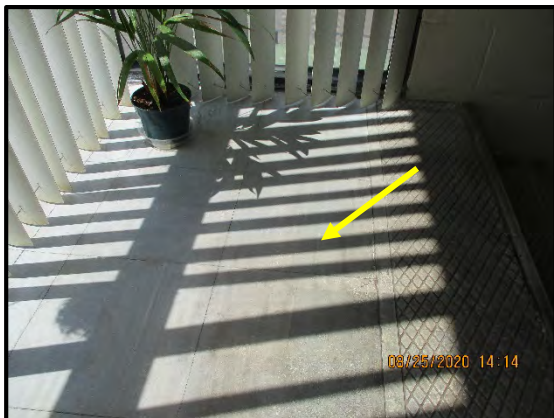
HM ID: 185
Admin Building
Floor 1

Stairwell
Gray 12" x 12" vinyl tile and mastic on concrete floor.

Non-ACM
2819-B-A51A-Vinyl floor tile: ND
2819-B-A51A-Mastic: ND
2819-B-A51B-Vinyl floor tile: ND
2819-B-A51B-Mastic: ND
2819-B-A51C-Vinyl floor tile: ND
2819-B-A51C-Mastic: ND

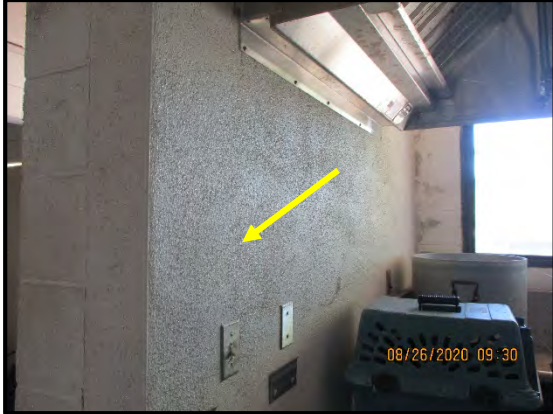
HM ID: 186
Admin Building
Floor 1

Boiler Room
White textured paint and skim coat on concrete wall.

Non-ACM

2819-B-A45A-Texture paint: ND
2819-B-A45A-Skim coat: ND
2819-B-A45B-Texture paint: ND
2819-B-A45B-Skim coat: ND
2819-B-A45C-Texture paint: ND
2819-B-A45C-Skim coat: ND

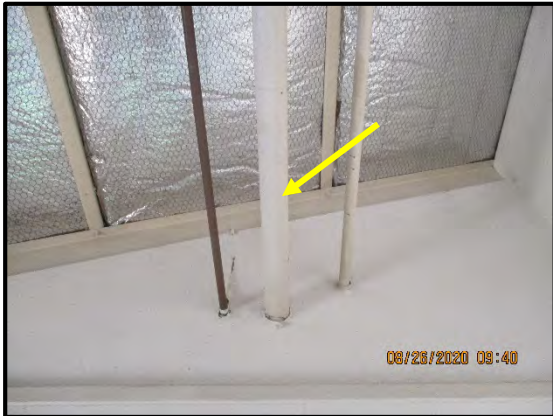
HM ID: 187
Admin Building
Floor 1

Boiler Room
White thermal system insulation on metal 4" pipe.

Non-ACM

2819-B-A46A-Wrap: ND
2819-B-A46A-Insulation: ND
2819-B-A46B-Wrap: ND
2819-B-A46B-Insulation: ND
2819-B-A46C-Wrap: ND
2819-B-A46C-Insulation: ND

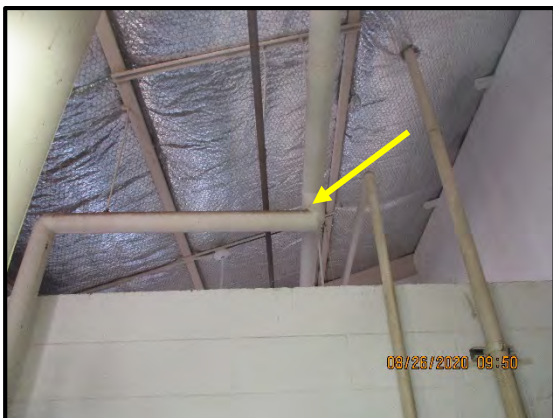
HM ID: 188
Admin Building
Floor 1

Stairwell
White thermal system insulation on metal 4" pipe elbow.

Non-ACM

2819-B-A47A-Wrap: ND
2819-B-A47A-Insulation: ND
2819-B-A47B-Wrap: ND
2819-B-A47B-Insulation: ND
2819-B-A47C-Wrap: ND
2819-B-A47C-Insulation: ND

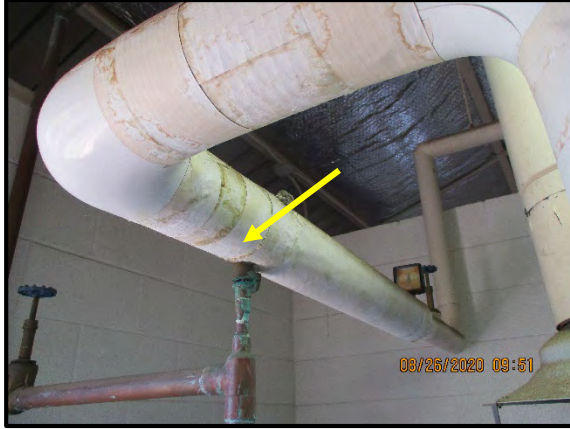
HM ID: 189
Admin Building
Floor 1

Boiler Room
White thermal system insulation on metal 6” pipe.

Non-ACM

2819-B-A48A-Wrap: ND
2819-B-A48A-Insulation: ND
2819-B-A48B-Wrap: ND
2819-B-A48B-Insulation: ND
2819-B-A48C-Wrap: ND
2819-B-A48C-Insulation: ND

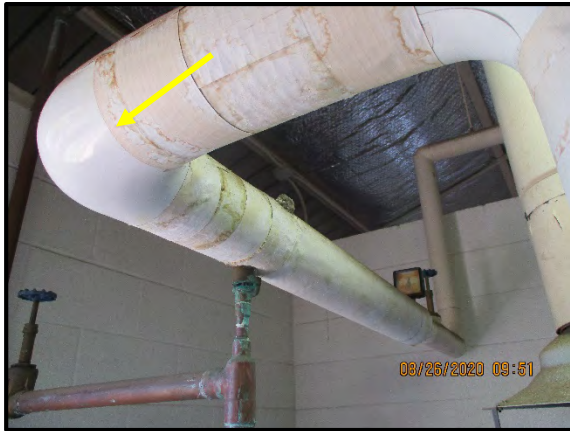
HM ID: 190
Admin Building
Floor 1

Boiler Room
White thermal system insulation on metal 6” pipe elbow.

Non-ACM

2819-B-A49A-Vinyl wrap: ND
2819-B-A49A-Insulation: ND
2819-B-A49B-Vinyl wrap: ND
2819-B-A49B-Insulation: ND
2819-B-A49C-Vinyl wrap: ND
2819-B-A49C-Insulation: ND

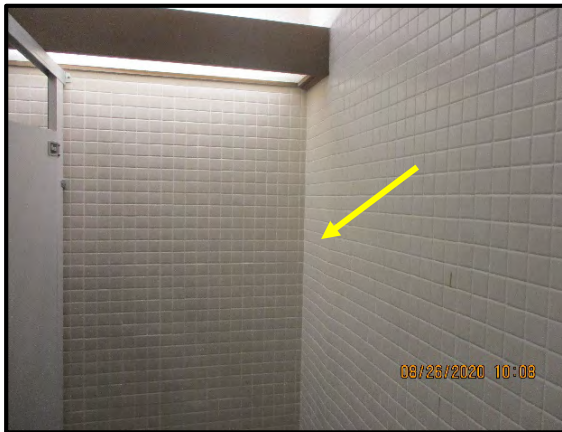
HM ID: 191
Admin Building
Floor 1

Men’s Locker Room
White grout 2” x 2” ceramic tile and grout on wall.

2819-B-A50A-Ceramic tile: ND
2819-B-A50A-Thinset: ND
2819-B-A50A-Mortar like: ND
2819-B-A50A-Texture like: ND
2819-B-A50B-Ceramic tile: ND
2819-B-A50B-Thinset: ND
2819-B-A50B-Mortar like: ND
2819-B-A50B-Grout: ND
2819-B-A50B-Mastic: ND
2819-B-A50B-Texture like: ND
2819-B-A50C-Ceramic tile: ND
2819-B-A50C-Thinset: ND
2819-B-A50C-Mortar like: ND
2819-B-A50C-Grout: ND

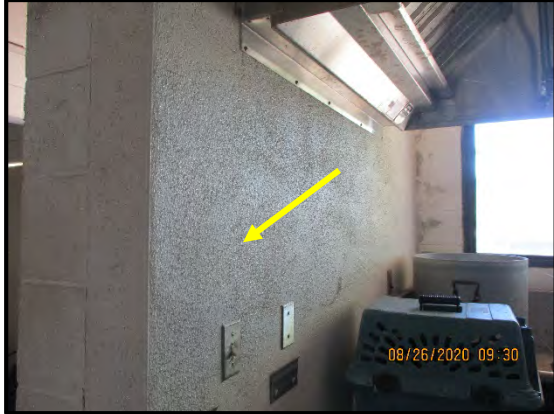
HM ID: 192
Admin Building
Floor 1

Boiler Room
White textured paint on concrete wall.

Non-LCP
2819-B-P79A: <40 mg/kg
2819-B-P79B: <40 mg/kg

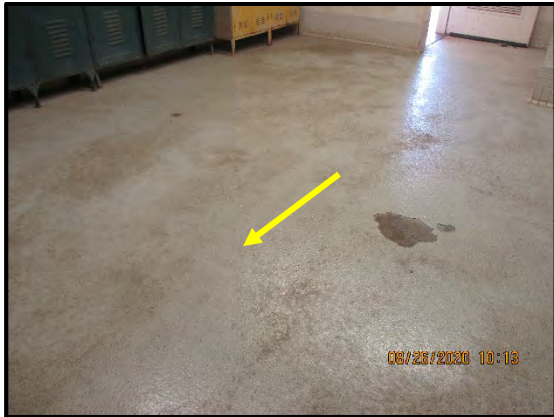
HM ID: 193
Admin Building
Floor 1

Boiler Room
Gray textured paint on concrete floor.

Non-LCP
2819-B-P80A: <40 mg/kg
2819-B-P80B: <40 mg/kg

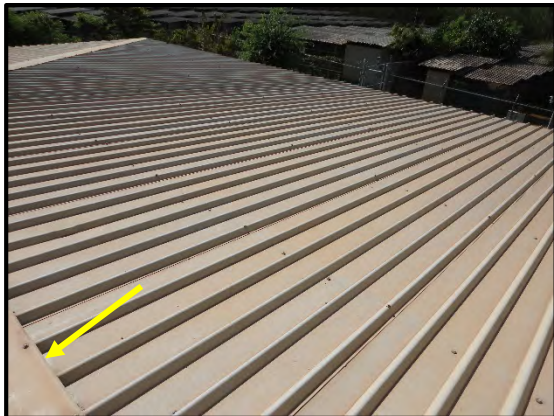
HM ID: 194
Admin Building
Roof

Exterior
White coating on metal roofing system.

Non-LCP
2819-B-P81A: <40 mg/kg
2819-B-P81B: <40 mg/kg

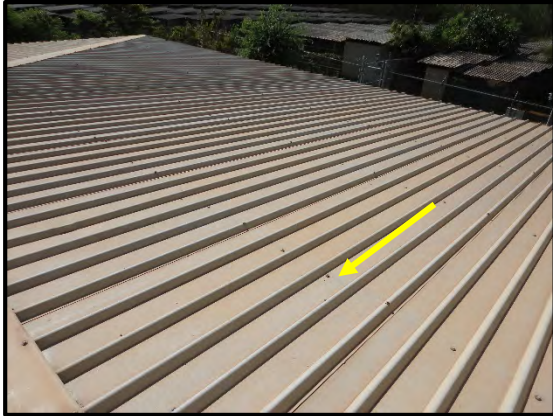
HM ID: 195
Admin Building
Roof

Exterior
Beige paint on metal roofing system.

LCP
2819-B-P82A: 88 mg/kg
2819-B-P82B: 82 mg/kg

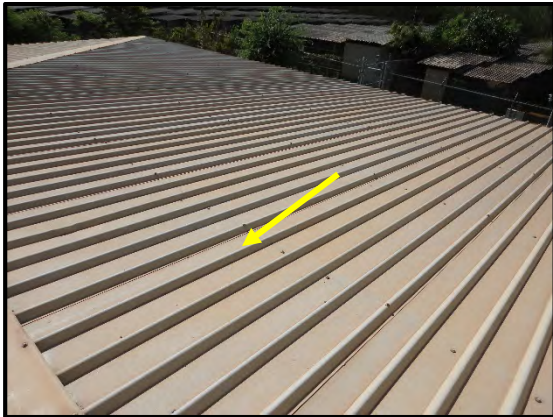
HM ID: 196
Admin Building
Roof

Exterior
White coating on metal roofing system.

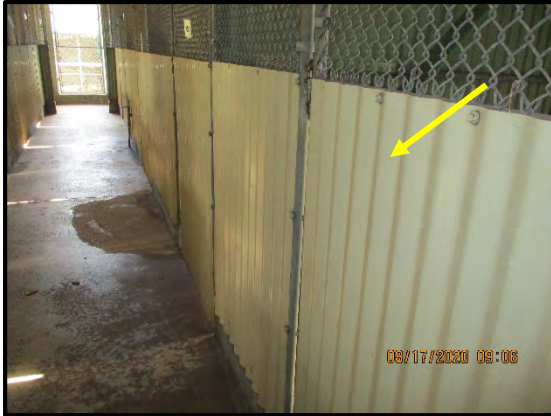
HM ID: 31
Cattery Type 1
Floor 1
Interior
Beige paint on metal wall.

Non-LCP
2819-B-P1A: <36 mg/kg
2819-B-P1B: <27 mg/kg

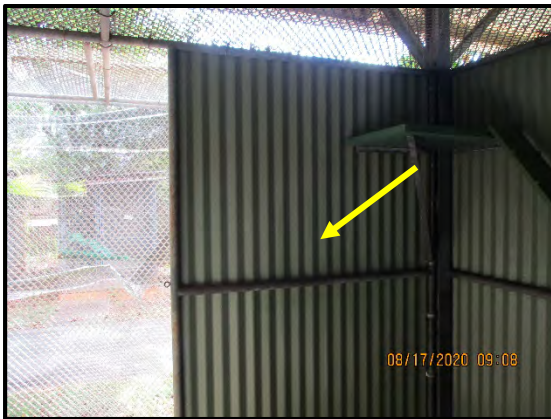
HM ID: 32
Cattery Type 1
Floor 1
Interior
Green paint on metal wall.

LCP
2819-B-P2A: 67 mg/kg
2819-B-P2B: 49 mg/kg

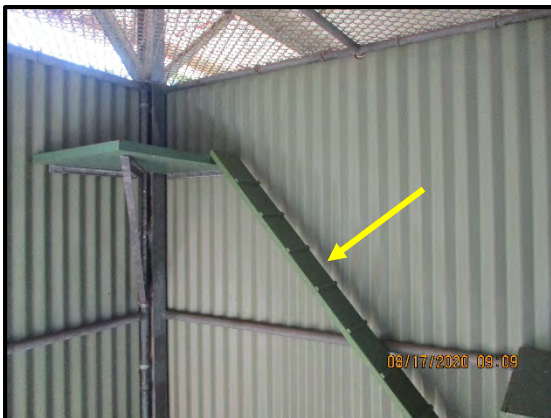
HM ID: 33
Cattery Type 1
Floor 1
Interior
Green paint on wood walkway.

Non-LCP
2819-B-P3A: <40 mg/kg
2819-B-P3B: <40 mg/kg
