**HAZARDOUS MATERIAL SURVEY REPORT
FOR
PHASE 2 OAHU COMMUNITY CORRECTIONAL CENTER
HDOA ANIMAL QUARANTINE STATION
99-951 HALAWA VALLEY STREET
AIEA, ISLAND OF OAHU 96701**

**MNA PROJECT 02819_2
AHL PROJECT No. 6930.001
DAGS JOB No. 12-27-5713**

November 30, 2020

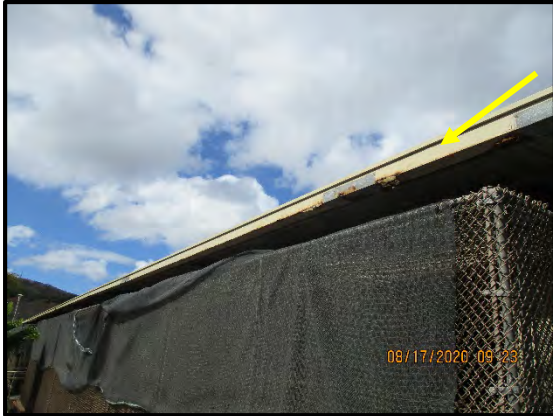
HM ID: 34
Cattery Type 1
Floor 1

Exterior
Beige paint on metal wall.

LCP
2819-B-P4A: 56 mg/kg
2819-B-P4B: 72 mg/kg

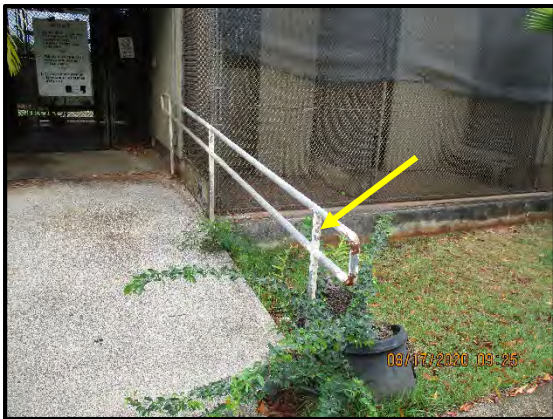
HM ID: 35
Cattery Type 1
Floor 1

Exterior
White paint on metal railing.

LCP
2819-B-P5A: 350 mg/kg
2819-B-P5B: 300 mg/kg

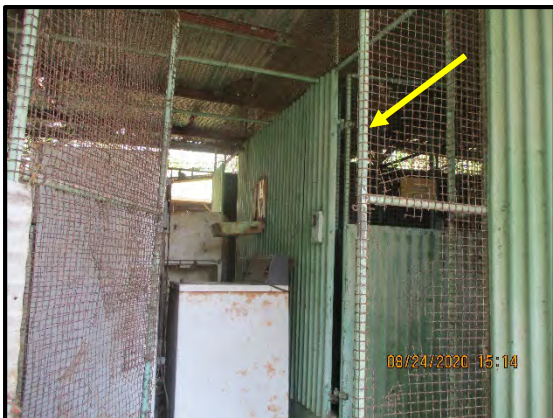
HM ID: 97
Cattery Type 2
Floor 1

Interior
Green paint on metal poles.

LCP
2819-B-P62A: 2,100 mg/kg
2819-B-P62B: 2,300 mg/kg

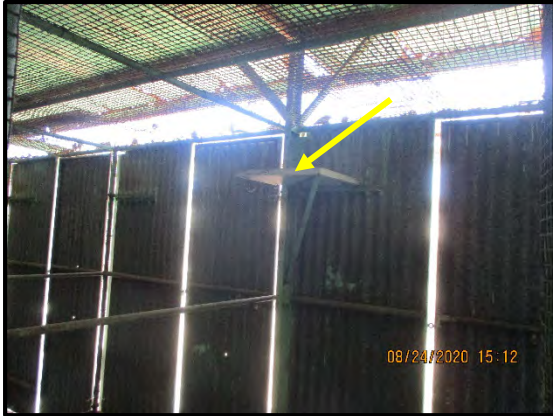
HM ID: 98
Cattery Type 2
Floor 1
Interior
White paint on wood shelves.

LCP
2819-B-P63A: 610 mg/kg
2819-B-P63B: 640 mg/kg

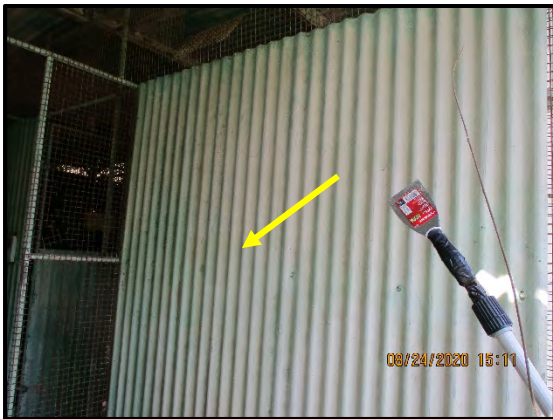
HM ID: 99
Cattery Type 2
Floor 1
Exterior
White paint on metal wall.

LCP
2819-B-P64A: 3,200 mg/kg
2819-B-P64B: 2,600 mg/kg

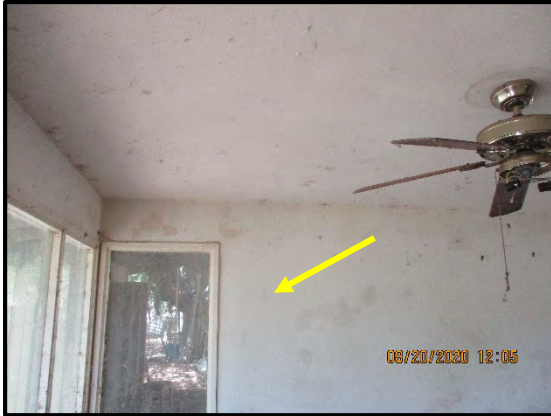
HM ID: 14
Cottage
Floor 1

Living room
White drywall and joint compound on wall.

Non-ACM

2819-B-A14A-Drywall: ND
2819-B-A14A-Joint compound: ND
2819-B-A14B-Drywall: ND
2819-B-A14B-Joint compound: ND
2819-B-A14C: ND

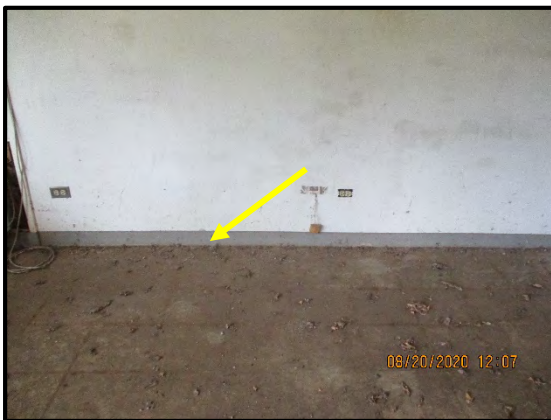
HM ID: 15
Cottage
Floor 1

Living room
Gray cove base and mastic on drywall wall.

Non-ACM

2819-B-A15A-Cove base: ND
2819-B-A15A-Mastic 1: ND
2819-B-A15A-Mastic 2: ND
2819-B-A15A-Cove base: ND
2819-B-A15A-Mastic: ND
2819-B-A15A-Cove base: ND
2819-B-A15A-Mastic: ND

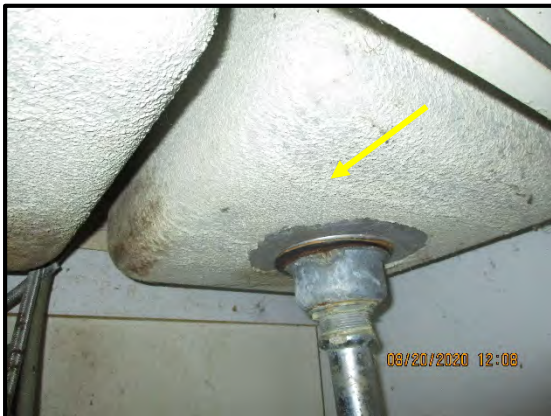
HM ID: 16
Cottage
Floor 1

Kitchen
White undercoating on metal sink.

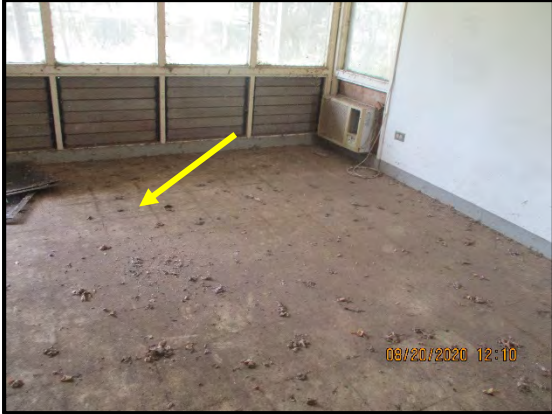
HM ID: 17
Cottage
Floor 1

Living room
Tan 12"x12" vinyl tile and mastic on concrete floor.

Non-ACM

2819-B-A17A-VFT: ND
2819-B-A17A-Mastic: ND
2819-B-A17B-VFT: ND
2819-B-A17B-Mastic: ND
2819-B-A17C-VFT: ND
2819-B-A17C-Mastic: ND

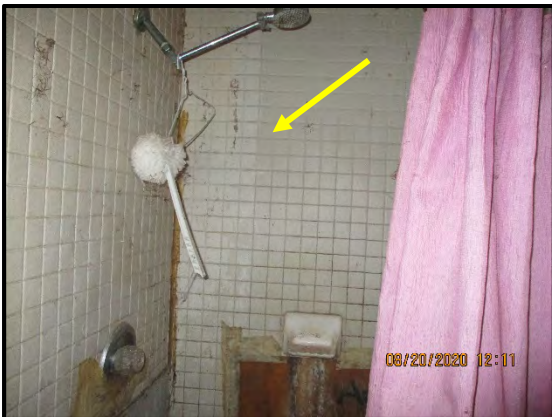
HM ID: 18
Cottage
Floor 1

Restroom
White grout on 4"x4" ceramic tile shower stall.

Non-ACM

2819-B-A18A: ND
2819-B-A18B: ND
2819-B-A18C: ND

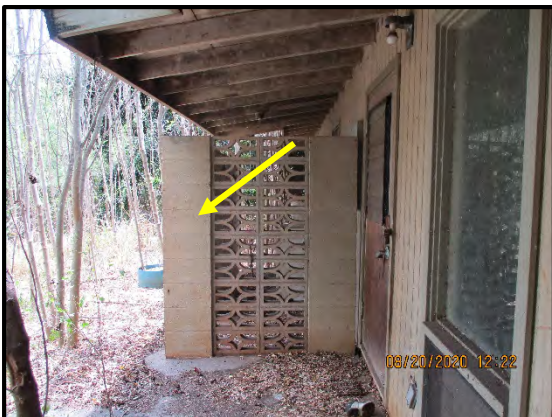
HM ID: 19
Cottage
Floor 1

Exterior
Beige textured paint on concrete block wall.

Non-ACM

2819-B-A19A: ND
2819-B-A19B: ND
2819-B-A19C-Texture paint: ND
2819-B-A19C-Paint: ND

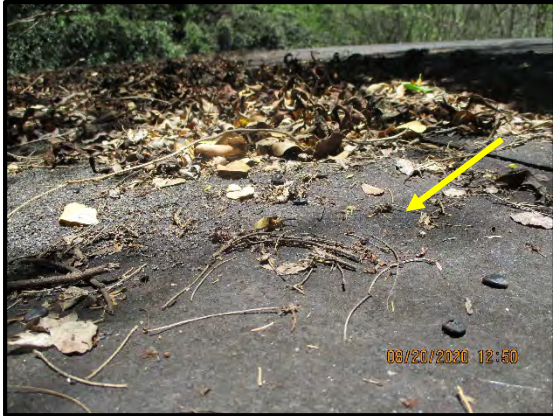
HM ID: 20
Cottage
Roof

Exterior
Black built-up roofing on wood roofing system.

Non-ACM

2819-B-A20A-Shingle: ND
2819-B-A20A-Felt: ND
2819-B-A20B-Felt: ND
2819-B-A20B-Tar: ND
2819-B-A20C-Felt: ND
2819-B-A20C-Tar: ND

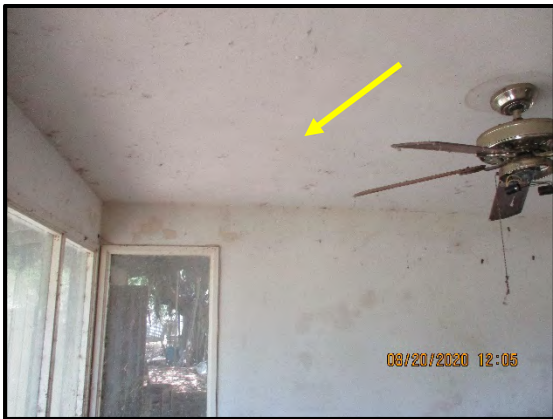
HM ID: 71
Cottage
Floor 1

Restroom
White paint on drywall ceiling.

Non-LCP

2819-B-P39A: <40 mg/kg
2819-B-P39B: <40 mg/kg

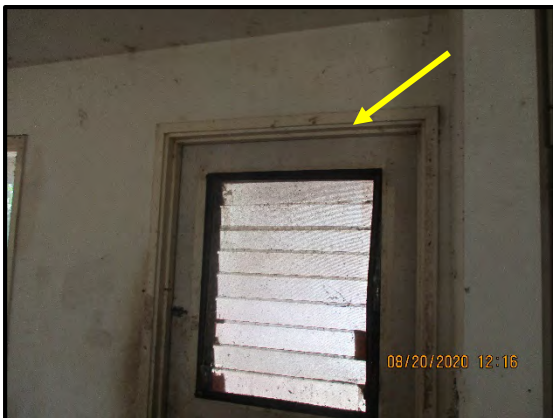
HM ID: 72
Cottage
Floor 1

Living Room
White paint on wood door frame.

2819-B-P40A: <40 mg/kg
2819-B-P40B: <40 mg/kg

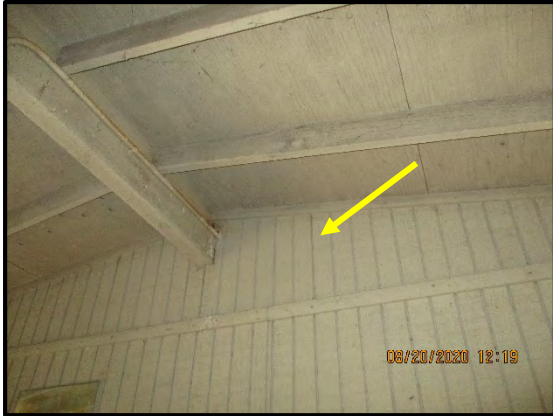
HM ID: 73
Cottage
Floor 1

Exterior
Brown paint on wood wall.

Non-LCP
2819-B-P41A: <40 mg/kg
2819-B-P41B: <40 mg/kg

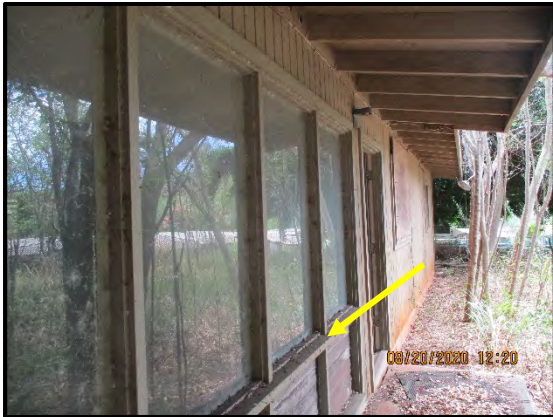
HM ID: 74
Cottage
Floor 1

Exterior
Dark brown paint on wood window frame.

Non-LCP
2819-B-P42A: <40 mg/kg
2819-B-P42B: <40 mg/kg

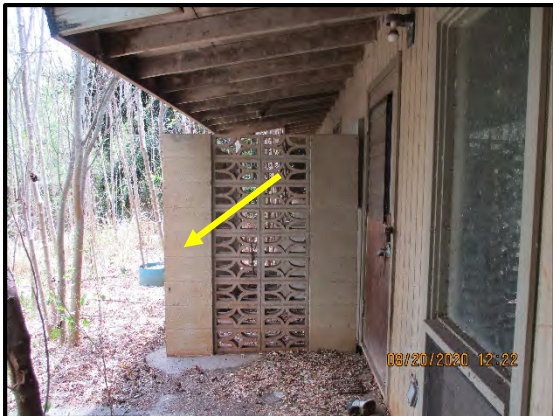
HM ID: 75
Cottage
Floor 1

Exterior
Beige paint on concrete block wall.

Non-LCP
2819-B-P43A: <40 mg/kg
2819-B-P43B: <40 mg/kg

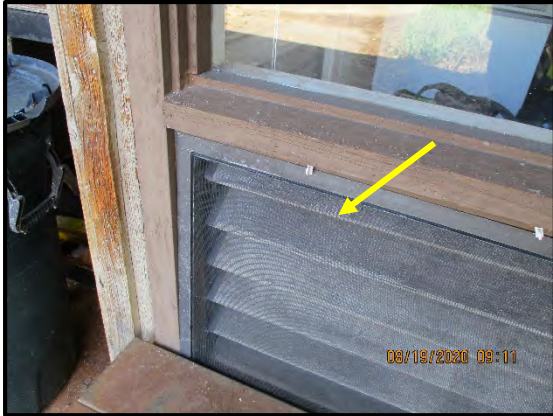
HM ID: 76
Cottage
Floor 1

Exterior
Brown paint on metal screen.

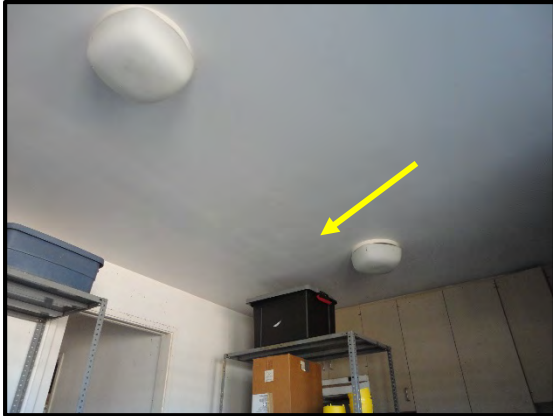
HM ID: 128
Duplex 1
Floor 1

Room 1
White paint on drywall ceiling.

Non-LCP
2819-A-P20A: <40 mg/kg
2819-A-P20B: <40 mg/kg

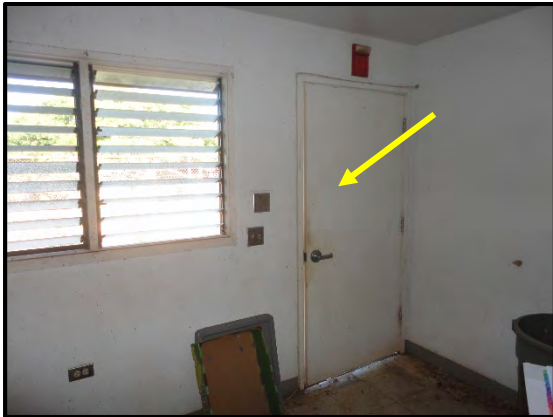
HM ID: 129
Duplex 1
Floor 1

Room 3
White paint on wood door.

Non-LCP
2819-A-P21A: <40 mg/kg
2819-A-P21B: <40 mg/kg

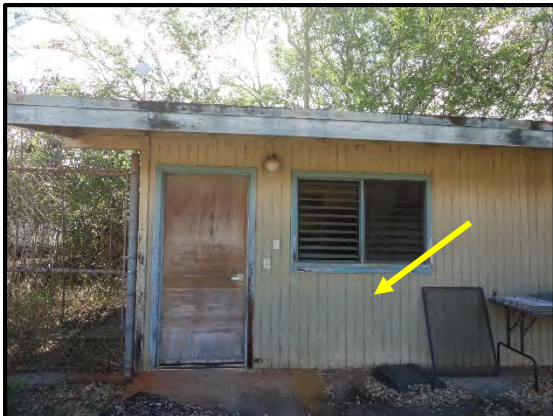
HM ID: 130
Duplex 1
Floor 1

Exterior
Beige paint on wood wall.

Non-LCP
2819-A-P23A: <40 mg/kg
2819-A-P23B: <40 mg/kg

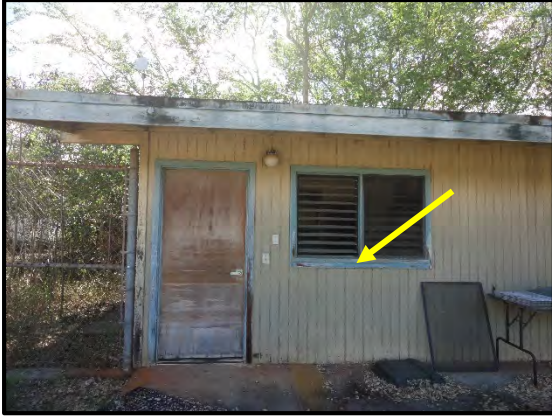
HM ID: 131
Duplex 1
Floor 1

Exterior
Light blue paint on wood window frame.

Non-LCP

2819-A-P24A: <40 mg/kg
2819-A-P24B: <40 mg/kg

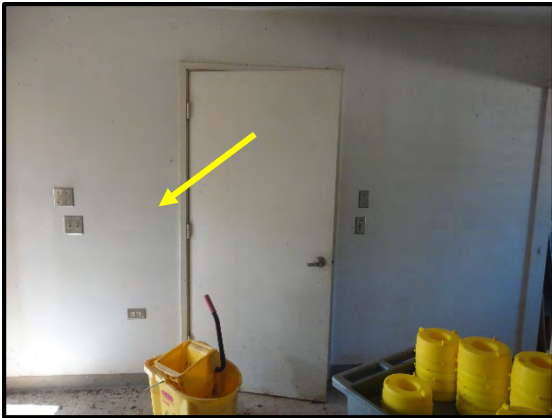
HM ID: 132
Duplex 1
Floor 1

Room 1
White drywall wall.

Non-ACM

2819-A-A9A-Drywall: ND
2819-A-A9A-Joint Compound: ND
2819-A-A9B-Drywall: ND
2819-A-A9B-Joint Compound: ND
2819-A-A9C-Drywall: ND
2819-A-A9C-Joint Compound: ND

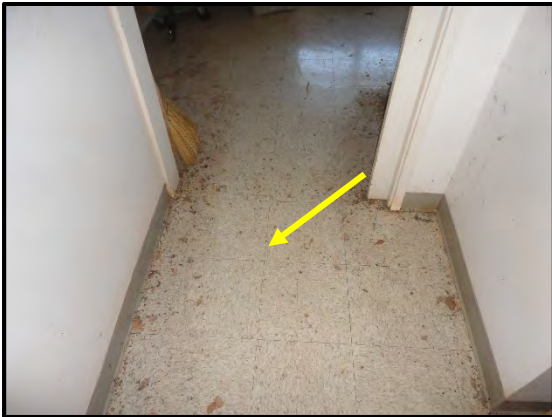
HM ID: 133
Duplex 1
Floor 1

Room 3
Off-white 12" x 12" vinyl tile with gray streaks on concrete floor.

Non-ACM

2819-A-A10A-VFT: ND
2819-A-A10A-Mastic: ND
2819-A-A10B-VFT: ND
2819-A-A10B-Mastic: ND
2819-A-A10C-VFT: ND
2819-A-A10C-Mastic: ND

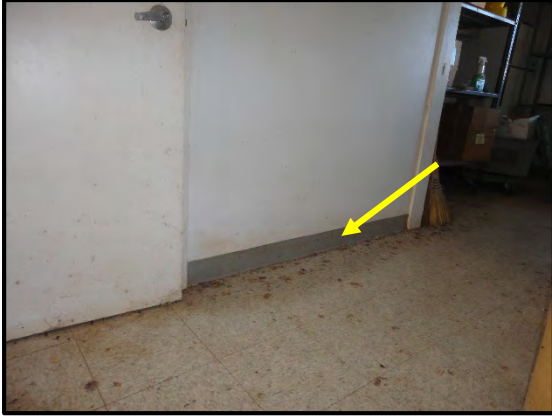
HM ID: 134
Duplex 1
Floor 1

Room 2
Gray cove base on drywall wall.

Non-ACM
2819-A-A11A-Cove base: ND
2819-A-A11A-Mastic: ND
2819-A-A11B-Cove base: ND
2819-A-A11B-Mastic: ND
2819-A-A11C-Cove base: ND
2819-A-A11C-Mastic: ND

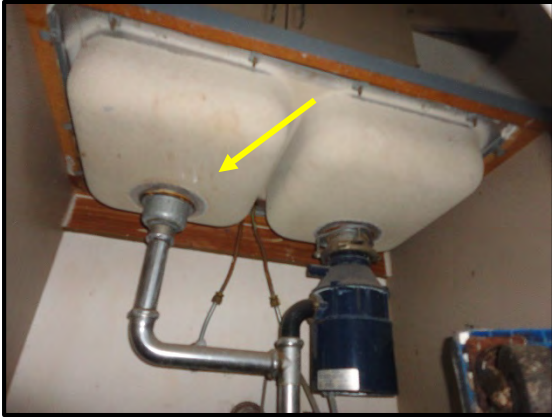
HM ID: 135
Duplex 1
Floor 1

Room 1
White undercoating on metal sink.

Non-ACM
2819-A-A12A: ND
2819-A-A12B: ND
2819-A-A12C: ND

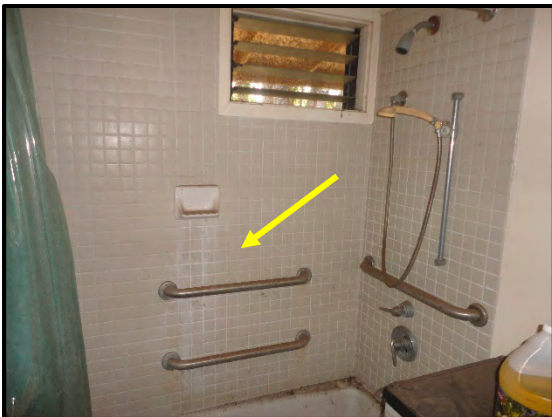
HM ID: 136
Duplex 1
Floor 1

Restroom 1
Light gray 2” x 2” ceramic tile on drywall wall.

Non-ACM
2819-A-A13A-Ceramic tile: ND
2819-A-A13A-Grout: ND
2819-A-A13A-Adhesive: ND
2819-A-A13A-Joint compound: ND
2819-A-A13B-Ceramic tile: ND
2819-A-A13B-Grout: ND
2819-A-A13B-Adhesive: ND
2819-A-A13B-Joint compound: ND
2819-A-A13C-Ceramic tile: ND
2819-A-A13C-Grout: ND
2819-A-A13C-Adhesive: ND
2819-A-A13C-Joint compound: ND

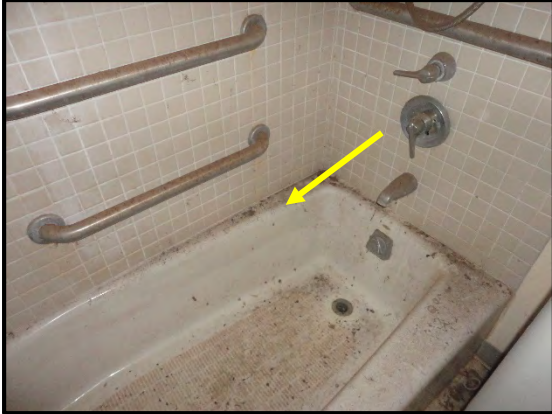
HM ID: 137
Duplex 1
Floor 1

Restroom 1
White caulking on porcelain bathtub.

Non-ACM

2819-A-A14A: ND
2819-A-A14B-Caulking: ND
2819-A-A14B-Joint compound: ND
2819-A-A14C-Caulking: ND
2819-A-A14C-Joint compound: ND

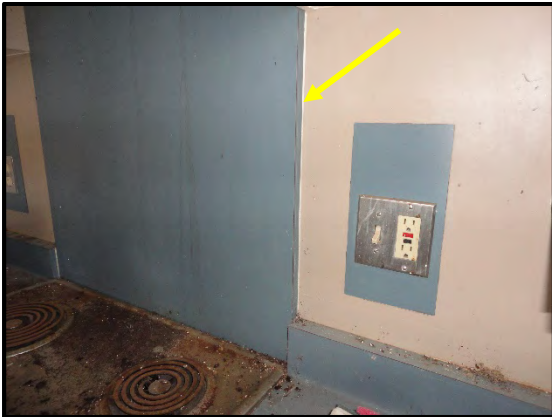
HM ID: 138
Duplex 1
Floor 1

Room 1
White caulking on wood wall.

Non-ACM

2819-A-A15A: ND
2819-A-A15B: ND
2819-A-A15C: ND

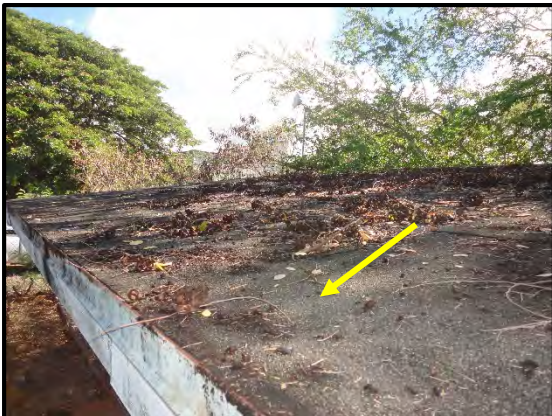
HM ID: 139
Duplex 1
Roof

Exterior
Black roofing sheets on wood roofing system.

Non-ACM

2819-A-A16A: ND
2819-A-A16B: ND
2819-A-A16C-Shingle: ND
2819-A-A16C-Tar: ND

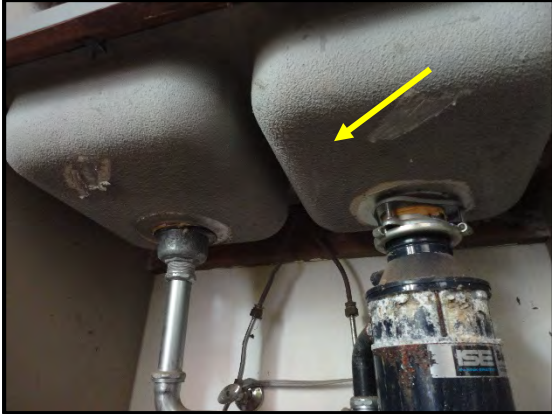
HM ID: 140
Duplex 1
Floor 1

Room 3
Gray undercoating on metal sink.

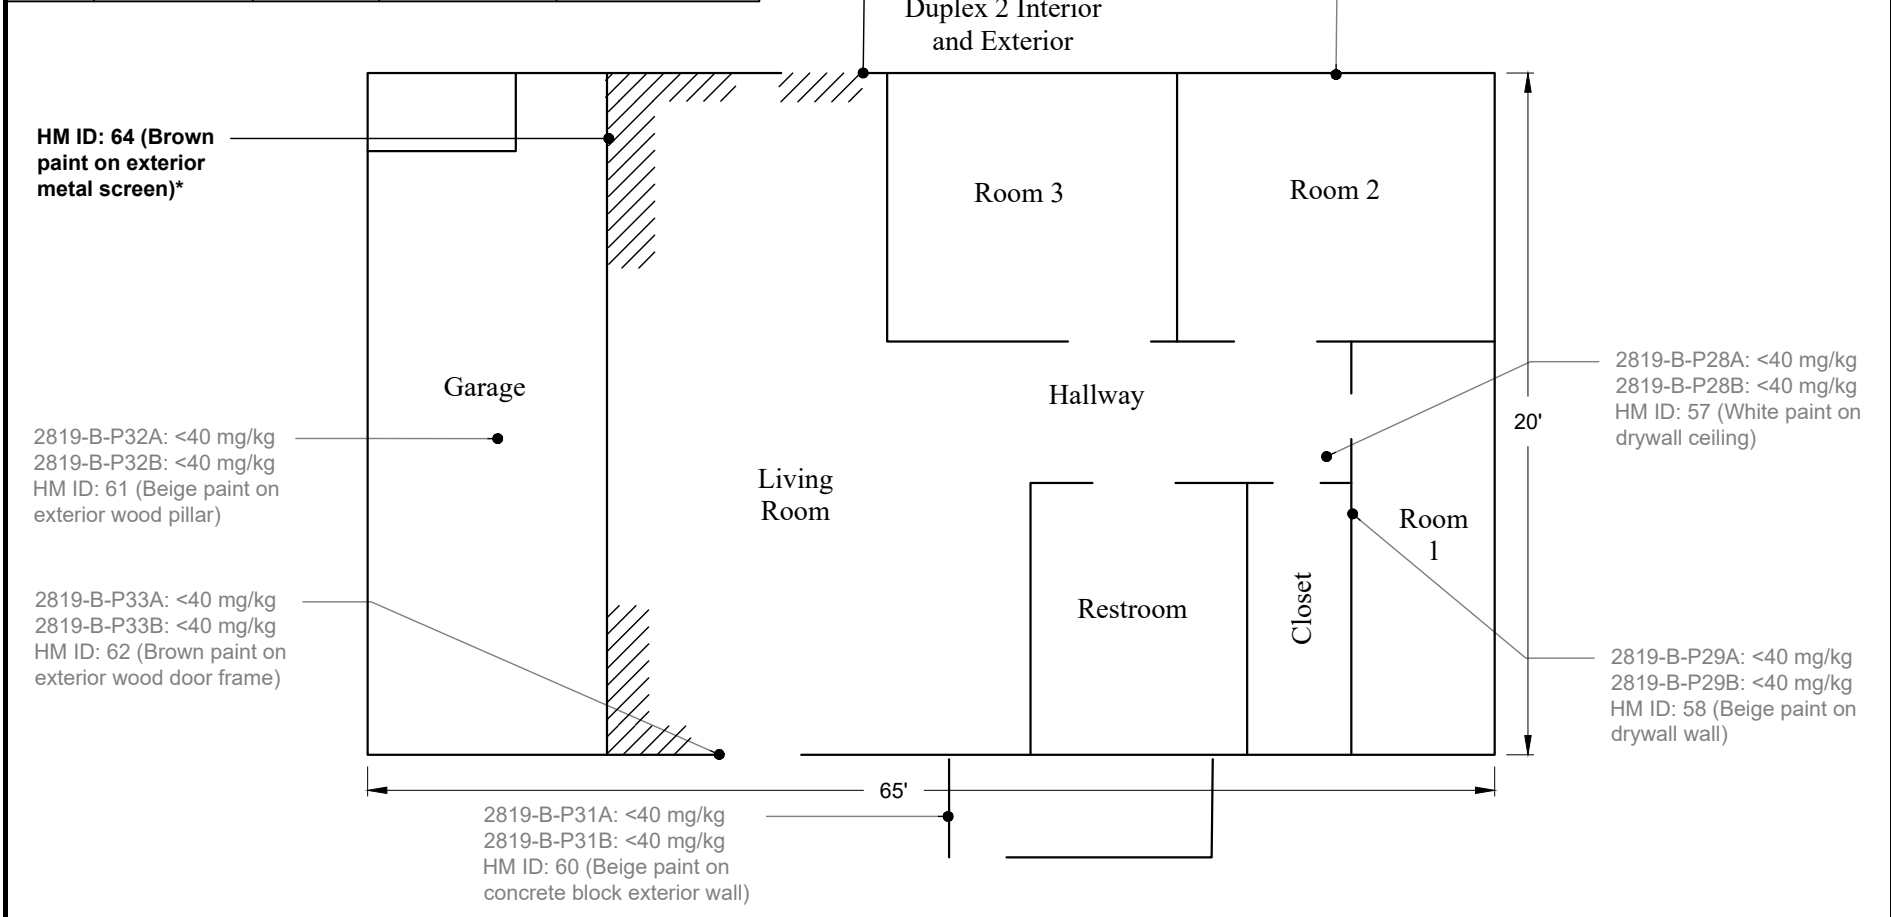
HM ID	Locations	Color	Substrate	Results (mg/kg)
64	Screen	Brown	Metal	Assumed LCP
65	Rear door	Black	Metal	Assumed LCP

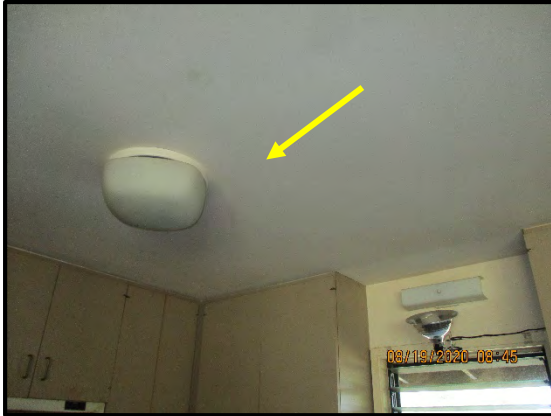
HM ID: 6
Duplex 2
Floor 1

Room 2
White drywall ceiling.

Non-ACM
2819-B-A6A: ND
2819-B-A6B: ND
2819-B-A6C: ND

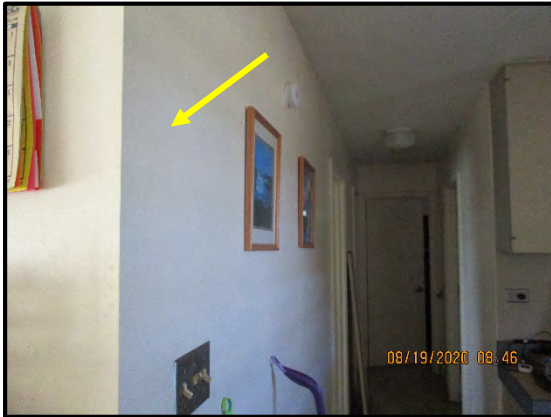
HM ID: 7
Duplex 2
Floor 1

Room 1
Beige drywall and joint compound on wall.

Non-ACM
2819-B-A7A-Drywall: ND
2819-B-A7A-Joint compound: ND
2819-B-A7B: ND
2819-B-A7C: ND

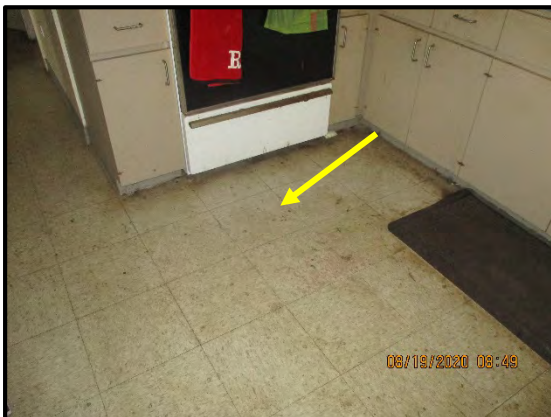
HM ID: 8
Duplex 2
Floor 1

Living Room
Tan 12" x 12" vinyl tile and mastic on concrete floor.

Non-ACM
2819-B-A8A-VFT: ND
2819-B-A8A-Mastic: ND
2819-B-A8B-VFT: ND
2819-B-A8B-Mastic: ND
2819-B-A8C-VFT: ND
2819-B-A8C-Mastic: ND

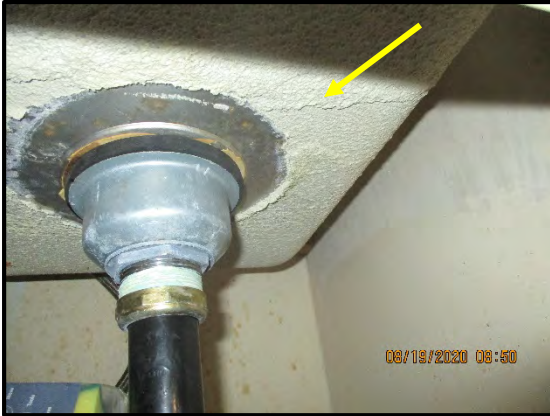
HM ID: 9
Duplex 2
Floor 1

Kitchen
White undercoating on metal sink.

Non-ACM

2819-B-A9A: ND
2819-B-A9B: ND
2819-B-A9C: ND

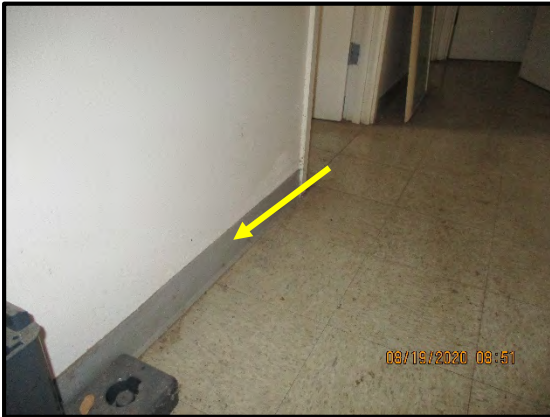
HM ID: 10
Duplex 2
Floor 1

Room 2
Gray cove base, mastic, and joint compound on drywall wall.

Non-ACM

2819-B-A10A-Cove base: ND
2819-B-A10A-Mastic: ND
2819-B-A10A-Joint compound: ND
2819-B-A10B-Cove base: ND
2819-B-A10B-Mastic: ND
2819-B-A10C-Cove base: ND
2819-B-A10C-Mastic: ND

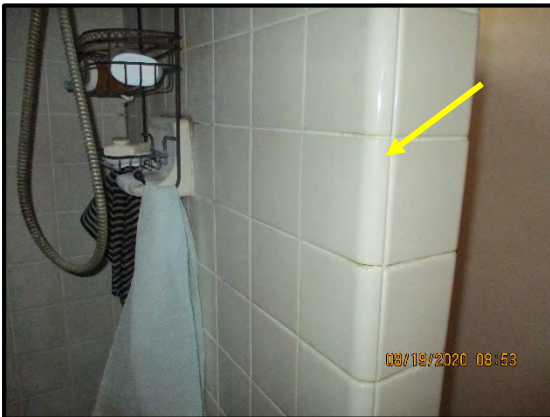
HM ID: 11
Duplex 2
Floor 1

Restroom
White grout on 4"x4" ceramic tile in shower stall.

Non-ACM

2819-B-A11A: ND
2819-B-A11B: ND
2819-B-A11C: ND

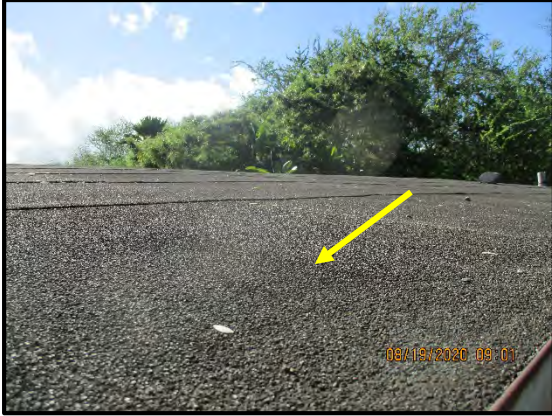
HM ID: 12
Duplex 2
Roof

Exterior
Black built-up roofing on wood roofing system.

Non-ACM

2819-B-A12A-Shingle: ND
2819-B-A12A-Felt: ND
2819-B-A12B-Shingle: ND
2819-B-A12B-Felt: ND
2819-B-A12C-Shingle: ND
2819-B-A12C-Tar: ND

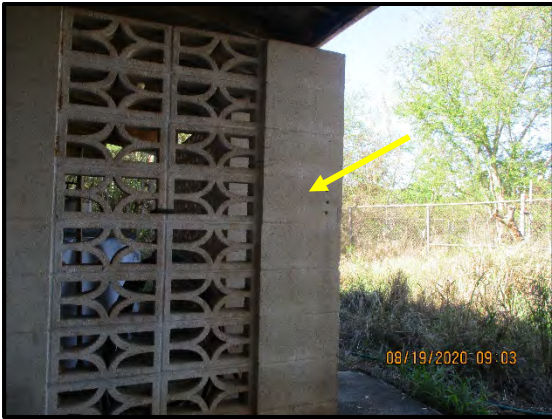
HM ID: 13
Duplex 2
Floor 1

Exterior
Beige paint and skim coat on concrete block wall.

Non-ACM

2819-B-A13A: ND
2819-B-A13B: ND
2819-B-A13C: ND

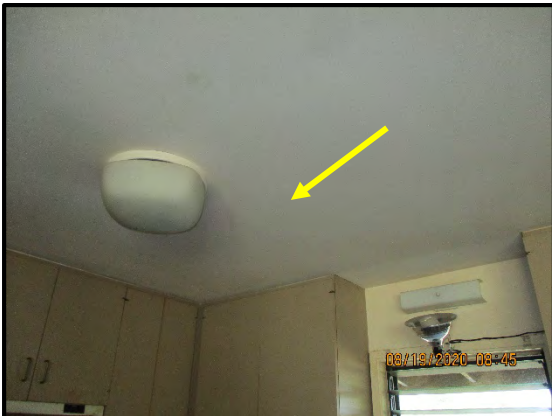
HM ID: 57
Duplex 2
Floor 1

Room 2
White paint on drywall ceiling.

2819-B-P28A: <40 mg/kg
2819-B-P28B: <40 mg/kg

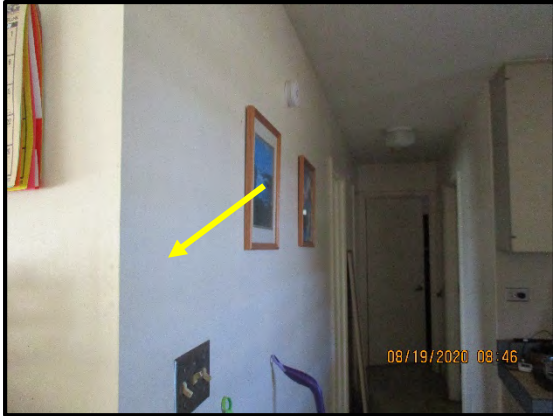
HM ID: 58
Duplex 2
Floor 1
Room 1
Beige paint on drywall wall.
Non-LCP
2819-B-P29A: <40 mg/kg
2819-B-P29B: <40 mg/kg

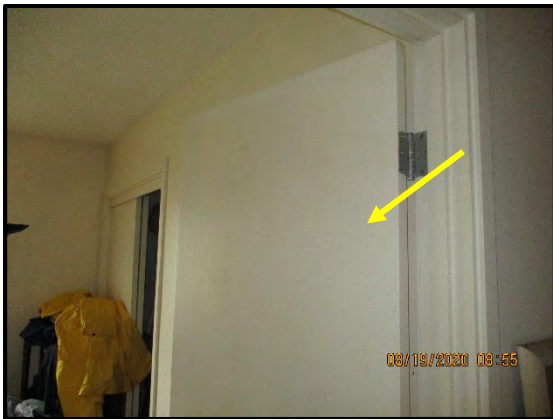
HM ID: 59
Duplex 2
Floor 1
Room 1
Beige paint on wood door.
Non-LCP
2819-B-P30A: <40 mg/kg
2819-B-P30B: <40 mg/kg

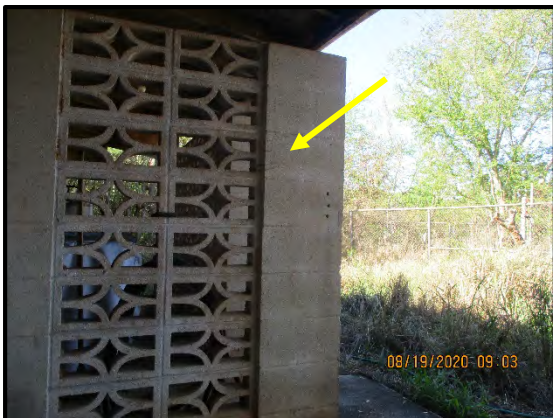
HM ID: 60
Duplex 2
Floor 1
Exterior
Beige paint on concrete block wall.
Non-LCP
2819-B-P31A: <40 mg/kg
2819-B-P31B: <40 mg/kg

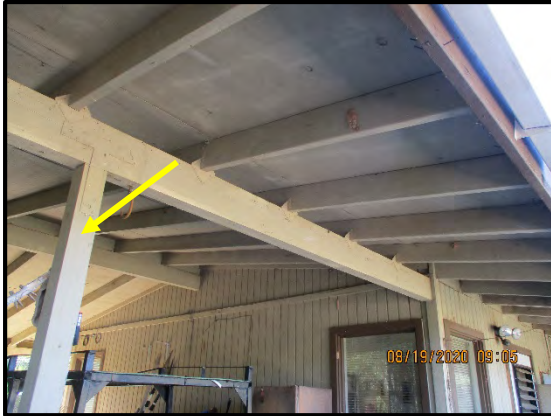
HM ID: 61
Duplex 2
Floor 1
Exterior
Beige paint on wood pillar.

Non-LCP
2819-B-P32A: <40 mg/kg
2819-B-P32B: <40 mg/kg

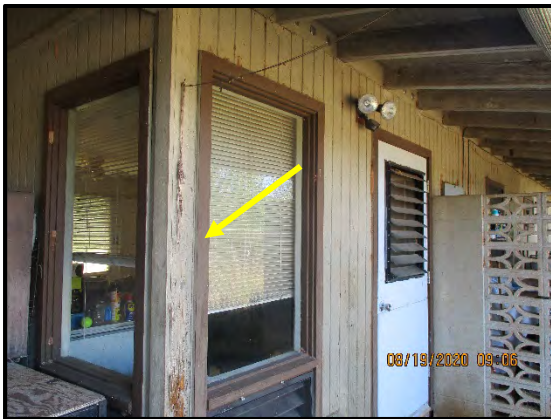
HM ID: 62
Duplex 2
Floor 1
Exterior
Brown paint on wood window frame.

Non-LCP
2819-B-P33A: <40 mg/kg
2819-B-P33B: <40 mg/kg

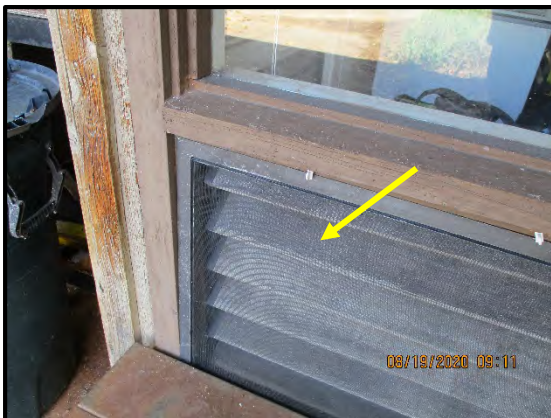
HM ID: 64
Duplex 2
Floor 1
Exterior
Brown paint on metal screen.

**Assumed LCP
(Baked on paint)**

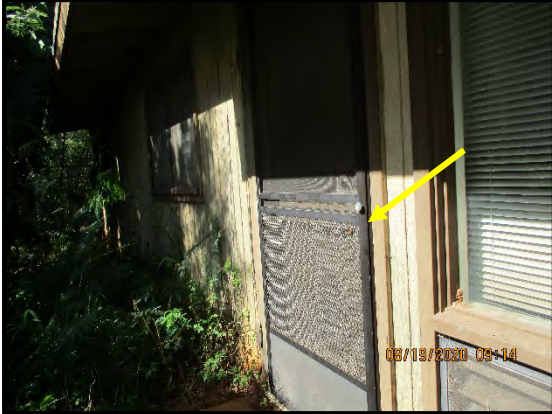
HM ID: 65
Duplex 2
Floor 1

Exterior
Black paint on metal rear door.

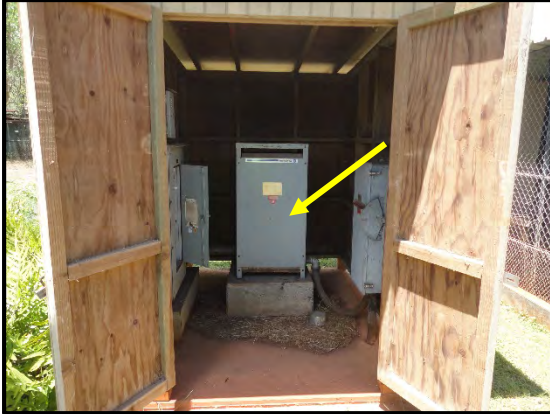
HM ID: 110
Electrical Shed
Floor 1

Interior
Light gray paint on metal electrical box.

Non-LCP
2819-A-P7A: <40 mg/kg
2819-A-P7B: <40 mg/kg

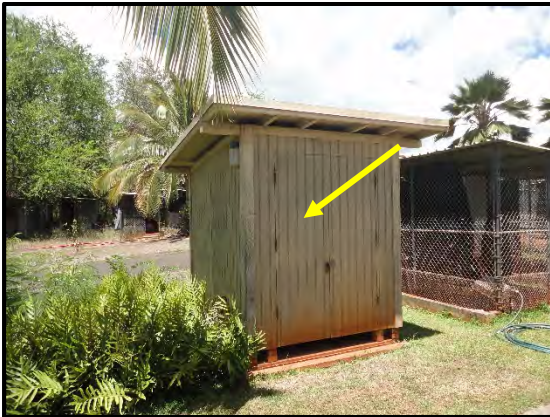
HM ID: 111
Electrical Shed
Floor 1

Exterior
Off-white paint on wood wall.

Non-LCP
2819-A-P8A: <40 mg/kg
2819-A-P8B: <40 mg/kg

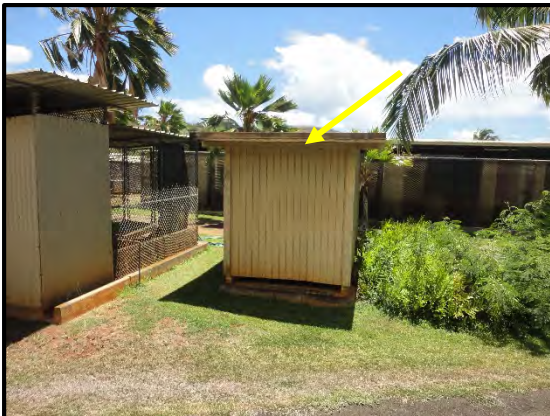
HM ID: 112
Electrical Shed
Floor 1

Exterior
Off-white paint on metal flashing.

Non-LCP
2819-A-P9A: <40 mg/kg
2819-A-P9B: <40 mg/kg

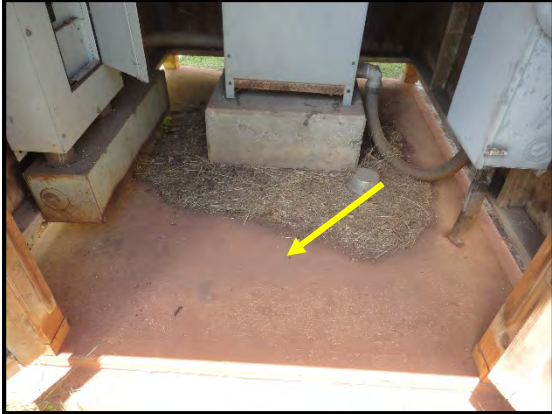
HM ID: 113
Electrical Shed
Floor 1

Interior
Light gray concrete floor.

Non-ACM
2819-A-A4A: ND
2819-A-A4B: ND
2819-A-A4C: ND

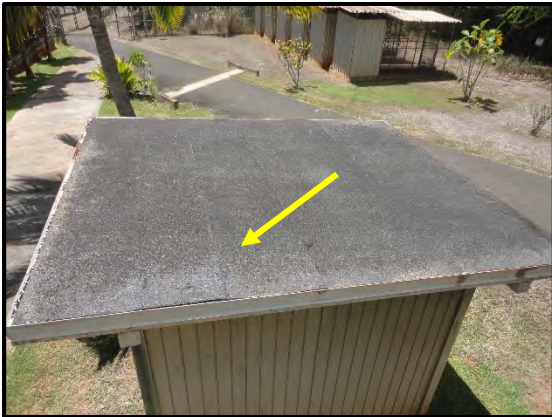
HM ID: 114
Electrical Shed
Roof

Exterior
Black tar shingles on wood roofing system.

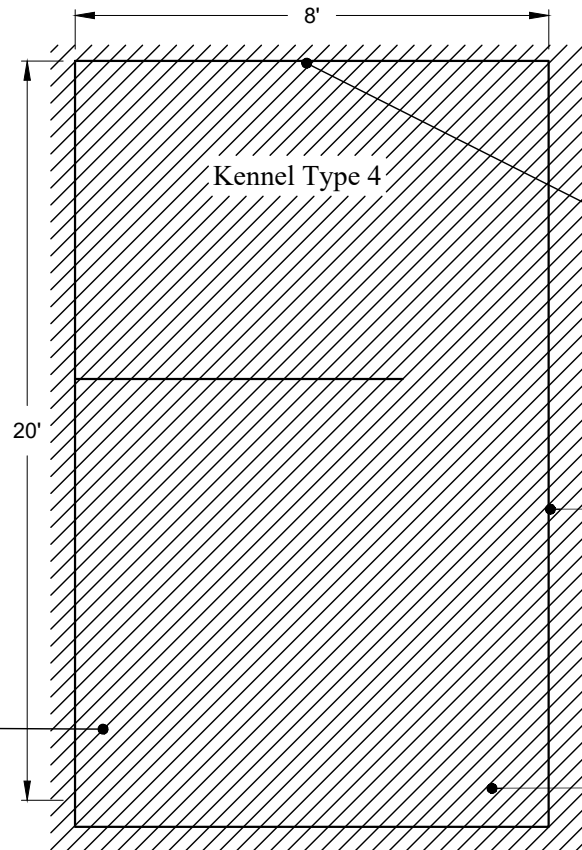
Sheet Number
 D7 -13

HM ID	Locations	Color	Substrate	Results (mg/kg)
115	Underside of roof, walls	White	Metal	LCP 340 - 390
118	Roofing system	Beige	Metal	LCP 99 - 160

2819-A-P13B: LCP 160 mg/kg
 2819-A-P13B: LCP 99 mg/kg
 HM ID: 118 (Beige paint on metal roofing system)

2819-A-P10B: LCP 340 mg/kg
 2819-A-P10B: LCP 390 mg/kg
 HM ID: 115 (White paint on metal wall)

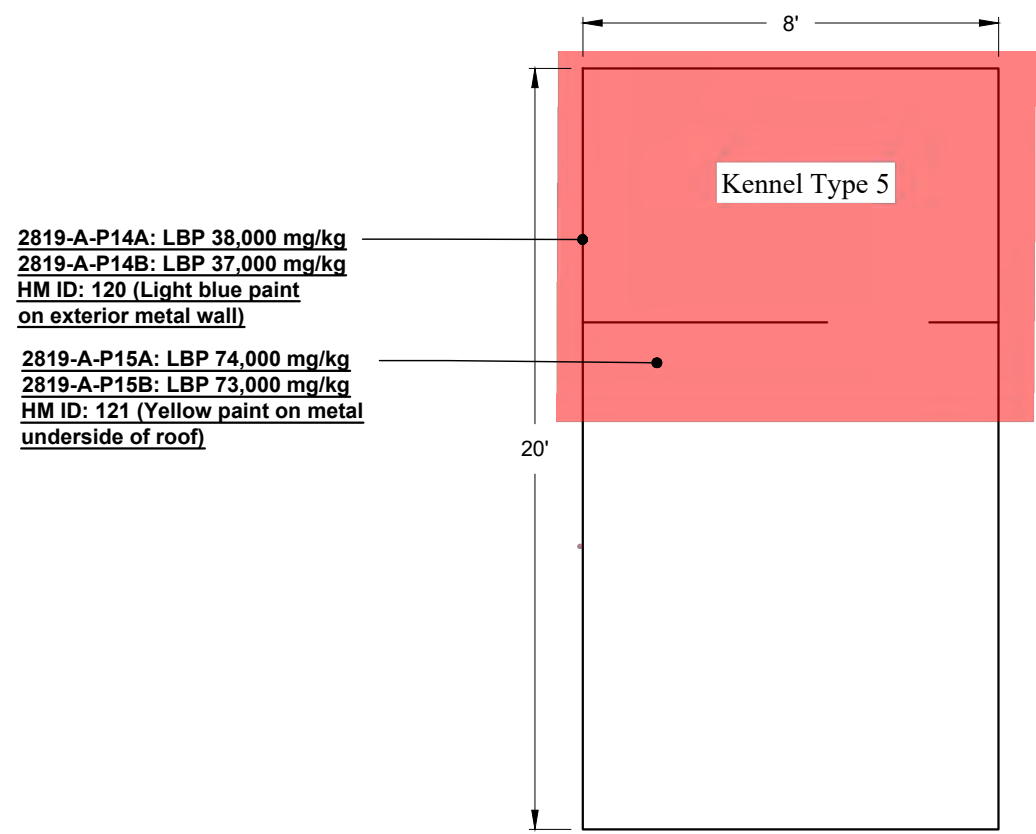
HM ID	Locations	Color	Substrate	Results (mg/kg)
120	Exterior walls	Lt. blue	Metal	LBP 37,000 - 38,000
121	Underside of roof	Yellow	Metal	LBP 73,000 - 74,000

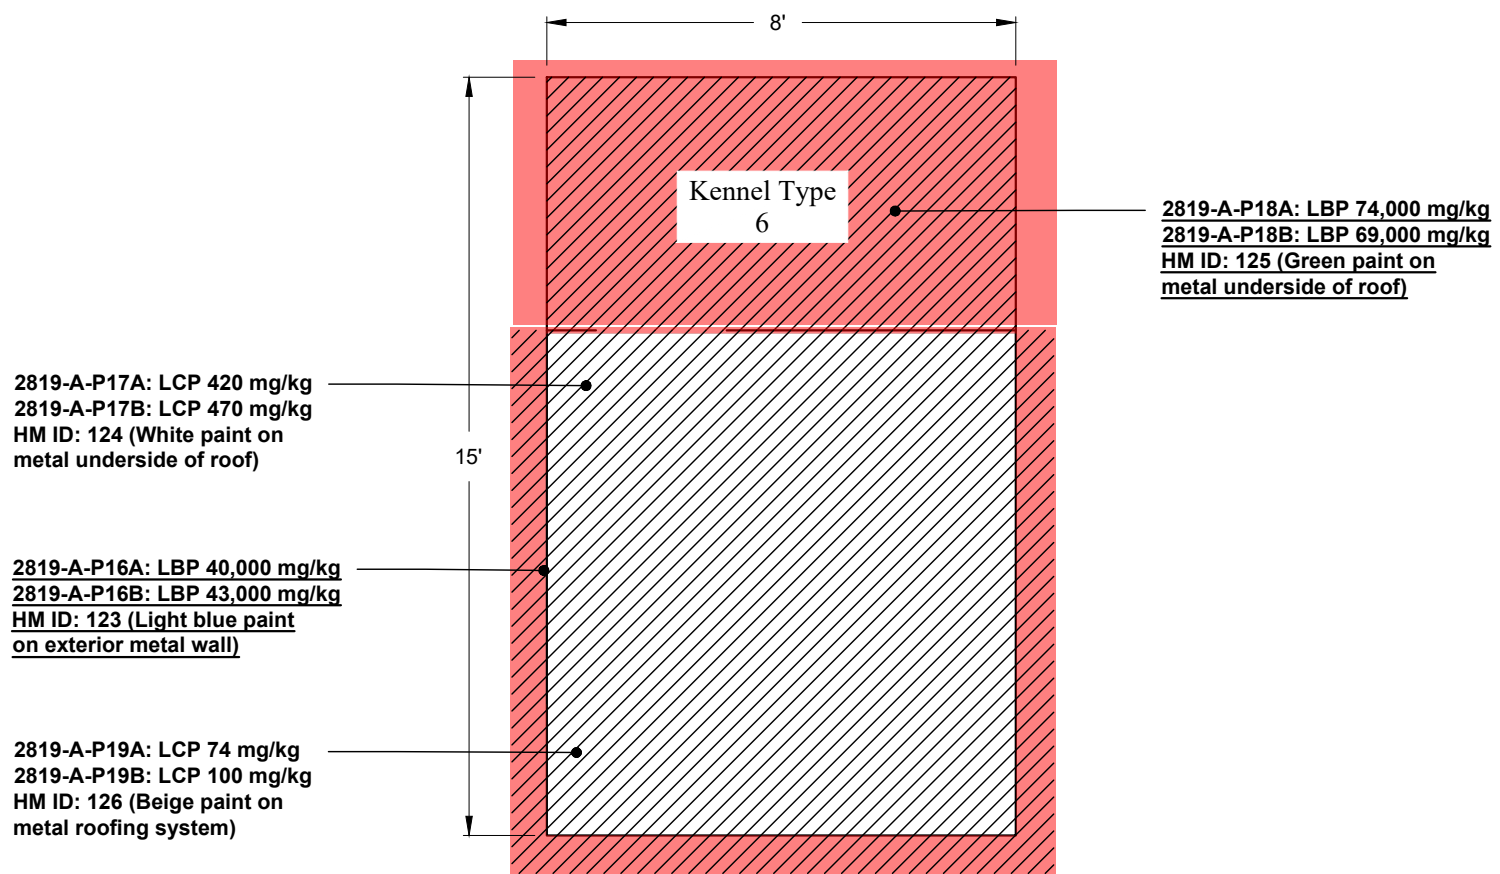
HM ID	Locations	Color	Substrate	Results (mg/kg)
123	Exterior walls	Lt. blue	Metal	LBP 40,000 - 43,000
124	Underside of roof	White	Metal	LCP 420 - 470

HM ID	Locations	Color	Substrate	Results (mg/kg)
125	Underside of roof	Green	Metal	LBP 69,000 - 74,000
126	Roofing system	Beige	Metal	LCP 74 - 100

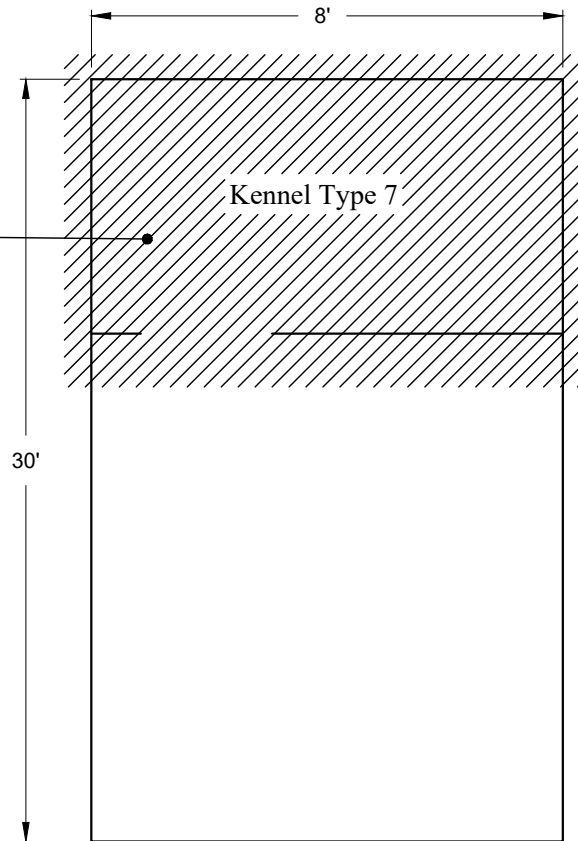
HM ID	Locations	Color	Substrate	Results (mg/kg)
141	Underside of roof, walls	Green	Metal	LCP 2,400 - 2,500

2819-A-P25B: LCP 2,500 mg/kg
 2819-A-P25B: LCP 2,400 mg/kg
 HM ID: 141 (Green paint on metal underside of roof)

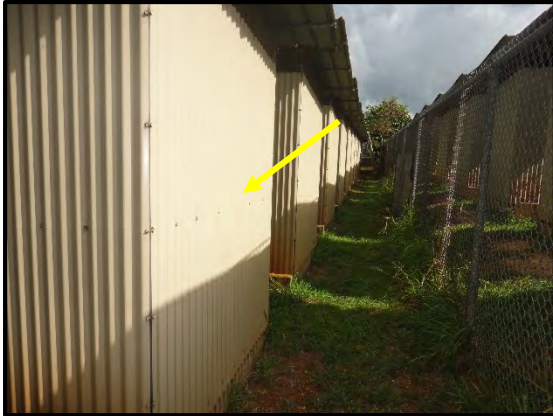
HM ID: 101
Kennel Type 1
Floor 1

Exterior
Off-white paint on metal wall.

LCP
2819-A-P1A: 160 mg/kg
2819-A-P1B: 110 mg/kg

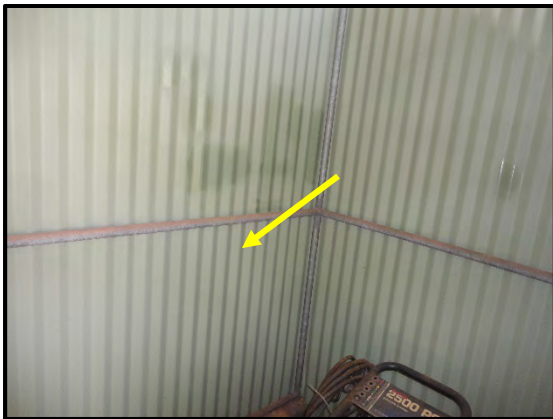
HM ID: 102
Kennel Type 1
Floor 1

Interior
Green paint on metal wall.

LCP
2819-A-P2A: 140 mg/kg
2819-A-P2B: 130 mg/kg

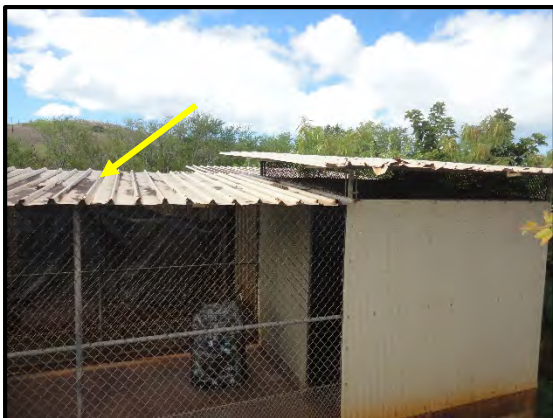
HM ID: 103
Kennel Type 1
Roof

Exterior
Beige paint on metal roofing system.

LCP
2819-A-P3A: 170 mg/kg
2819-A-P3B: 120 mg/kg

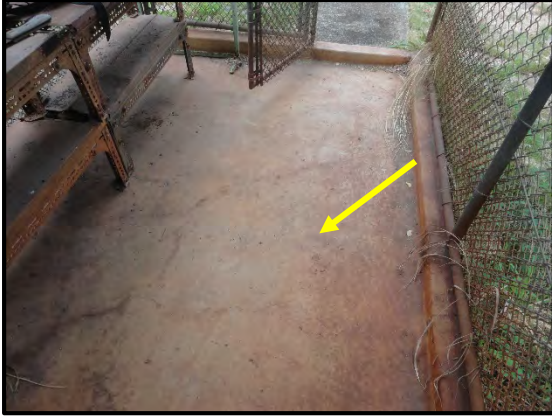
HM ID: 104
Kennel Type 1
Floor 1

Interior
Light gray concrete floor.

Non-ACM

2819-A-A1A: ND
2819-A-A1B: ND
2819-A-A1C: ND

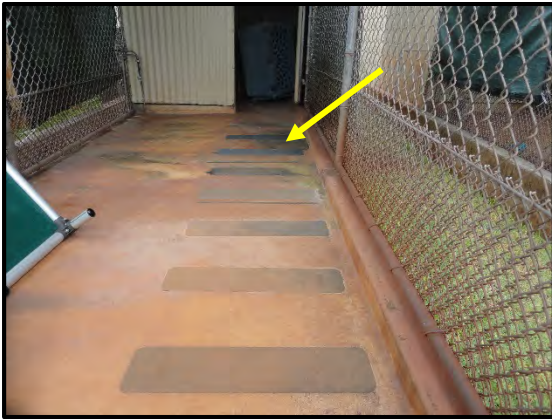
HM ID: 105
Kennel Type 2
Floor 1

Interior
Black coating on concrete floor.

Non-ACM

2819-A-A2A: ND
2819-A-A2B: ND
2819-A-A2C: ND

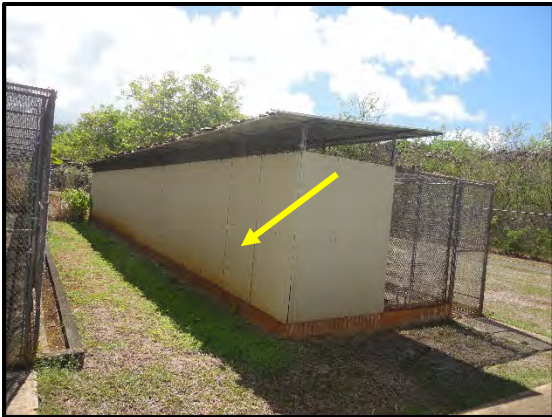
HM ID: 106
Kennel Type 3
Floor 1

Exterior
Off-white paint on metal wall.

Non-LCP

2819-A-P4A: <40 mg/kg
2819-A-P4B: <40 mg/kg

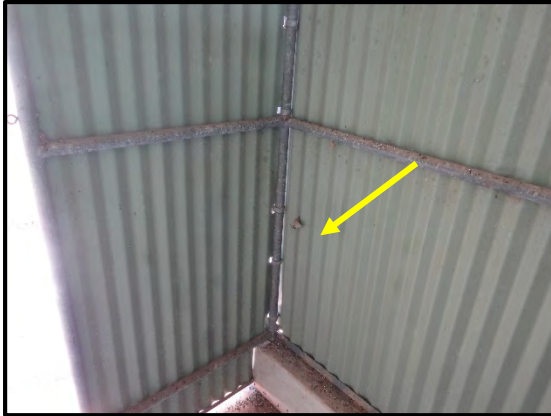
HM ID: 107
Kennel Type 3
Floor 1

Interior
Light green paint on metal wall.

LCP
2819-A-P5A: 43 mg/kg
2819-A-P5B: <40 mg/kg

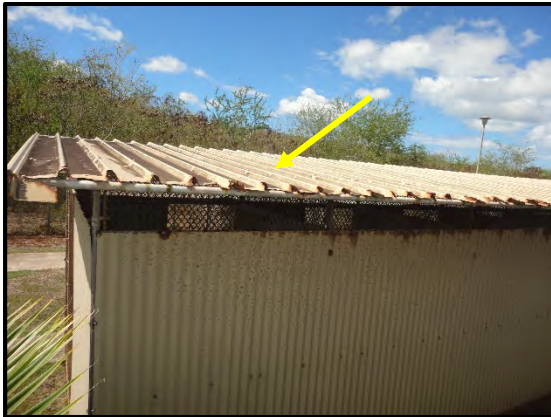
HM ID: 108
Kennel Type 3
Roof

Exterior
Beige paint on metal roofing system.

LCP
2819-A-P6A: 170 mg/kg
2819-A-P6B: 150 mg/kg

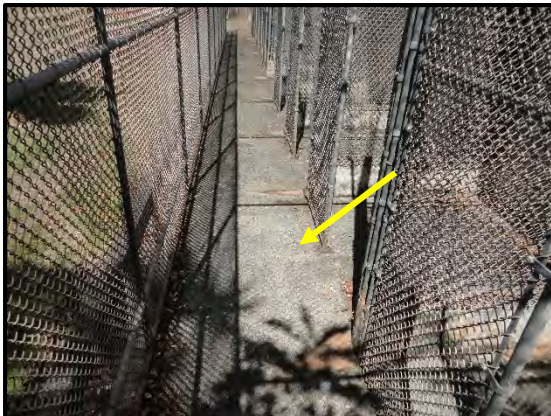
HM ID: 109
Kennel Type 3
Floor 1

Interior
Light gray concrete floor.

Non-ACM
2819-A-A3A: ND
2819-A-A3B: ND
2819-A-A3C: ND

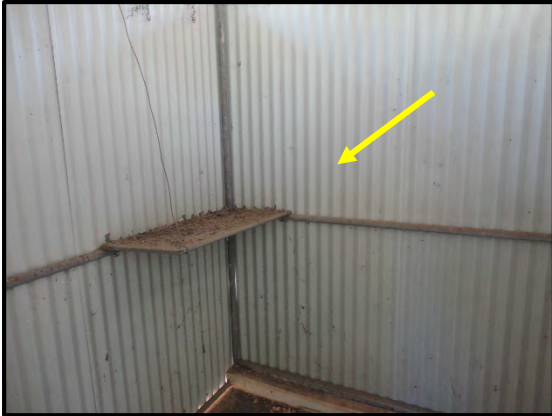
HM ID: 115
Kennel Type 4
Floor 1

Interior
White paint on metal wall.

LCP
2819-A-P10A: 340 mg/kg
2819-A-P10B: 390 mg/kg

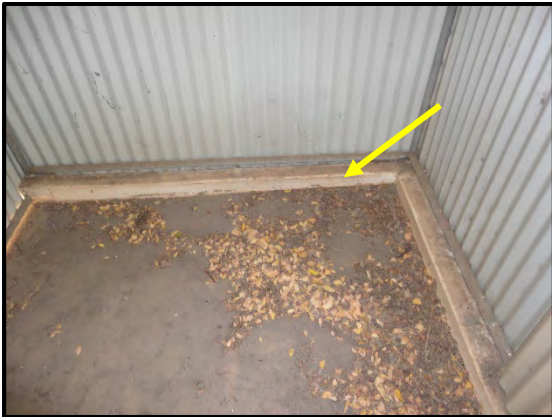
HM ID: 116
Kennel Type 4
Floor 1

Interior
Off-white paint on concrete floor.

Non-LCP
2819-A-P11A: <40 mg/kg
2819-A-P11B: <40 mg/kg

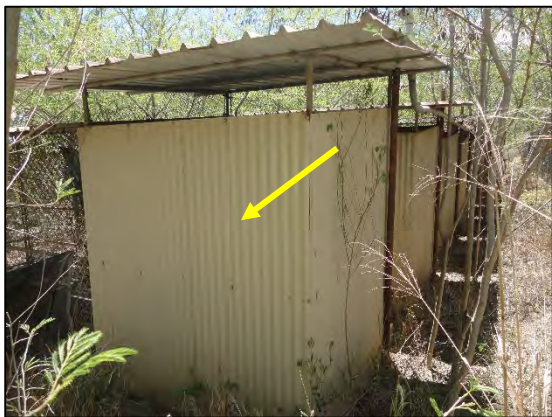
HM ID: 117
Kennel Type 4
Floor 1

Exterior
Off-white paint on metal wall.

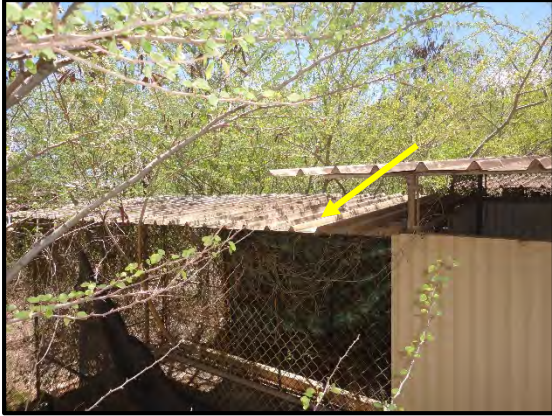
HM ID: 118
Kennel Type 4
Roof

Exterior
Beige paint on metal roofing system.

LCP
2819-A-P13A: 160 mg/kg
2819-A-P13B: 99 mg/kg

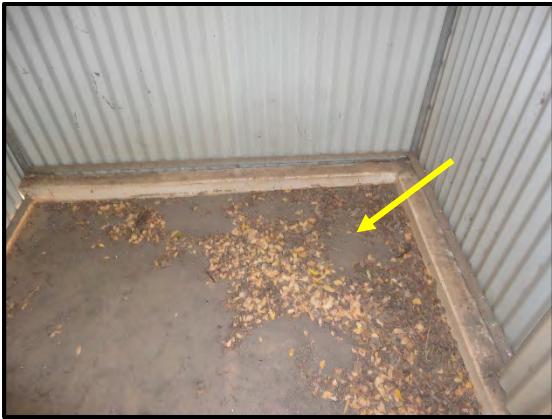
HM ID: 119
Kennel Type 4
Floor 1

Interior
Light gray concrete floor.

Non-ACM
2819-A-A6A: ND
2819-A-A6B: ND
2819-A-A6C: ND
