**HAZARDOUS MATERIAL SURVEY REPORT
FOR
PHASE 2 OAHU COMMUNITY CORRECTIONAL CENTER
HDOA ANIMAL QUARANTINE STATION
99-951 HALAWA VALLEY STREET
AIEA, ISLAND OF OAHU 96701**

**MNA PROJECT 02819_2
AHL PROJECT No. 6930.001
DAGS JOB No. 12-27-5713**

November 30, 2020

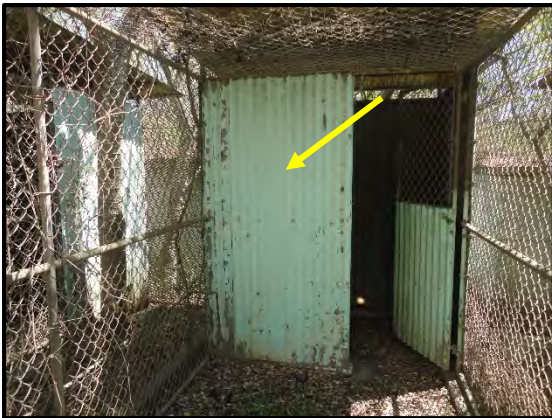
HM ID: 120
Kennel Type 5
Floor 1

Exterior
Light blue paint on metal wall.

LBP
2819-A-P14A: 38,000 mg/kg
2819-A-P14B: 37,000 mg/kg

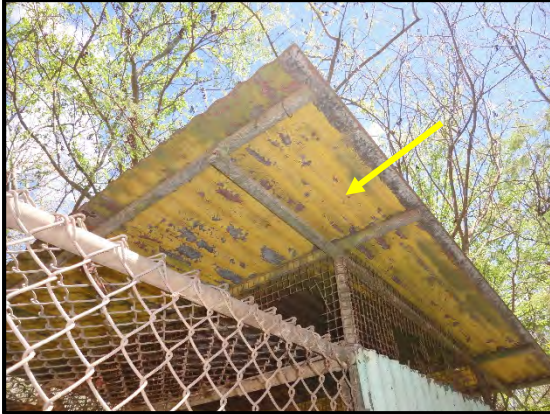
HM ID: 121
Kennel Type 5
Floor 1

Interior
Yellow paint on metal underside of roof.

LBP
2819-A-P15A: 74,000 mg/kg
2819-A-P15B: 73,000 mg/kg

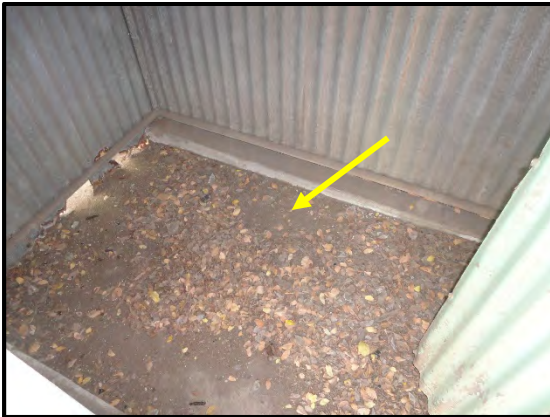
HM ID: 122
Kennel Type 5
Floor 1

Interior
Light gray concrete floor.

Non-ACM
2819-A-A7A: ND
2819-A-A7B: ND
2819-A-A7C: ND

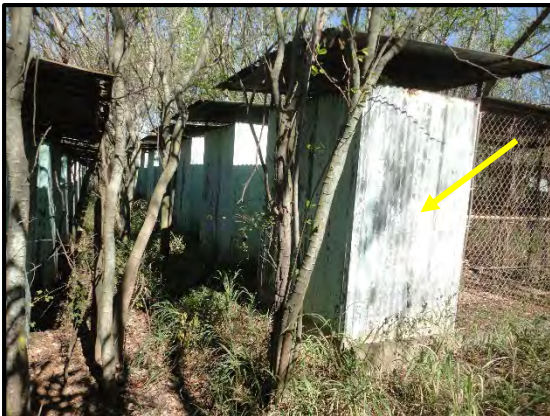
HM ID: 123
Kennel Type 6
Floor 1

Exterior
Light blue paint on metal wall.

LBP
2819-A-P16A: 40,000 mg/kg
2819-A-P16B: 43,000 mg/kg

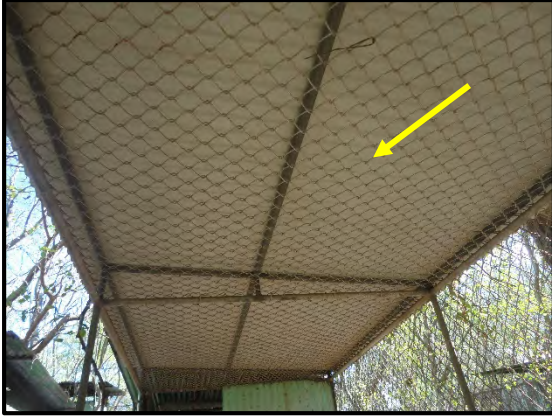
HM ID: 124
Kennel Type 6
Floor 1

Interior
White paint on metal underside of roof.

LCP
2819-A-P17A: 420 mg/kg
2819-A-P17B: 470 mg/kg

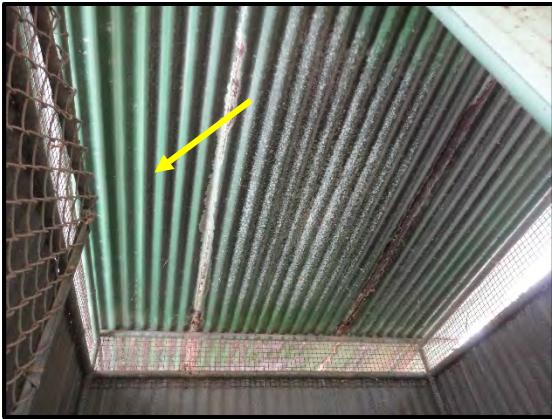
HM ID: 125
Kennel Type 6
Floor 1

Interior
Green paint on metal underside of roof.

LBP
2819-A-P18A: 74,000 mg/kg
2819-A-P18B: 69,000 mg/kg

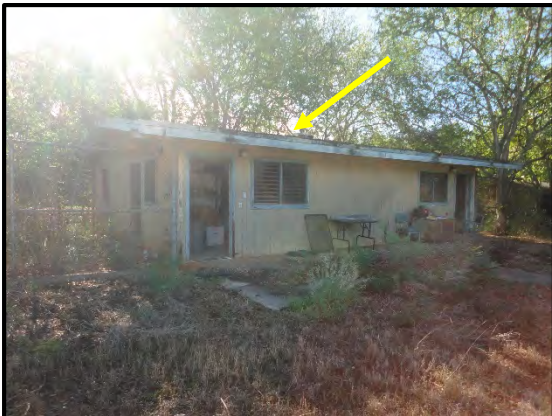
HM ID: 126
Kennel Type 6
Roof

Exterior
Beige paint on metal roofing system.

LCP
2819-A-P19A: 74 mg/kg
2819-A-P19B: 100 mg/kg

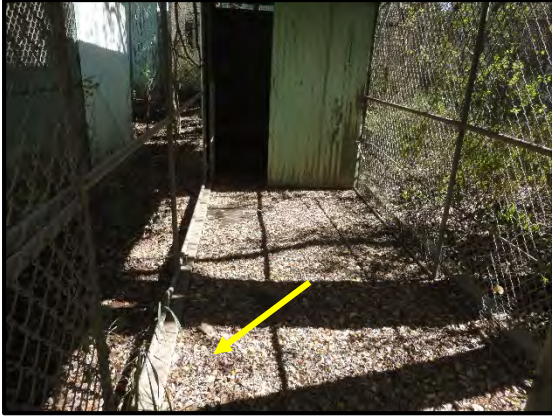
HM ID: 127
Kennel Type 6
Floor 1

Interior
Light gray concrete floor.

Non-ACM
2819-A-A8A: ND
2819-A-A8B: ND
2819-A-A8C-Cementitious 1: ND
2819-A-A8C-Cementitious 2: ND

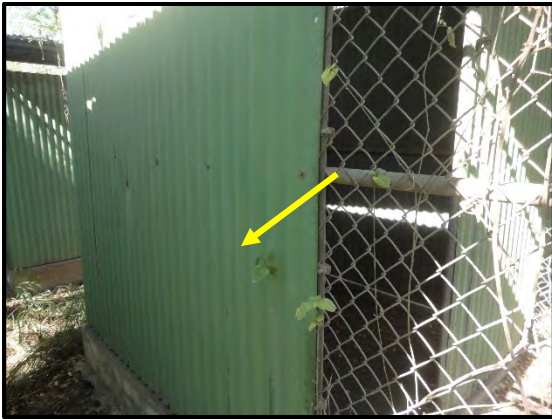
HM ID: 141
Kennel Type 7
Floor 1

Interior
Green paint on metal wall.

LCP
2819-A-P25A: 2,400 mg/kg
2819-A-P25B: <40 mg/kg

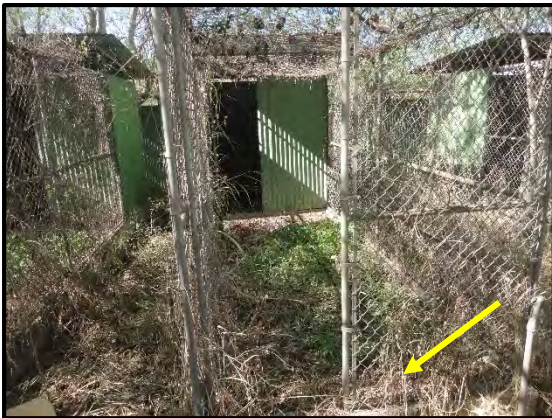
HM ID: 142
Kennel Type 7
Floor 1

Interior
Light gray concrete floor.

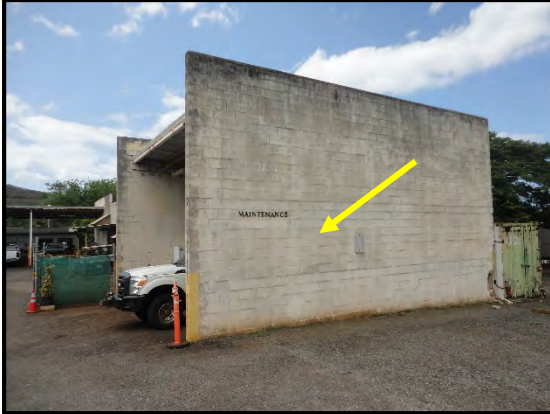
HM ID: 197
Maintenance Shop
Floor 1
Exterior
White paint on concrete block wall.

LCP
2819-A-P34A: 91 mg/kg
2819-A-P34B: 100 mg/kg

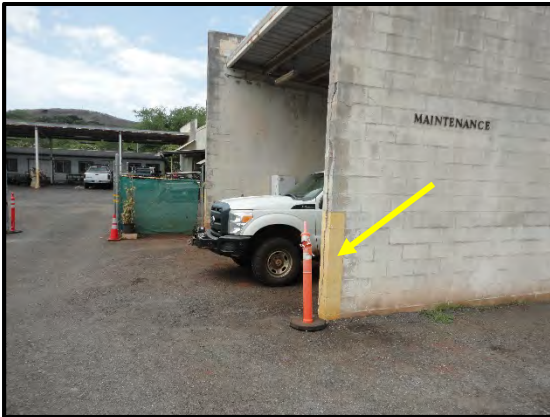
HM ID: 198
Maintenance Shop
Floor 1
Exterior
Yellow paint on concrete block wall.

LBP
2819-A-P35A: 25,000 mg/kg
2819-A-P35B: 19,000 mg/kg

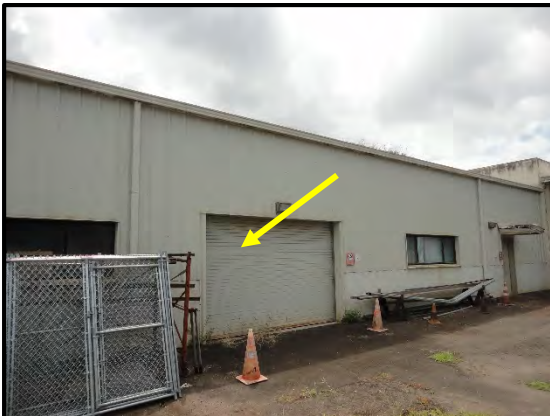
HM ID: 199
Maintenance Shop
Floor 1
Exterior
Off-white paint on metal door.

Non-LCP
2819-A-P36A: <40 mg/kg
2819-A-P36B: <40 mg/kg

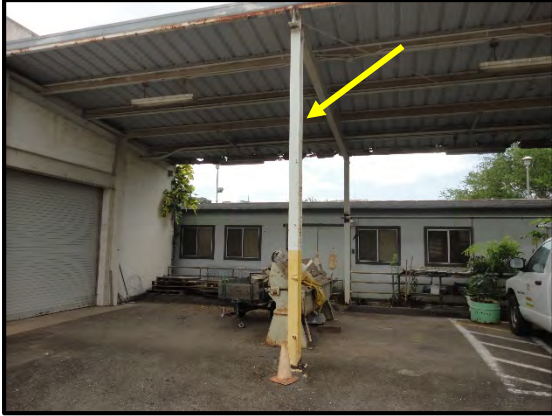
HM ID: 200
Maintenance Shop
Floor 1
Exterior
White paint on metal conduit.

LBP
2819-A-P37A: 160,000 mg/kg
2819-A-P37B: 240,000 mg/kg

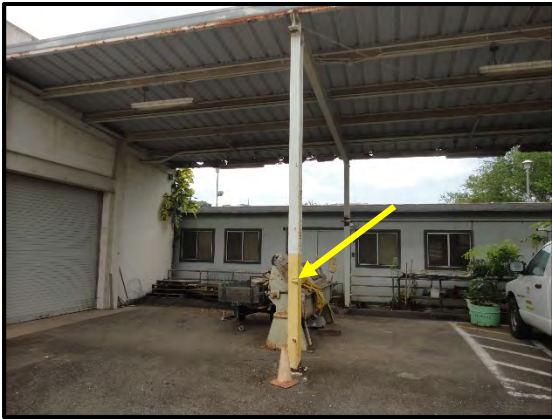
HM ID: 201
Maintenance Shop
Floor 1
Exterior
Yellow paint on metal corner trim.

LBP
2819-A-P38A: 38,000 mg/kg
2819-A-P38B: 35,000 mg/kg

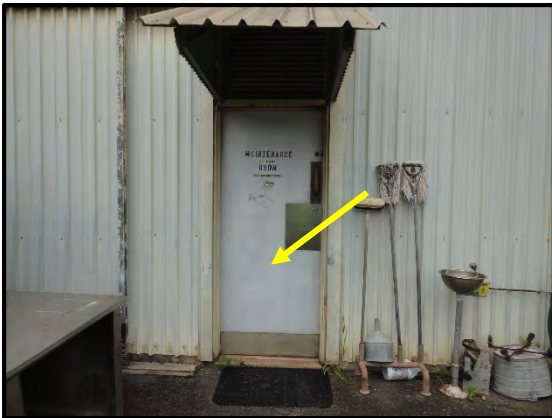
HM ID: 202
Maintenance Shop
Floor 1
Exterior
Light gray paint on metal door.

LCP
2819-A-P39A: 1,100 mg/kg
2819-A-P39B: 3,800 mg/kg

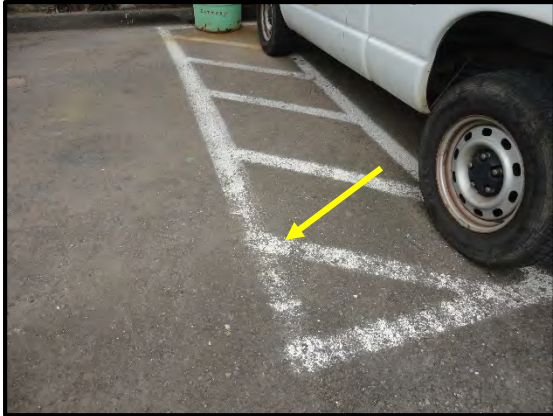
HM ID: 203
Maintenance Shop
Floor 1

Exterior
White paint on asphalt parking lanes.

LCP
2819-A-P40A: 93 mg/kg
2819-A-P40B: 68 mg/kg

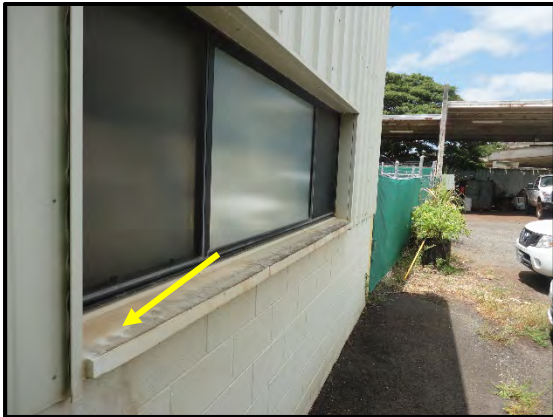
HM ID: 204
Maintenance Shop
Floor 1

Exterior
White paint on concrete window ledge.

Non-LCP
2819-A-P41A: <40 mg/kg
2819-A-P41B: <40 mg/kg

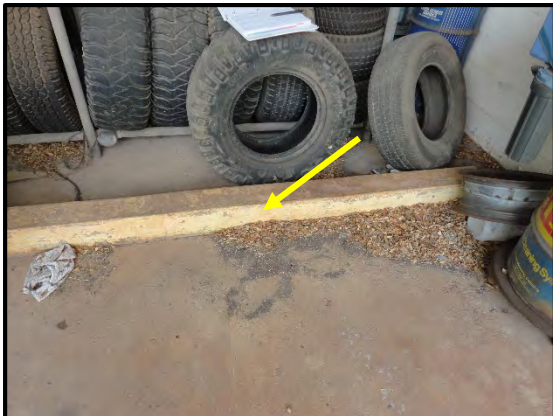
HM ID: 205
Maintenance Shop
Floor 1

Exterior
Yellow paint on concrete curb.

LCP
2819-A-P42A: 860 mg/kg
2819-A-P42B: 930 mg/kg

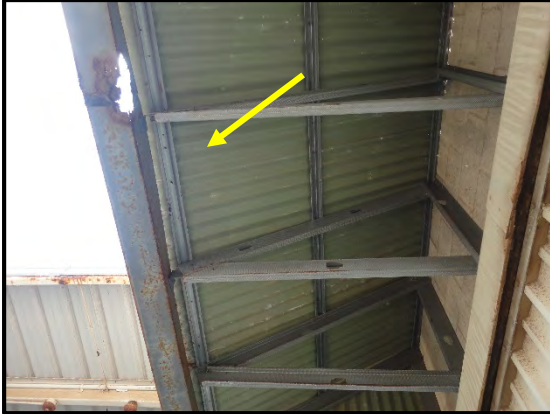
HM ID: 206
Maintenance Shop
Floor 1

Exterior
Green paint on metal underside of roof.

Non-LCP

2819-A-P43A: <40 mg/kg
2819-A-P43B: <40 mg/kg

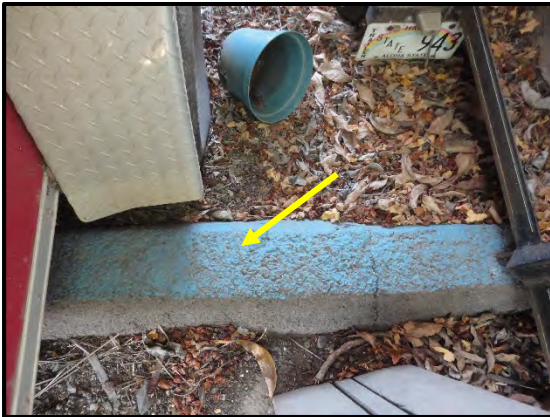
HM ID: 207
Maintenance Shop
Floor 1

Exterior
Blue paint on concrete curb.

LCP

2819-A-P44A: 210 mg/kg
2819-A-P44B: 75 mg/kg

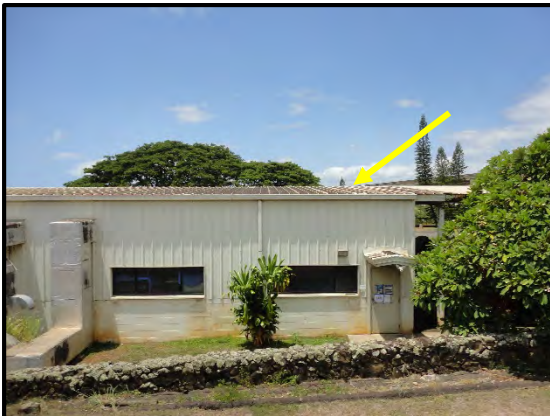
HM ID: 208
Maintenance Shop
Roof

Exterior
White paint on metal roofing system.

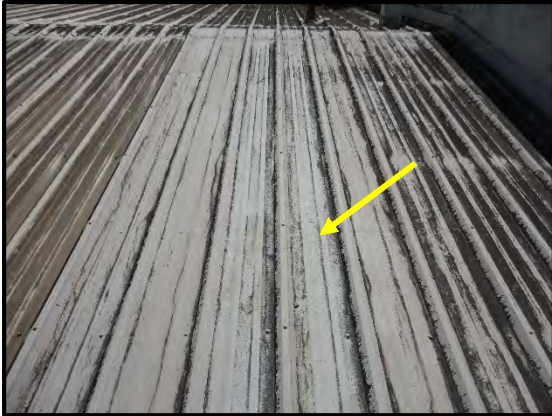
HM ID: 209
Maintenance Shop
Roof

Exterior
White coating on metal roofing system.

Non-LCP
2819-A-P46A: <40 mg/kg
2819-A-P46B: <40 mg/kg

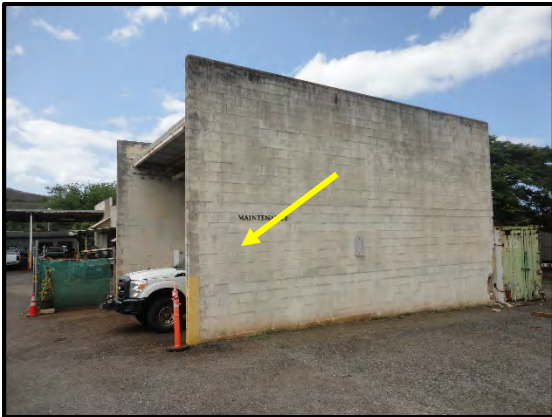
HM ID: 210
Maintenance Shop
Floor 1

Exterior
White paint and skim coat on concrete block wall.

Non-ACM
2819-A-A26A-Skim coat/Plaster: ND
2819-A-A26B-Skim coat/Plaster: ND
2819-A-A26C: ND

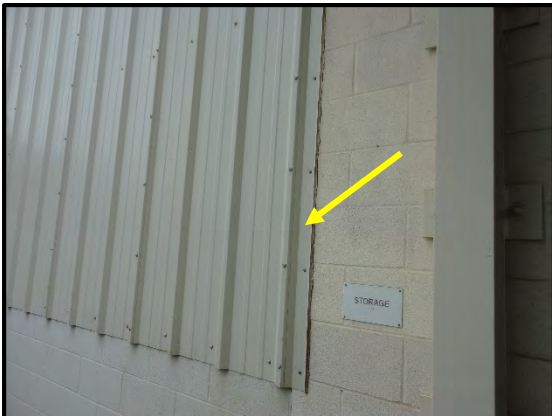
HM ID: 211
Maintenance Shop
Floor 1

Exterior
White caulking on metal door frame.

Non-ACM
2819-A-A27A: ND
2819-A-A27B: ND
2819-A-A27C: ND

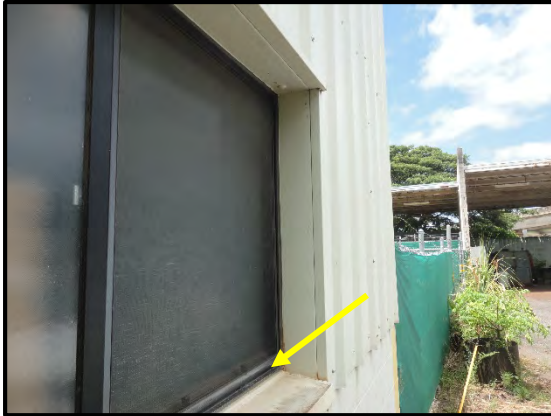
HM ID: 212
Maintenance Shop
Floor 1

Exterior
Black caulking on metal window frame.

Non-ACM
2819-A-A28A: ND
2819-A-A28B: ND
2819-A-A28C: ND

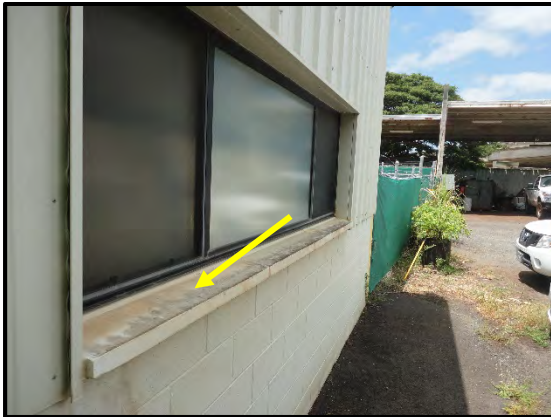
HM ID: 213
Maintenance Shop
Floor 1

Exterior
White paint and skim coat on concrete window ledge.

Non-ACM
2819-A-A29A-Skim coat/Plaster: ND
2819-A-A29B-Skim coat/Plaster: ND
2819-A-A29C-Skim coat/Plaster: ND

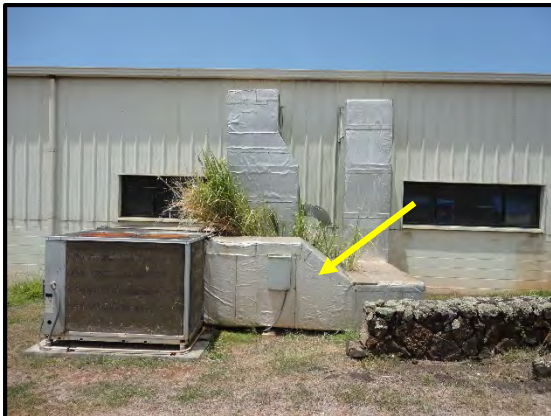
HM ID: 214
Maintenance Shop
Floor 1

Exterior
Yellow insulation with silver wrap on metal ducting.

Non-ACM
2819-A-A30A-Wrap: ND
2819-A-A30A-Insulation: ND
2819-A-A30B-Wrap: ND
2819-A-A30B-Insulation: ND
2819-A-A30C-Wrap: ND
2819-A-A30C-Insulation: ND

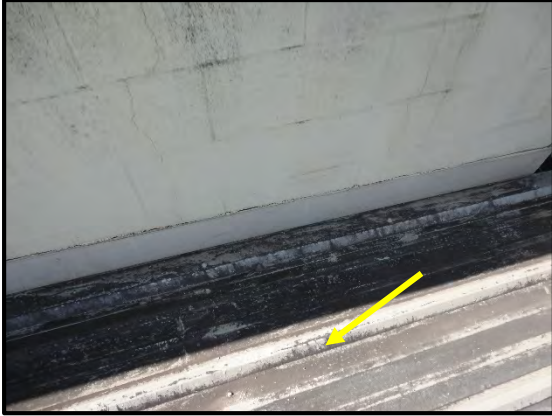
HM ID: 215
Maintenance Shop
Roof

Exterior
White caulking on metal roofing system.

Non-ACM

2819-A-A31A-Caulking 1: ND
2819-A-A31A-Caulking 2: ND
2819-A-A31B-Caulking 1: ND
2819-A-A31B-Caulking 2: ND
2819-A-A31C-Caulking 1: ND
2819-A-A31C-Caulking 2: ND

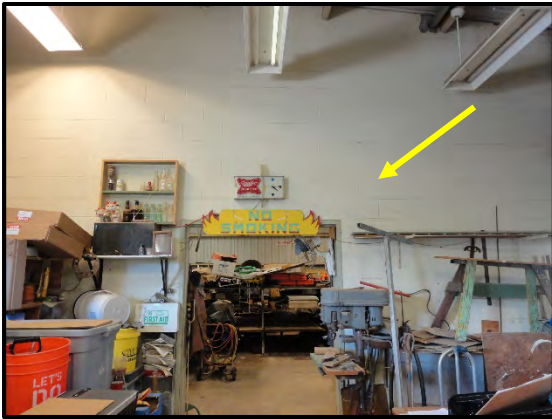
HM ID: 216
Maintenance Shop
Floor 1

Warehouse
Off-white paint on concrete block wall.

LCP

2819-A-P47A: 53 mg/kg
2819-A-P47B: 46 mg/kg

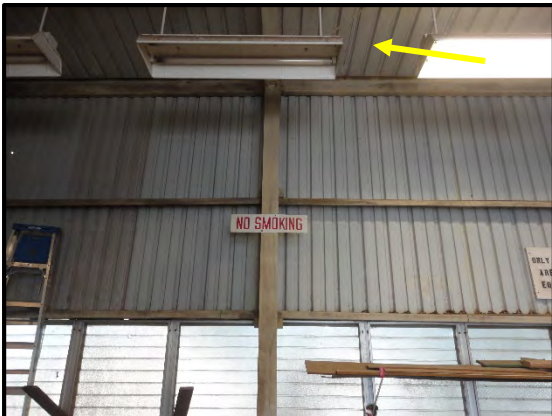
HM ID: 217
Maintenance Shop
Floor 1

Warehouse
Light gray paint on metal underside of roof.

LCP

2819-A-P48A: 2,300 mg/kg
2819-A-P48B: 2,400 mg/kg

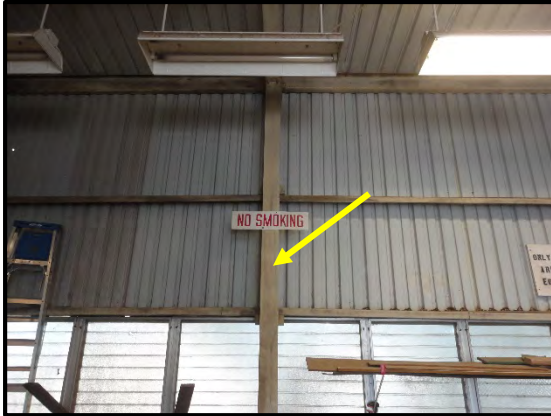
HM ID: 218
Maintenance Shop
Floor 1

Warehouse
Off-white paint on metal H-beam.

LBP
2819-A-P49A: 140,000 mg/kg
2819-A-P49B: 140,000 mg/kg

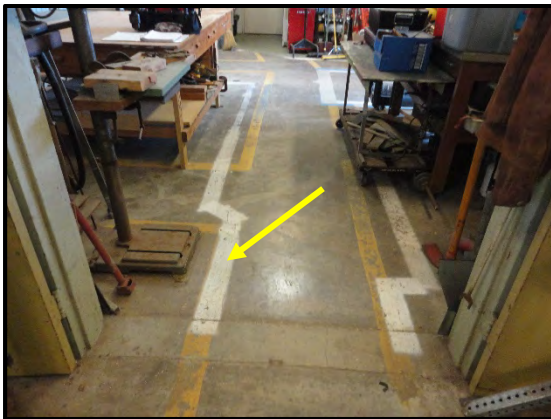
HM ID: 220
Maintenance Shop
Floor 1

Warehouse
White paint on concrete floor.

LCP
2819-A-P50A: <40 mg/kg
2819-A-P50B: 96 mg/kg

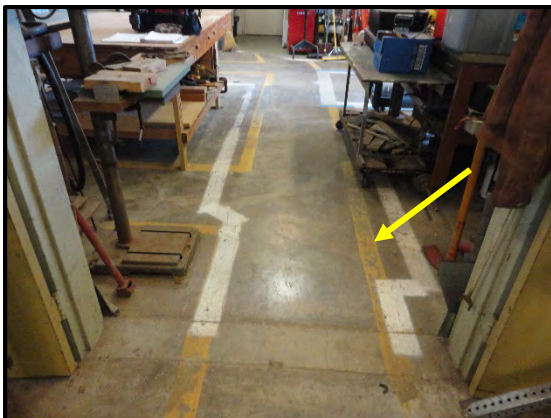
HM ID: 221
Maintenance Shop
Floor 1

Warehouse
Yellow paint on concrete floor.

LBP
2819-A-P51A: 39,000 mg/kg
2819-A-P51B: 41,000 mg/kg

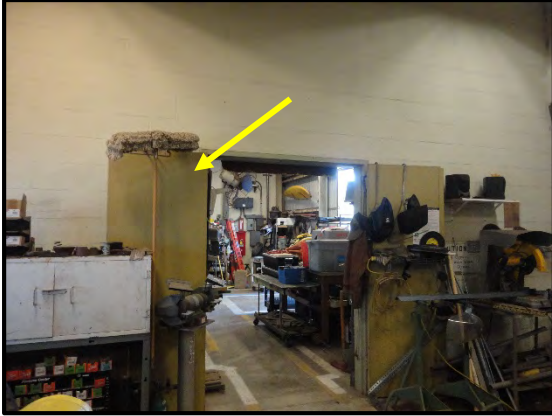
HM ID: 222
Maintenance Shop
Floor 1

Warehouse
Beige paint on metal door.

LCP
2819-A-P52A: 7,300 mg/kg
2819-A-P52B: 5,800 mg/kg

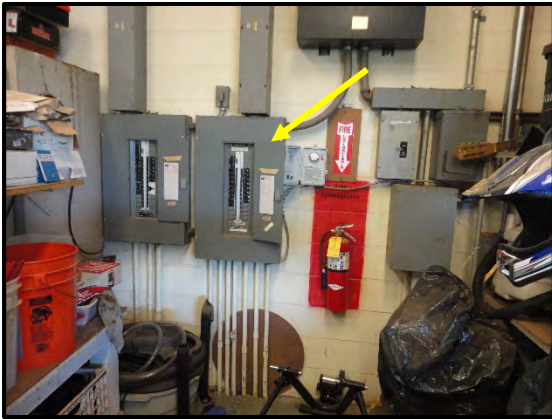
HM ID: 223
Maintenance Shop
Floor 1

Warehouse
Dark gray paint on metal electrical box.

LBP
2819-A-P53A: 2,800 mg/kg
2819-A-P53B: 11,000 mg/kg

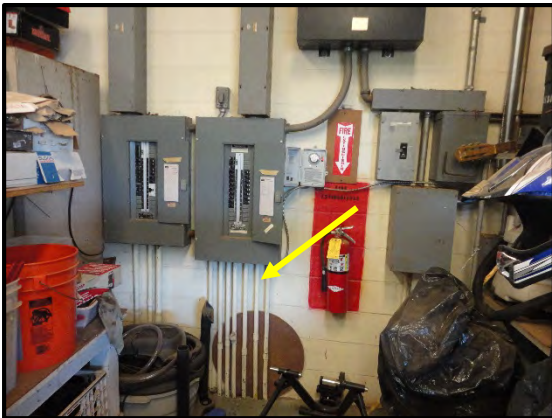
HM ID: 224
Maintenance Shop
Floor 1

Warehouse
White paint on metal conduit.

LCP
2819-A-P54A: 340 mg/kg
2819-A-P54B: 650 mg/kg

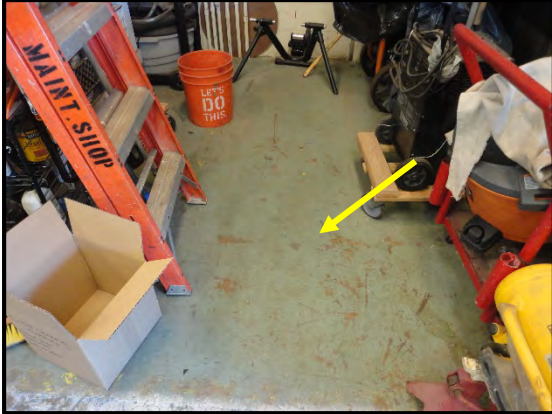
HM ID: 225
Maintenance Shop
Floor 1
Warehouse
Gray paint on concrete floor.

LCP
2819-A-P55A: 83 mg/kg
2819-A-P55B: 93 mg/kg

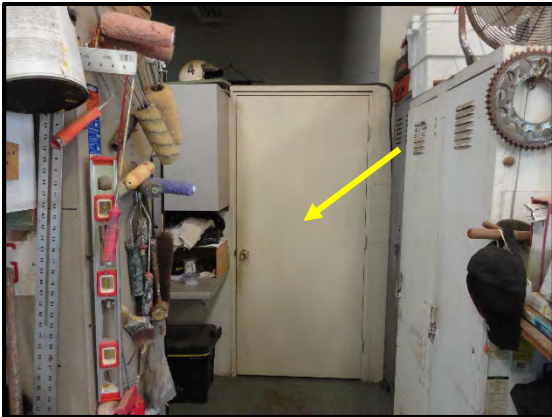
HM ID: 226
Maintenance Shop
Floor 1
Warehouse
Off-white paint on wood door.

LCP
2819-A-P56A: <40 mg/kg
2819-A-P56B: 40 mg/kg

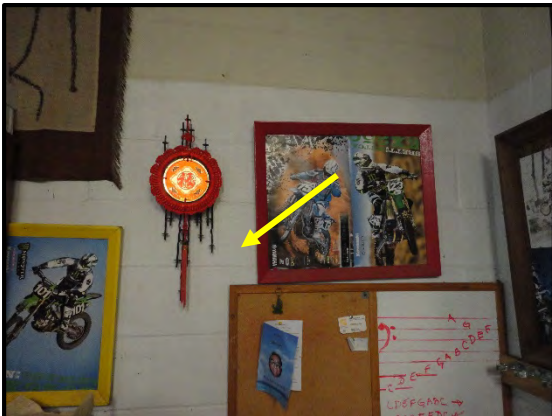
HM ID: 227
Maintenance Shop
Floor 1
Warehouse
White paint on concrete block wall.

LCP
2819-A-P57A: 110 mg/kg
2819-A-P57B: 110 mg/kg

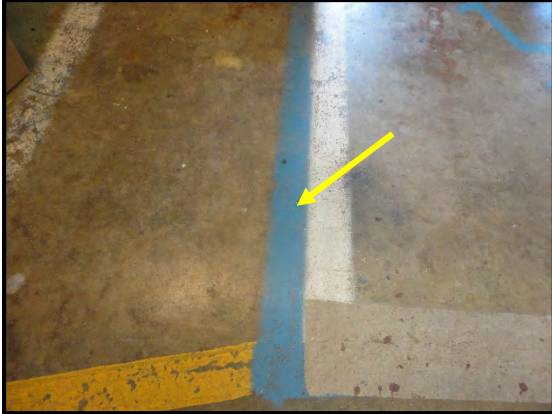
HM ID: 228
Maintenance Shop
Floor 1

Warehouse
Blue paint on concrete floor.

LCP
2819-A-P58A: 800 mg/kg
2819-A-P58B: 700 mg/kg

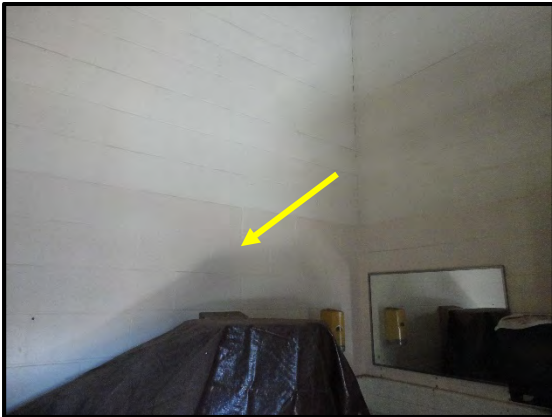
HM ID: 229
Maintenance Shop
Floor 1

Restroom
Light pink paint on concrete wall.

LCP
2819-A-P59A: 110 mg/kg
2819-A-P59B: 86 mg/kg

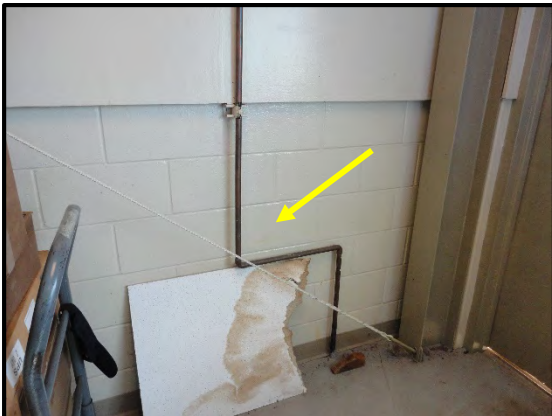
HM ID: 230
Maintenance Shop
Floor 1

Storage 1
Light beige paint on concrete block wall.

Non-LCP
2819-A-P60A: <40 mg/kg
2819-A-P60B: <40 mg/kg

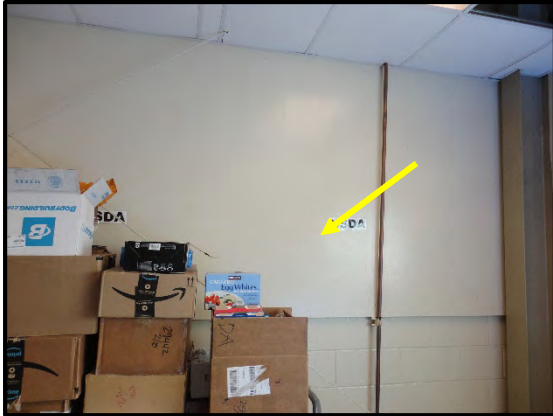
HM ID: 231
Maintenance Shop
Floor 1

Storage 1
Light beige paint on drywall wall.

Non-LCP

2819-A-P61A: <40 mg/kg
2819-A-P61B: <40 mg/kg

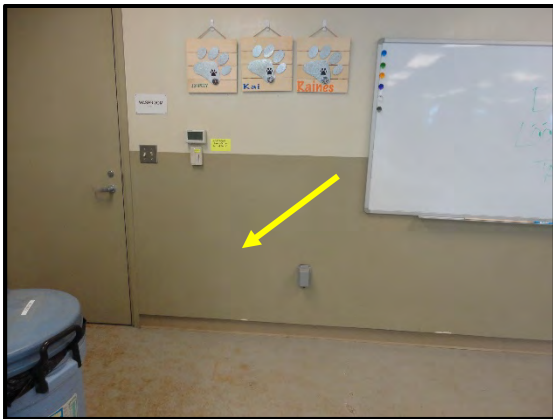
HM ID: 232
Maintenance Shop
Floor 1

Room 1
Beige paint on drywall wall.

Non-LCP

2819-A-P62A: <40 mg/kg
2819-A-P62B: <40 mg/kg

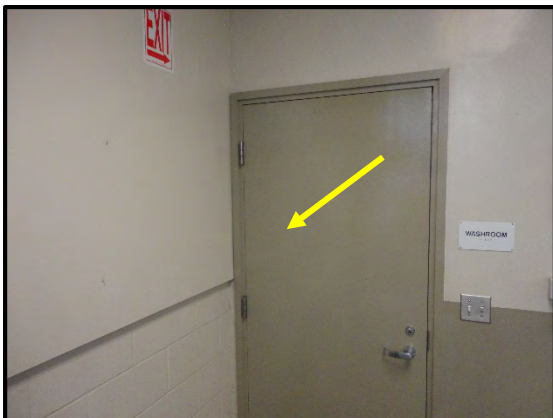
HM ID: 233
Maintenance Shop
Floor 1

Room 1
Beige paint on wood door.

Non-LCP

2819-A-P63A: <40 mg/kg
2819-A-P63B: <40 mg/kg

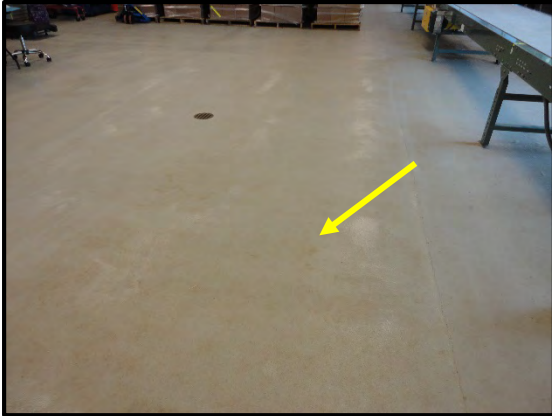
HM ID: 234
Maintenance Shop
Floor 1

Room 1
Beige paint on concrete floor.

Non-LCP
2819-A-P64A: <40 mg/kg
2819-A-P64B: <40 mg/kg

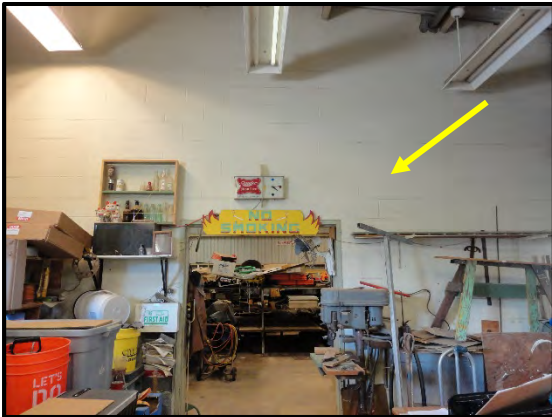
HM ID: 235
Maintenance Shop
Floor 1

Warehouse
Off-white paint and skim coat on concrete block wall.

Non-ACM
2819-A-A32A-Skim coat/Plaster: ND
2819-A-A32B-Skim coat/Plaster: ND
2819-A-A32C-Skim coat/Plaster: ND

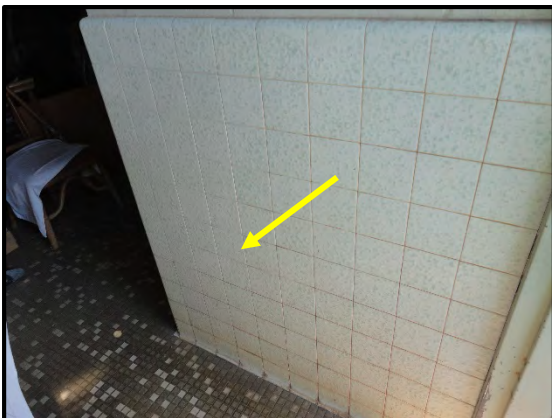
HM ID: 236
Maintenance Shop
Floor 1

Restroom 1
Light gray 4" x 4" ceramic tile and grout on concrete block floor.

Non-ACM
2819-A-A33A-Ceramic: ND
2819-A-A33A-Grout: ND
2819-A-A33B-Ceramic: ND
2819-A-A33B-Grout: ND
2819-A-A33C-Ceramic: ND
2819-A-A33C-Grout: ND

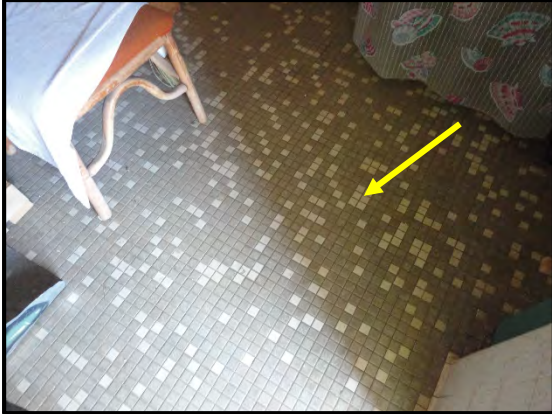
HM ID: 237
Maintenance Shop
Floor 1

Restroom 1
White 1" x 1" ceramic tile and grout on concrete floor.

Non-ACM

2819-A-A34A-Ceramic: ND
2819-A-A34A-Grout: ND
2819-A-A34B-Ceramic: ND
2819-A-A34B-Grout: ND
2819-A-A34C-Ceramic: ND
2819-A-A34C-Grout: ND

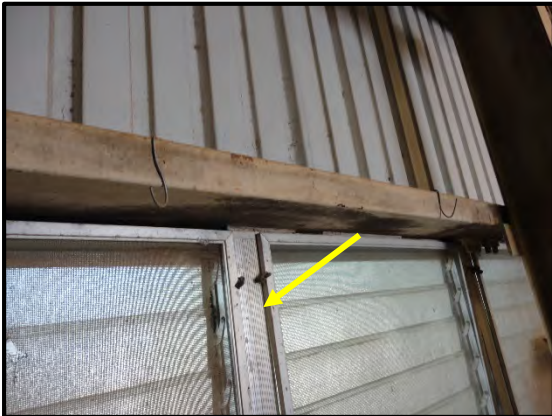
HM ID: 238
Maintenance Shop
Floor 1

Warehouse
White caulking on metal window frame.

Non-ACM

2819-A-A35A: ND
2819-A-A35B: ND
2819-A-A35C: ND

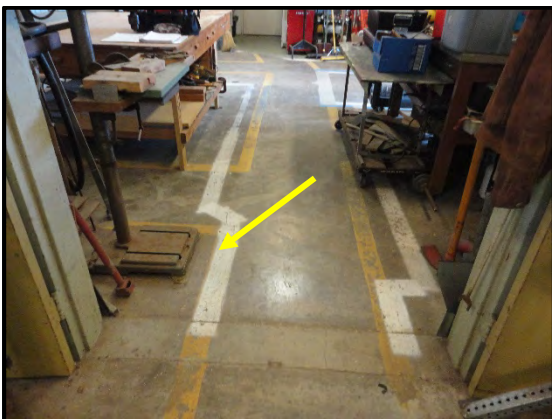
HM ID: 239
Maintenance Shop
Floor 1

Warehouse
White paint and skim coat on concrete floor.

Non-ACM

2819-A-A36A-Skim coat/Plaster: ND
2819-A-A36B-Skim coat/Plaster: ND
2819-A-A36C-Skim coat/Plaster: ND

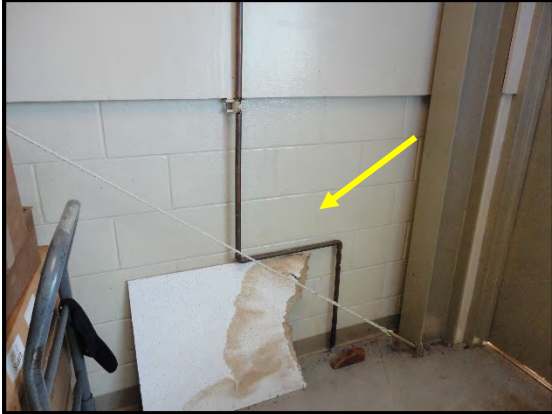
HM ID: 240
Maintenance Shop
Floor 1

Storage 1
Beige paint and skim coat on concrete block wall.

Non-ACM

2819-A-A37A-Skim coat/Plaster: ND
2819-A-A37B-Skim coat/Plaster: ND
2819-A-A37C-Skim coat/Plaster: ND

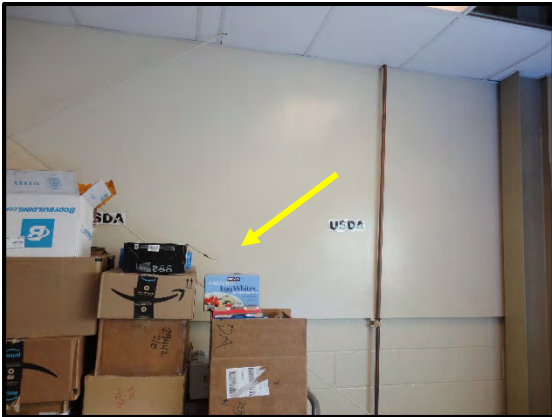
HM ID: 241
Maintenance Shop
Floor 1

Room 1
Beige over drywall and joint compound on concrete block wall.

Non-ACM

2819-A-A38A: ND
2819-A-A38B: ND
2819-A-A38C-Joint compound: ND

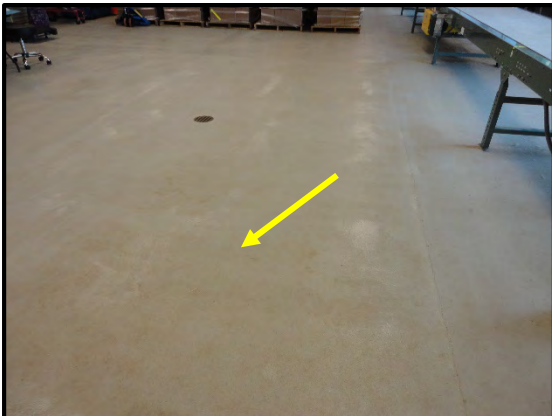
HM ID: 242
Maintenance Shop
Floor 1

Room 1
Beige paint and skim coat on concrete floor.

Non-ACM

2819-A-A39A-Texture: ND
2819-A-A29A-Skim coat/Plaster: ND
2819-A-A39B-Texture: ND
2819-A-A29B-Skim coat/Plaster: ND
2819-A-A39C-Texture: ND
2819-A-A29C-Skim coat/Plaster: ND

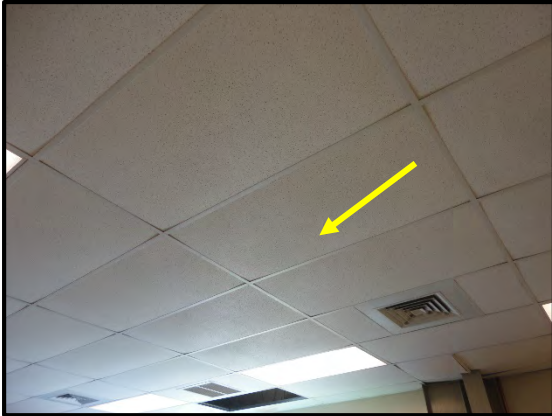
HM ID: 243
Maintenance Shop
Floor 1

Room 1
White 2' x 4' acoustic tile on ceiling.

Non-ACM
2819-A-A40A: ND
2819-A-A40B: ND
2819-A-A40C: ND

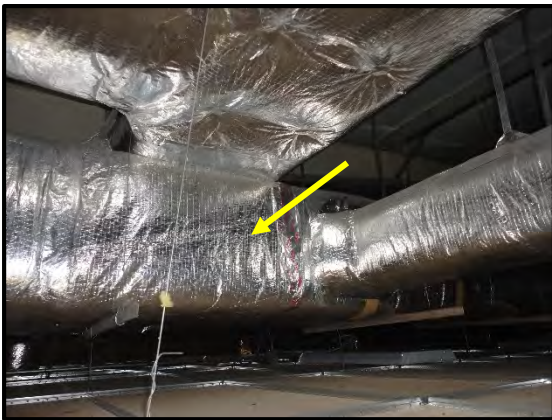
HM ID: 244
Maintenance Shop
Floor 1

Plenum
Yellow thermal system insulation with silver wrap on metal ducting.

Non-ACM
2819-A-A41A-Wrap: ND
2819-A-A41A-Insulation: ND
2819-A-A41B-Wrap: ND
2819-A-A41B-Insulation: ND
2819-A-A41C-Wrap: ND
2819-A-A41C-Insulation: ND

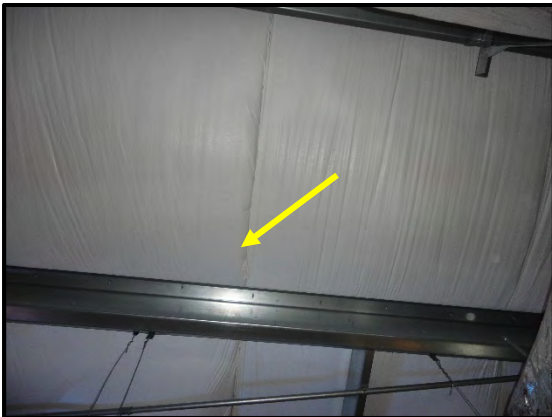
HM ID: 245
Maintenance Shop
Floor 1

Plenum
Yellow thermal system insulation with white wrap on metal ceiling.

Non-ACM
2819-A-A42A-Wrap: ND
2819-A-A42A-Insulation: ND
2819-A-A42B-Wrap: ND
2819-A-A42B-Insulation: ND
2819-A-A42C-Wrap: ND
2819-A-A42C-Insulation: ND

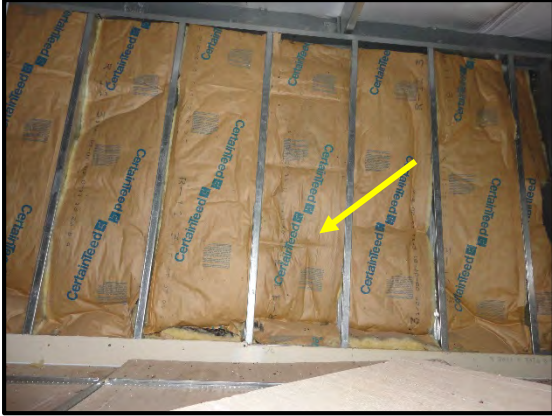
HM ID: 246
Maintenance Shop
Floor 1

Plenum
Yellow thermal system insulation with brown wrap on drywall wall.

Non-ACM

2819-A-A43A-Wrap: ND
2819-A-A43A-Insulation: ND
2819-A-A43B-Wrap: ND
2819-A-A43B-Insulation: ND
2819-A-A43C-Wrap: ND
2819-A-A43C-Insulation: ND

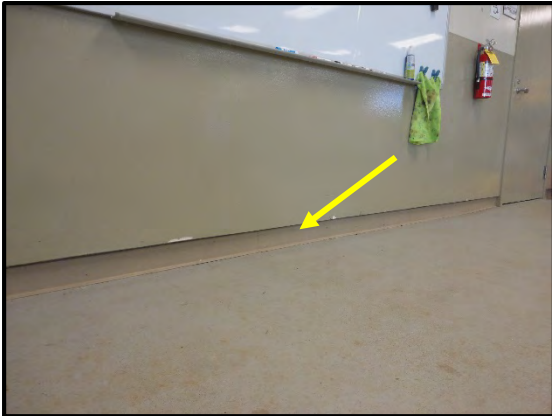
HM ID: 247
Maintenance Shop
Floor 1

Room 1
Beige cove base and mastic on concrete block wall.

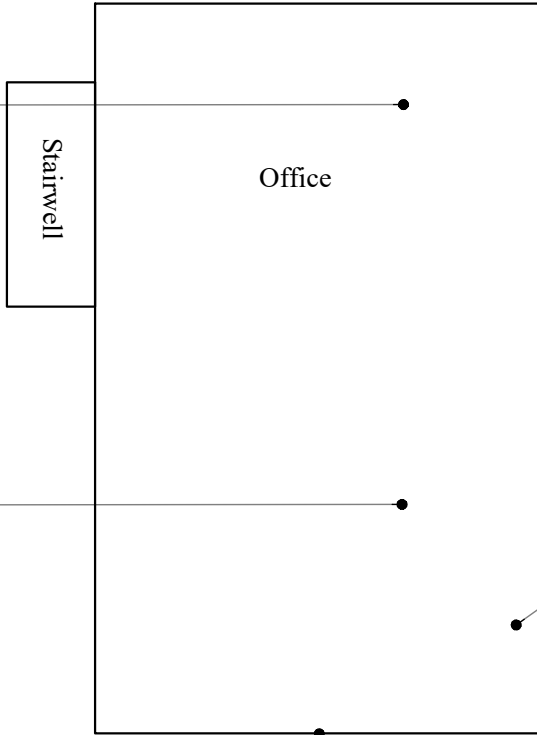
2819-B-A23A-Vinyl tile: ND
 2819-B-A23A-Mastic: ND
 2819-B-A23A-Leveling compound: ND
 2819-B-A23B-Vinyl tile: ND
 2819-B-A23B-Mastic: ND
 2819-B-A23B-Leveling compound: ND
 2819-B-A23C-Vinyl tile: ND
 2819-B-A23C-Mastic: ND
 HM ID: 23 (Gray 12" x 12" vinyl tile with mastic and leveling compound on concrete floor)

2819-B-A21A: ND
 2819-B-A21B: ND
 2819-B-A21C: ND
 HM ID: 21 (White drywall on ceiling)

2819-B-A24A-Cove base: ND
 2819-B-A24A-Mastic: ND
 2819-B-A24B-Cove base: ND
 2819-B-A24B-Mastic: ND
 2819-B-A24C: ND
 HM ID: 24 (White cove base and mastic on drywall wall)

2819-B-A25A-Shingle: ND
 2819-B-A25A-Felt: ND
 2819-B-A25B-Shingle: ND
 2819-B-A25B-Felt: ND
 2819-B-A25C-Shingle 1: ND
 2819-B-A25C-Shingle 2: ND
 2819-B-A25C-Felt: ND
 HM ID: 25 (Black built-up roofing on wood roofing system)

2819-B-A22A: ND
 2819-B-A22B: ND
 2819-B-A22C: ND
 HM ID: 22 (Blue drywall on wall)

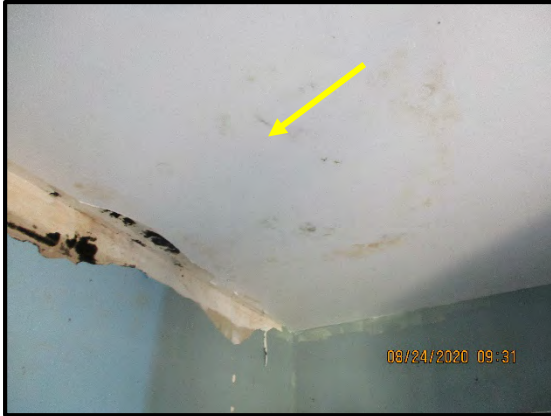
HM ID: 21
Office
Floor 1

Interior
White paint and skim coat on drywall ceiling.

Non-ACM
2819-B-A21A: ND
2819-B-A21B: ND
2819-B-A21C: ND

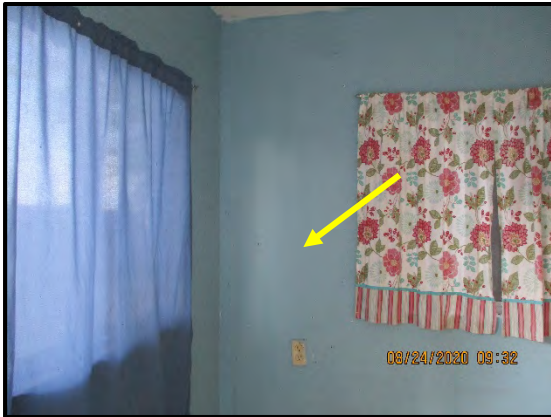
HM ID: 22
Office
Floor 1

Interior
Blue paint and skim coat on drywall wall.

Non-ACM
2819-B-A22A: ND
2819-B-A22B: ND
2819-B-A22C: ND

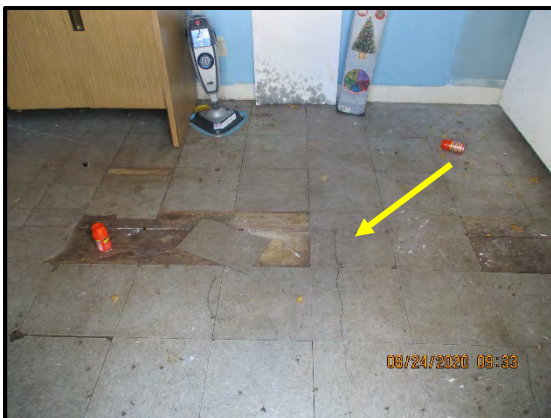
HM ID: 23
Office
Floor 1

Interior
Gray 12"x12" vinyl tile, mastic, and leveling compound on wood floor.

Non-ACM
2819-B-A23A-VFT: ND
2819-B-A23A-Mastic: ND
2819-B-A23A-Leveling compound: ND
2819-B-A23B-VFT: ND
2819-B-A23B-Mastic: ND
2819-B-A23B-Leveling compound: ND
2819-B-A23C-VFT: ND
2819-B-A23C-Mastic: ND

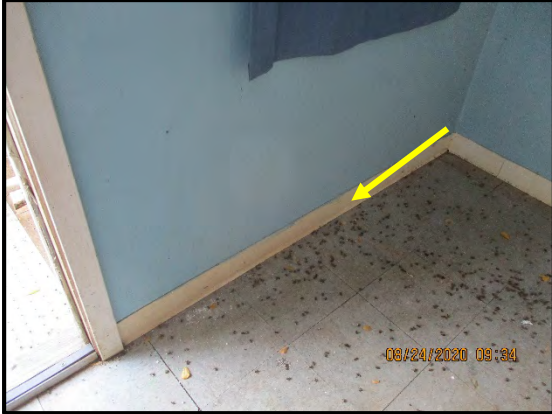
HM ID: 24
Office
Floor 1

Interior
White cove base and mastic on drywall wall.

Non-ACM

2819-B-A24A-Cove base: ND
2819-B-A24A-Mastic: ND
2819-B-A24B-Cove base: ND
2819-B-A24B-Mastic: ND
2819-B-A24C: ND

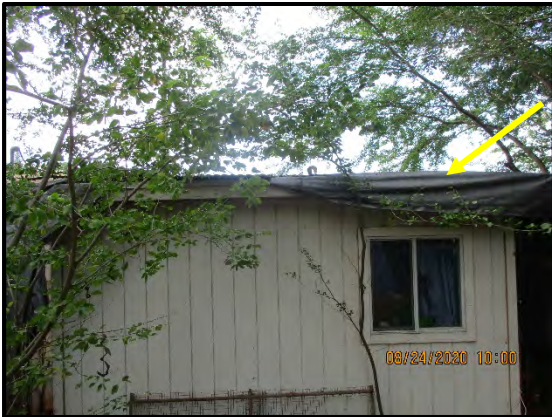
HM ID: 25
Office
Roof

Exterior
Black built-up roofing on wood roofing system.

Non-ACM

2819-B-A25A-Shingle: ND
2819-B-A25A-Felt: ND
2819-B-A25B-Shingle: ND
2819-B-A25B-Felt: ND
2819-B-A25C-Shingle 1: ND
2819-B-A25C-Shingle 2: ND
2819-B-A25C-Felt: ND

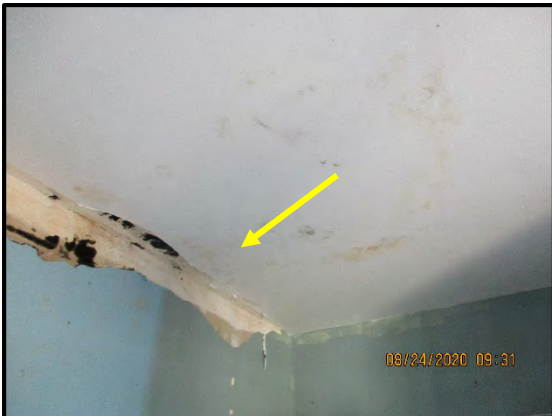
HM ID: 80
Office
Floor 1

Interior
White paint on drywall ceiling.

2819-B-P46A: <40 mg/kg
2819-B-P46B: <40 mg/kg

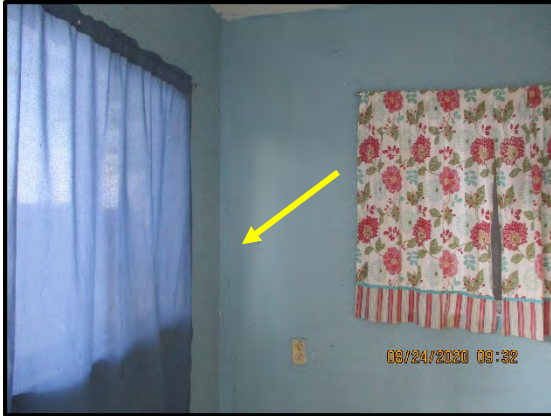
HM ID: 81
Office
Floor 1
Interior
Blue paint on drywall wall.
Non-LCP
2819-B-P47A: <40 mg/kg
2819-B-P47B: <40 mg/kg

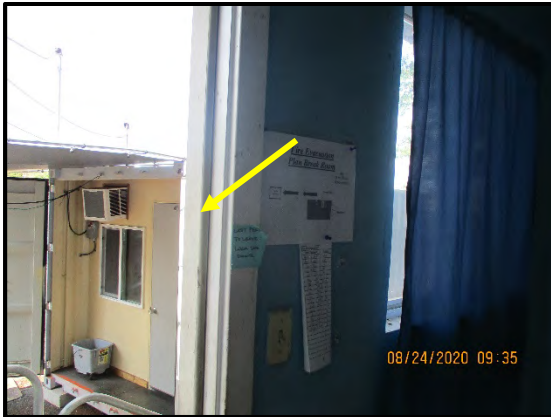
HM ID: 82
Office
Floor 1
Interior
White paint on wood door frame.
Non-LCP
2819-B-P48A: <40 mg/kg
2819-B-P48B: <40 mg/kg

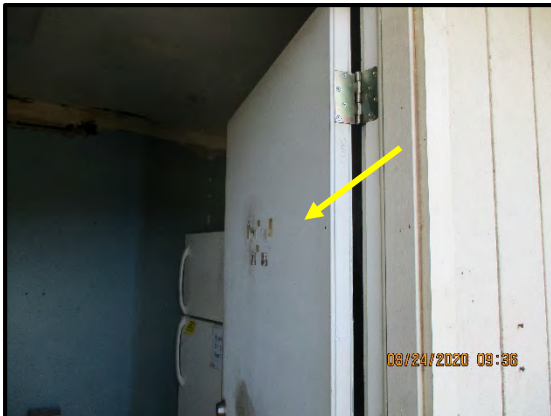
HM ID: 83
Office
Floor 1
Exterior
White paint on metal door.
LCP
2819-B-P49A: <40 mg/kg
2819-B-P49B: 35 mg/kg

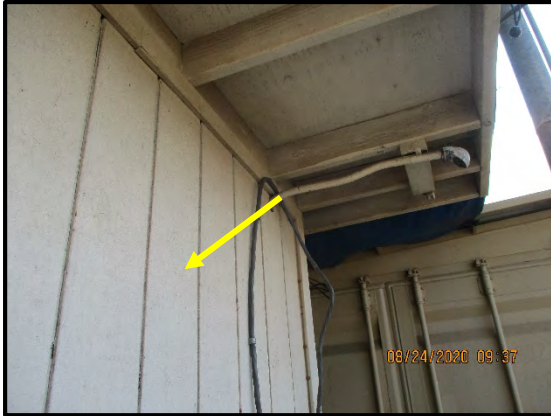
HM ID: 84
Office
Floor 1

Exterior
White paint on wood wall.

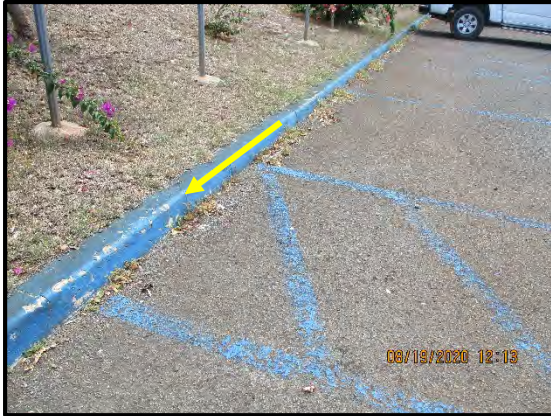
HM ID: 66
Parking Lot
Floor 1

Exterior
Blue paint on concrete curb.

Non-LCP

2819-B-P34A: <40 mg/kg
2819-B-P34B: <40 mg/kg

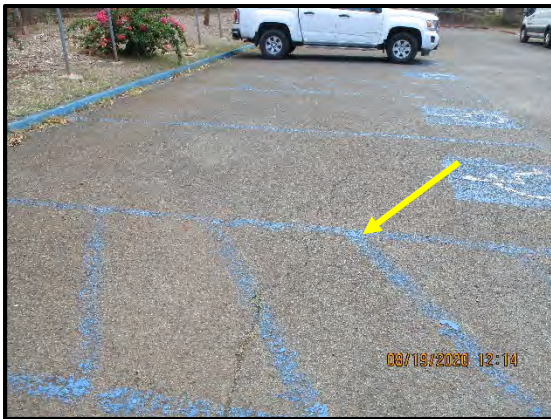
HM ID: 67
Parking Lot
Floor 1

Exterior
Blue paint on asphalt parking stall.

Non-LCP

2819-B-P35A: <40 mg/kg
2819-B-P35B: <40 mg/kg

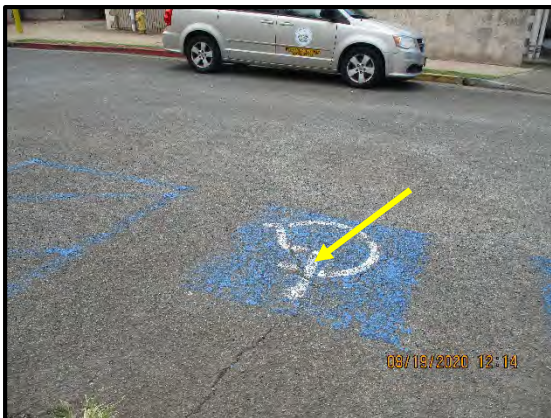
HM ID: 68
Parking Lot
Floor 1

Exterior
White paint on asphalt parking stall.

2819-B-P36A: <40 mg/kg
2819-B-P36B: <40 mg/kg

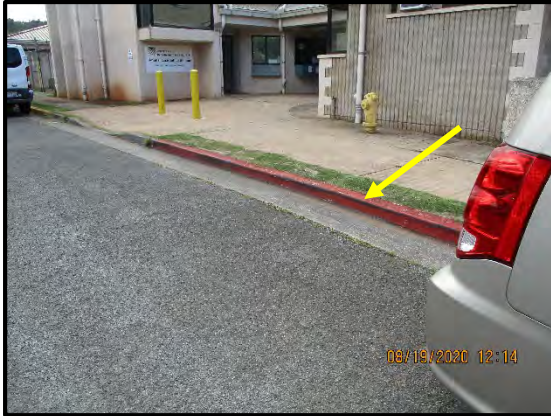
HM ID: 69
Parking Lot
Floor 1

Exterior
Red paint on concrete curb.

Non-LCP
2819-B-P37A: <40 mg/kg
2819-B-P37B: <40 mg/kg

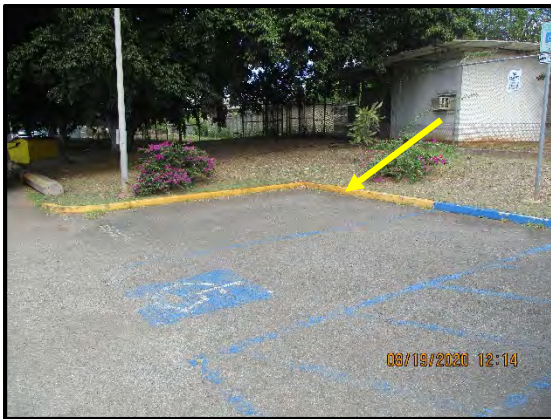
HM ID: 70
Parking Lot
Floor 1
Exterior
Yellow paint on concrete curb.

LBP
2819-B-P38A: 28,000 mg/kg
2819-B-P38B: 19,000 mg/kg

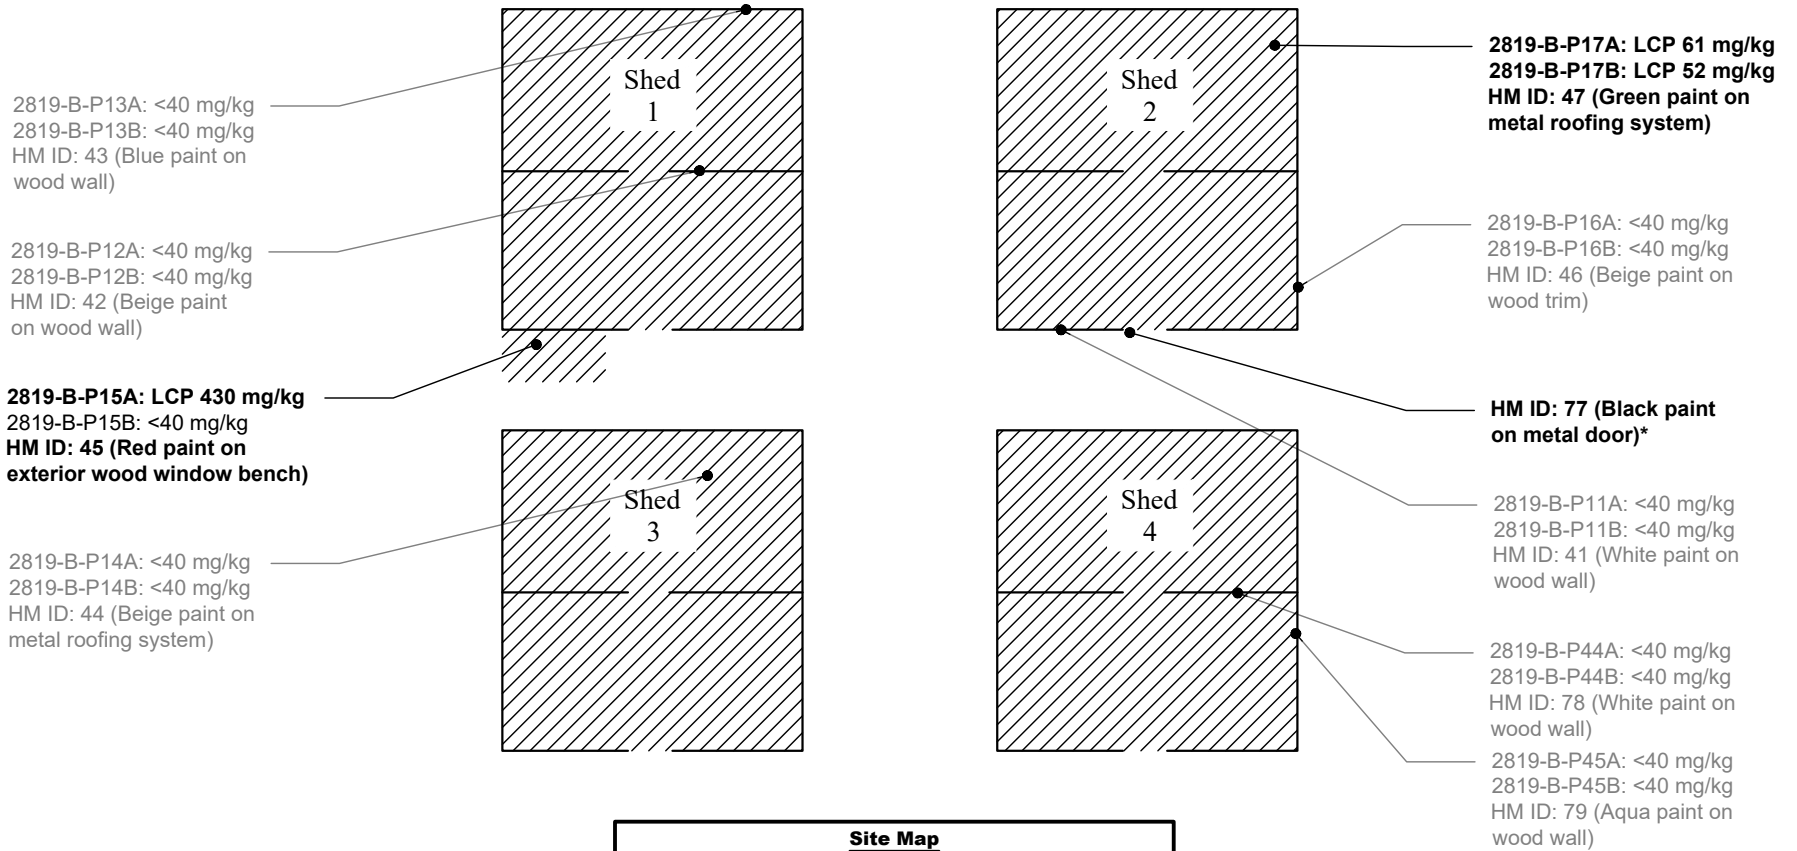
Small Sheds 1 -4

HM ID	Locations	Color	Substrate	Results (mg/kg)
45	Bench, door frame, window frame	Red	Wood	LCP <40 - 430
47	Roofing systems	Green	Metal	LCP 52 - 61
77	Door, door frame	Black	Metal	Assumed LCP

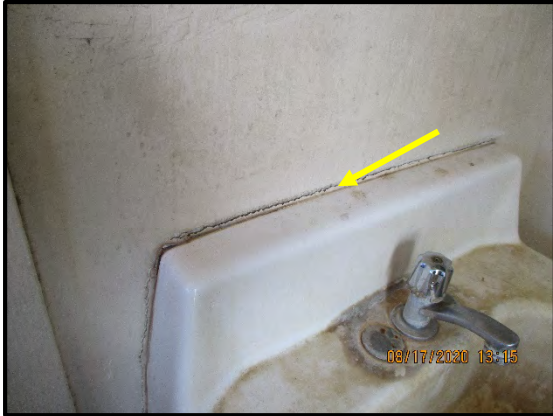
HM ID: 2
Small Shed
Floor 1

Shed 2
White caulking on porcelain sink.

Non-ACM
2819-B-A2A: ND
2819-B-A2B: ND
2819-B-A2C: ND
