**HAZARDOUS MATERIAL SURVEY REPORT
FOR
PHASE 2 OAHU COMMUNITY CORRECTIONAL CENTER
HDOA ANIMAL QUARANTINE STATION
99-951 HALAWA VALLEY STREET
AIEA, ISLAND OF OAHU 96701**

**MNA PROJECT 02819_2
AHL PROJECT No. 6930.001
DAGS JOB No. 12-27-5713**

November 30, 2020

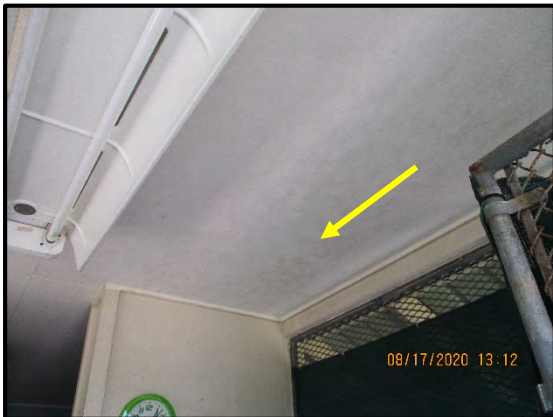
HM ID: 41
Small Shed
Floor 1

Shed 1, 2, 3
White paint on wood ceiling.

Non-LCP
2819-B-P11A: <40 mg/kg
2819-B-P11B: <40 mg/kg

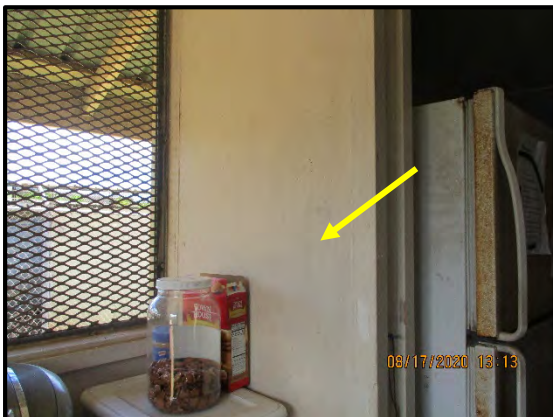
HM ID: 42
Small Shed
Floor 1

Shed 1
Beige paint on wood wall.

Non-LCP
2819-B-P12A: <40 mg/kg
2819-B-P12B: <40 mg/kg

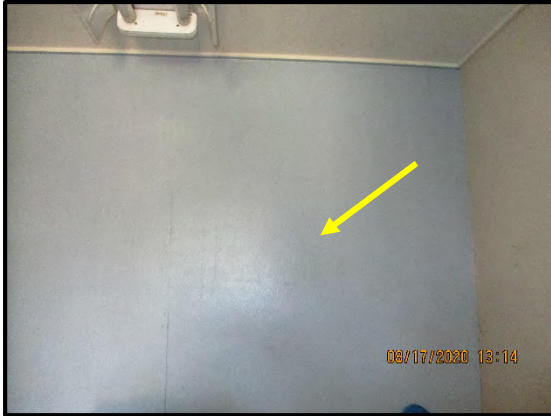
HM ID: 43
Small Shed
Floor 1

Shed 1
Blue paint on wood wall.

Non-LCP
2819-B-P13A: <40 mg/kg
2819-B-P13B: <40 mg/kg

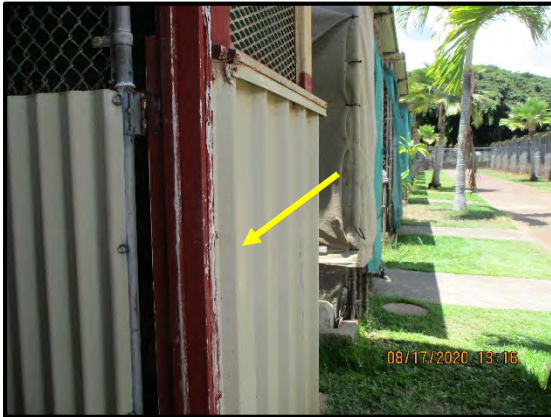
HM ID: 44
Small Shed
Floor 1

Shed 2 Exterior
Beige paint on metal wall.

Non-LCP
2819-B-P14A: <40 mg/kg
2819-B-P14B: <40 mg/kg

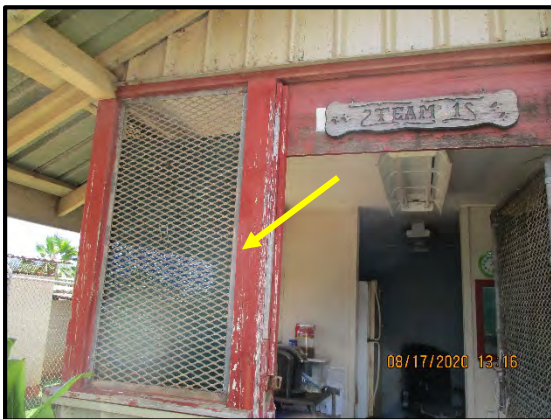
HM ID: 45
Small Shed
Floor 1

Shed 1 Exterior
Red paint on wood window frame.

LCP
2819-B-P15A: 430 mg/kg
2819-B-P15B: <40 mg/kg

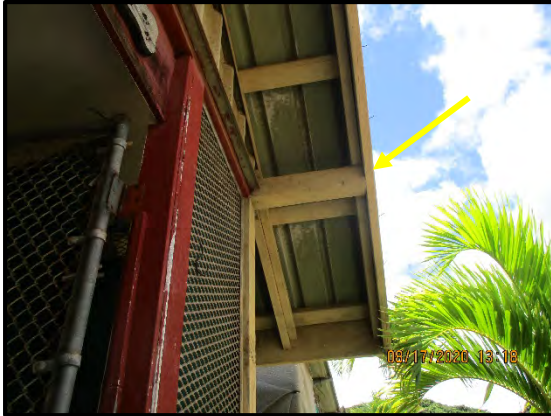
HM ID: 46
Small Shed
Floor 1

Shed 1, 2, 3, 4 Exterior
Beige paint on wood trim.

Non-LCP

2819-B-P16A: <40 mg/kg
2819-B-P16B: <40 mg/kg

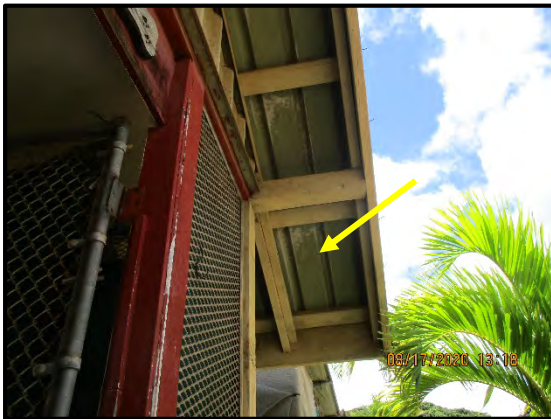
HM ID: 47
Small Shed
Roof

Shed 1, 2, 3, 4 Exterior
Green paint on metal roofing system.

LCP

2819-B-P17A: 61 mg/kg
2819-B-P17B: 52 mg/kg

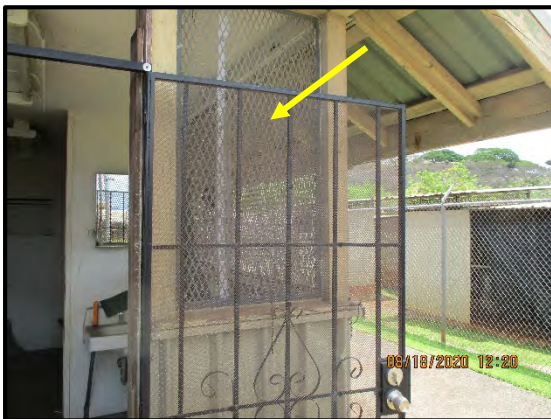
HM ID: 77
Small Shed
Floor 1

Shed 2 Exterior
Black paint on metal door.

**Assumed LCP
(Baked on paint)**

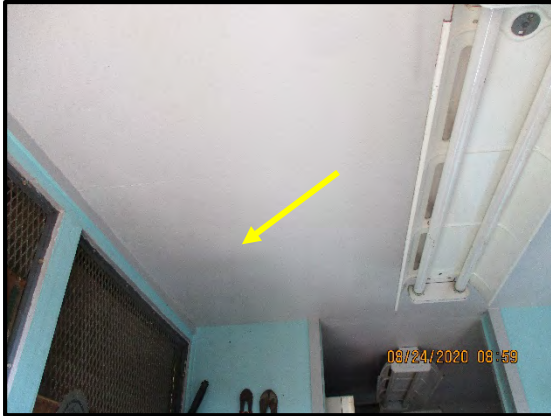
HM ID: 78
Small Shed
Floor 1

Shed 4
White paint on wood ceiling.

Non-LCP
2819-B-P44A: <40 mg/kg
2819-B-P44B: <40 mg/kg

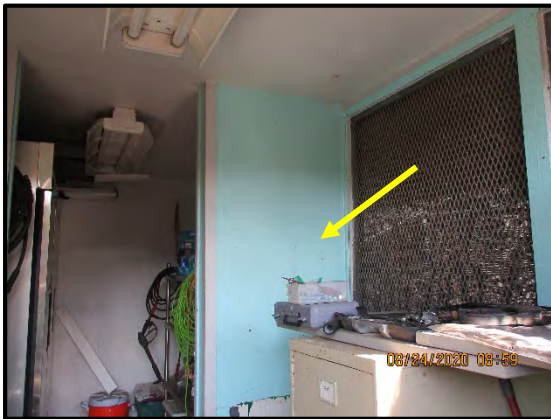
HM ID: 79
Small Shed
Floor 1

Shed 4
Aqua paint on wood wall.

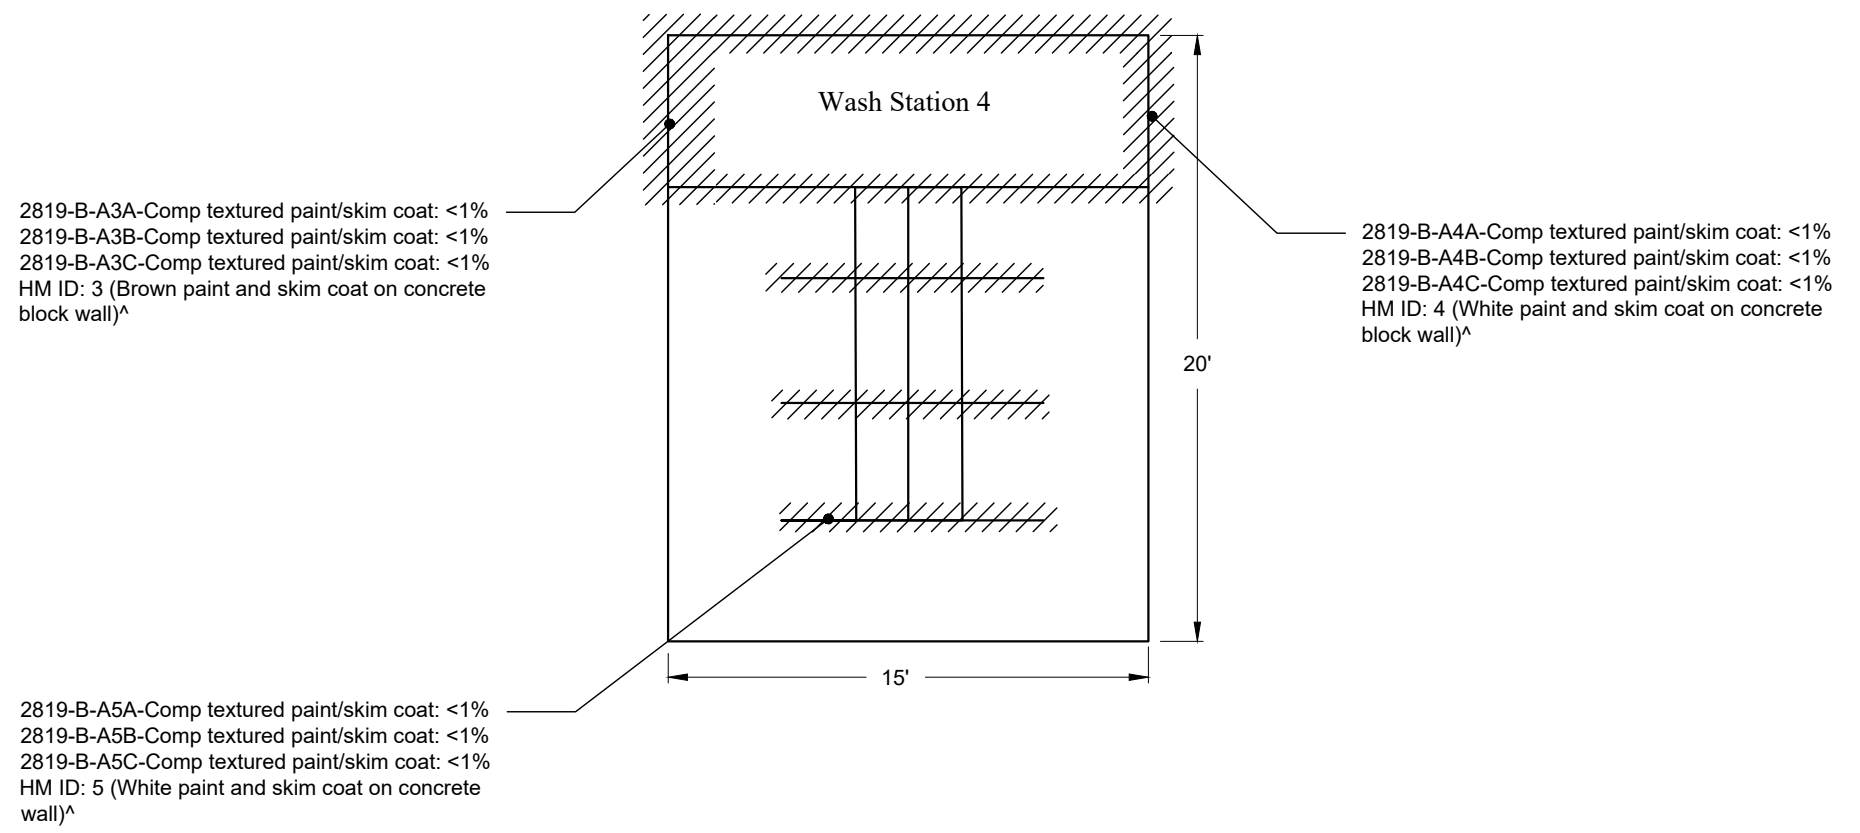
Wash Area Type 2

HM ID	Locations	Color	Material	Substrate	Results
3	Walls	Brown	Paint/skim coat	Concrete block	Trace Asbestos^
4	Walls	White	Paint/skim coat	Concrete block	Trace Asbestos^
5	Walls	White	Paint/skim coat	Concrete	Trace Asbestos^

^ One or more asbestos fibers was identified using the point count method. While the less than 1% asbestos is not a regulated material, trace amounts can be a health hazard.

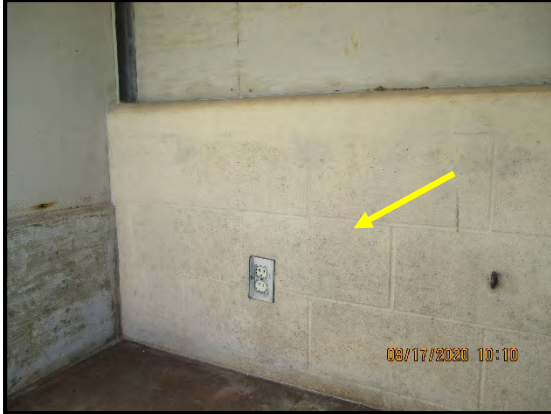
HM ID: 1
Wash Area Type 1
Floor 1

Wash 3
Beige textured paint on concrete block wall.

Non-ACM

2819-B-A1A-Texture paint: ND
2919-B-A1A-Paint: ND
2819-B-A1B-Texture paint: ND
2919-B-A1B-Paint: ND
2819-B-A1C-Texture paint: ND
2919-B-A1C-Paint: ND

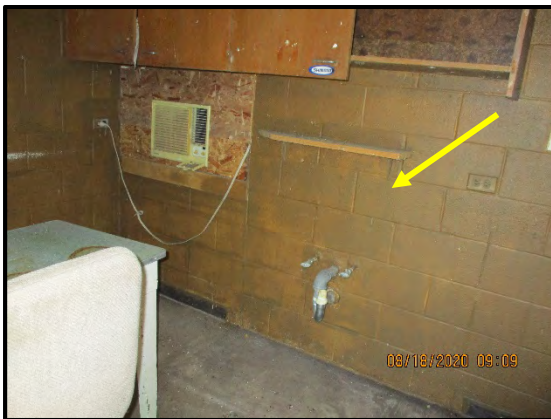
HM ID: 3
Wash Area Type 2
Floor 1

Wash 4
Brown paint and skim coat on concrete block wall.

Trace Asbestos

2819-B-A3A-Comp Texture / Skim: 0.1% Chrysotile
2819-B-A3B-Comp Texture / Skim: 0.1% Chrysotile
2819-B-A3C-Comp Texture / Skim: <0.1% Chrysotile

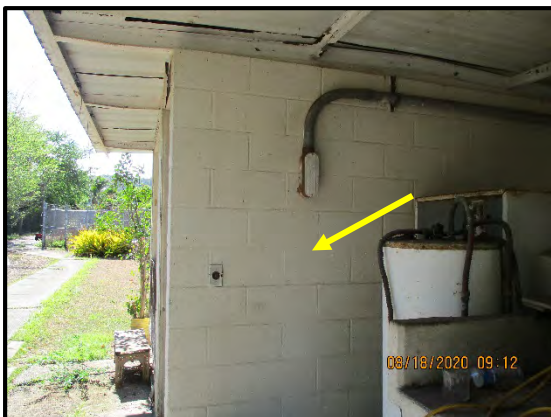
HM ID: 4
Wash Area Type 2
Floor 1

Wash 4
White paint and skim coat on concrete block wall.

Trace Asbestos

2819-B-A4A-Comp Texture / Skim: 0.2% Chrysotile
2819-B-A4B-Comp Texture / Skim: 0.1% Chrysotile
2819-B-A4C-Comp Texture / Skim: <0.1% Chrysotile

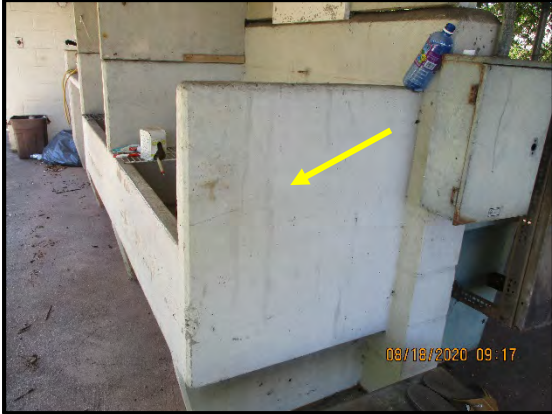
HM ID: 5
Wash Area Type 2
Floor 1

Wash 4
White paint and skim coat on concrete wall.

Trace Asbestos

2819-B-A5A-Comp Texture / Skim: <0.1% Chrysotile
2819-B-A5B-Comp Texture / Skim: <0.1% Chrysotile
2819-B-A5C-Comp Texture / Skim: 0.1% Chrysotile

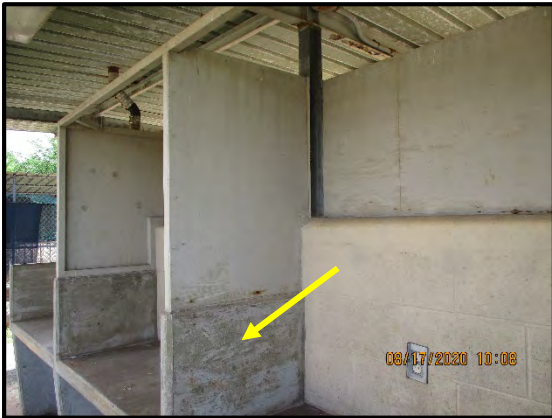
HM ID: 36
Wash Type 1
Floor 1

Exterior Wash Area 3
Beige paint on wood divider.

LCP

2819-B-P6A: 340 mg/kg
2819-B-P6B: 91 mg/kg

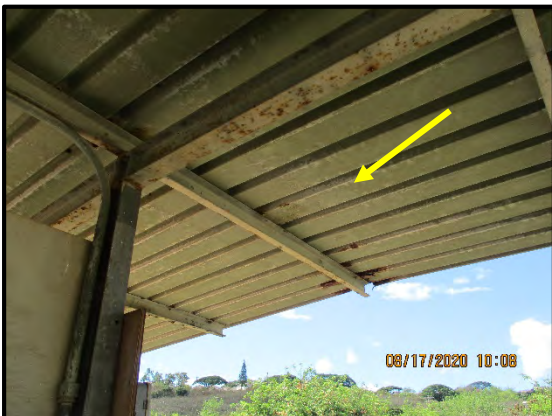
HM ID: 37
Wash Area Type 1
Floor 1

Exterior Wash Area 1
Green paint on metal ceiling.

Non-LCP

2819-B-P7A: <40 mg/kg
2819-B-P7B: <40 mg/kg

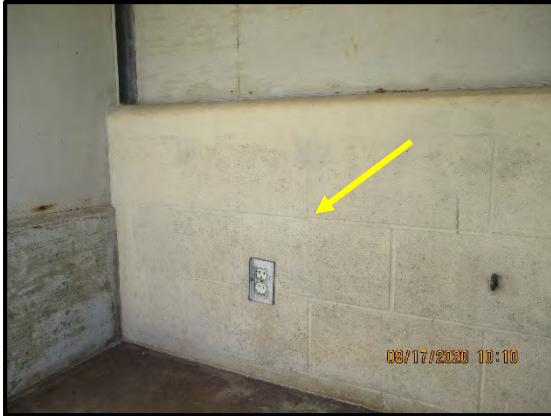
HM ID: 38
Wash Area Type 1
Floor 1

Exterior Wash Area 3
Beige paint on concrete block wall.

Non-LCP

2819-B-P8A: <40 mg/kg
2819-B-P8B: <40 mg/kg

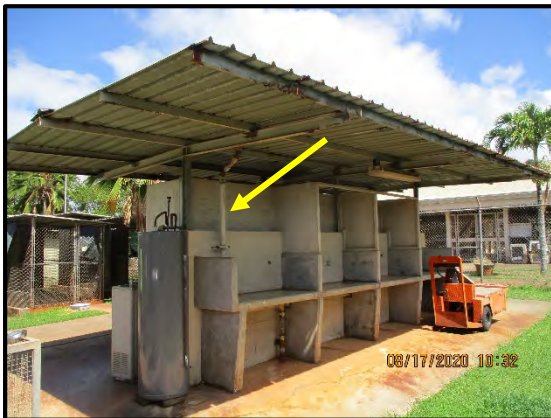
HM ID: 39
Wash Area Type 1
Floor 1

Exterior Wash Area 3
Beige paint on metal pipe.

LBP

2819-B-P9A: 8,700 mg/kg
2819-B-P9B: <40 mg/kg

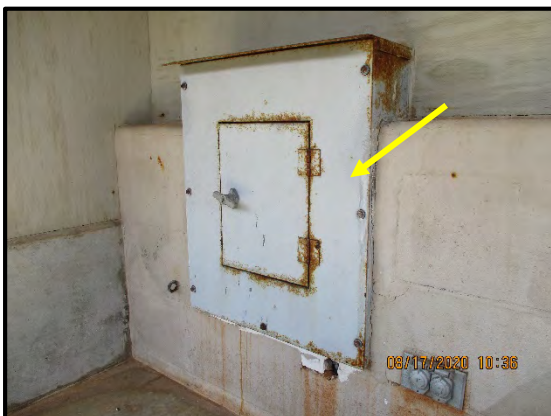
HM ID: 40
Wash Area Type 1
Floor 1

Exterior Wash Area 1, 2, 3
Light blue paint on metal electrical box.

Non-LCP

2819-B-P10A: <39 mg/kg
2819-B-P10B: <37 mg/kg

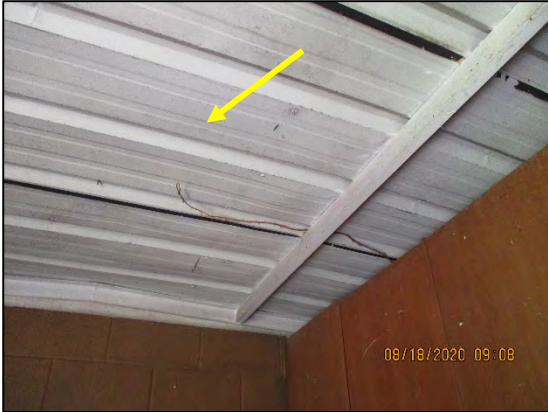
HM ID: 48
Wash Area Type 2
Floor 1

Wash 4
White paint on metal ceiling.

LCP
2819-B-P19A: 3,000 mg/kg
2819-B-P19B: 3,000 mg/kg

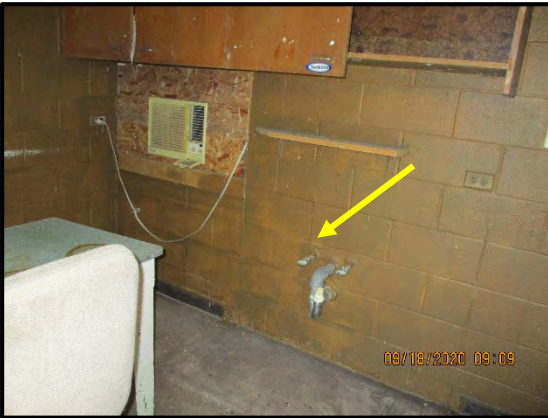
HM ID: 49
Wash Area Type 2
Floor 1

Wash 4
Brown paint on concrete block wall.

LCP
2819-B-P20A: 1,600 mg/kg
2819-B-P20B: 2,600 mg/kg

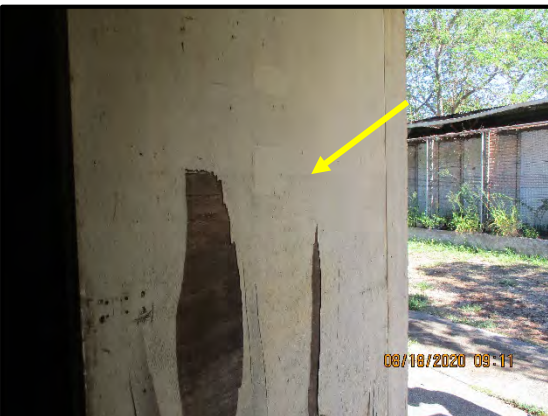
HM ID: 50
Wash Area Type 2
Floor 1

Wash 4
White paint on wood door.

LBP
2819-B-P21A: 6,000 mg/kg
2819-B-P21B: 4,800 mg/kg

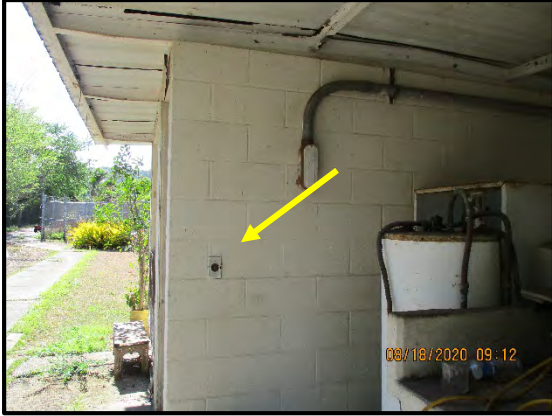
HM ID: 51
Wash Area Type 2
Floor 1

Wash 4
White paint on concrete block wall.

LCP
2819-B-P22A: 4,200 mg/kg
2819-B-P22B: 3,500 mg/kg

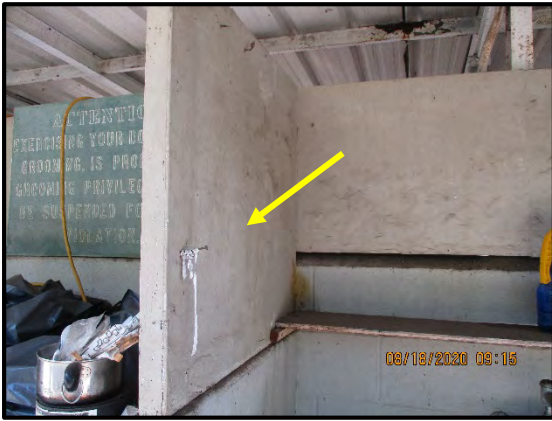
HM ID: 52
Wash Area Type 2
Floor 1

Wash 4
Beige paint on wood divider.

Non-LCP
2819-B-P23A: <40 mg/kg
2819-B-P23B: <40 mg/kg

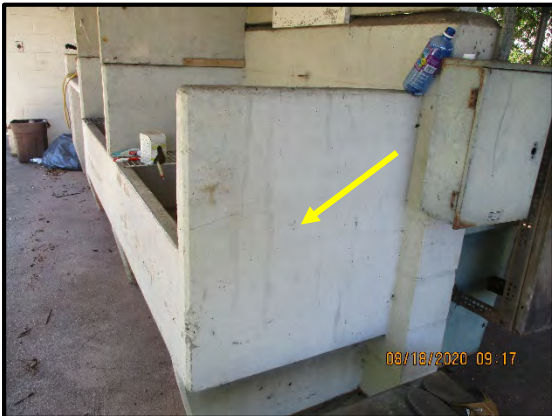
HM ID: 53
Wash Area Type 2
Floor 1

Wash 4 Exterior
White paint on concrete wall.

LCP
2819-B-P24A: 3,900 mg/kg
2819-B-P24B: 3,600 mg/kg

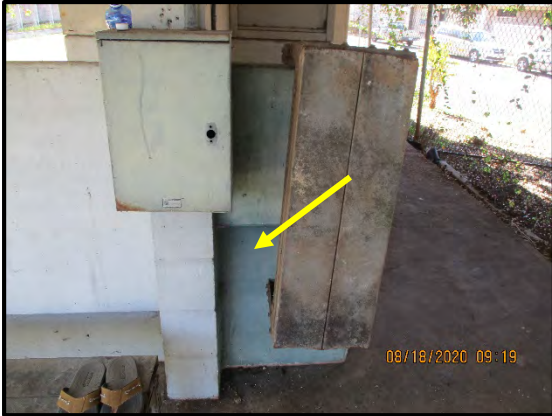
HM ID: 54
Wash Area Type 2
Floor 1

Wash 4 Exterior
Green paint on concrete wall.

LCP
2819-B-P25A: 3,100 mg/kg
2819-B-P25B: 3,100 mg/kg

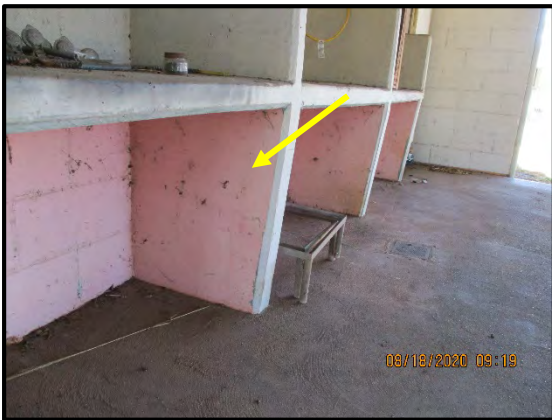
HM ID: 55
Wash Area Type 2
Floor 1

Wash 4 Exterior
Pink paint on concrete wall.

LBP
2819-B-P26A: 6,600 mg/kg
2819-B-P26B: 6,900 mg/kg

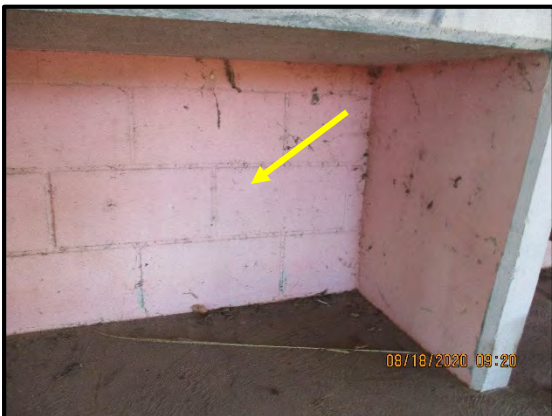
HM ID: 56
Wash Area Type 2
Floor 1

Wash 4 Exterior
Pink paint on concrete block wall.

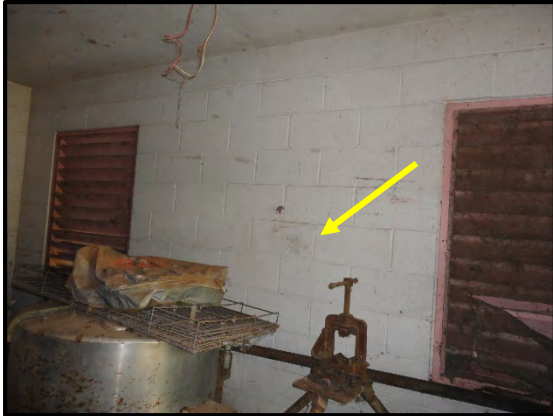
HM ID: 143
Water Shed
Floor 1

Interior
White paint on concrete block wall.

Non-LCP

2819-A-P26A: <40 mg/kg
2819-A-P26B: <40 mg/kg

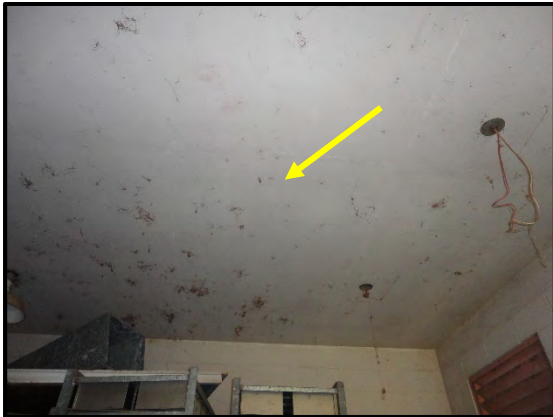
HM ID: 144
Water Shed
Floor 1

Interior
White paint on concrete ceiling.

Non-LCP

2819-A-P27A: 40 mg/kg
2819-A-P27B: 40 mg/kg

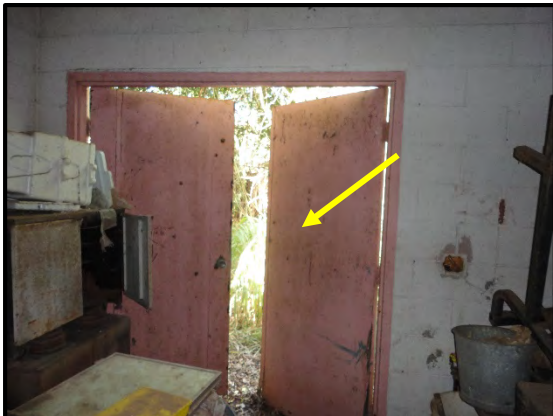
HM ID: 145
Water Shed
Floor 1

Interior
Pink paint on metal door.

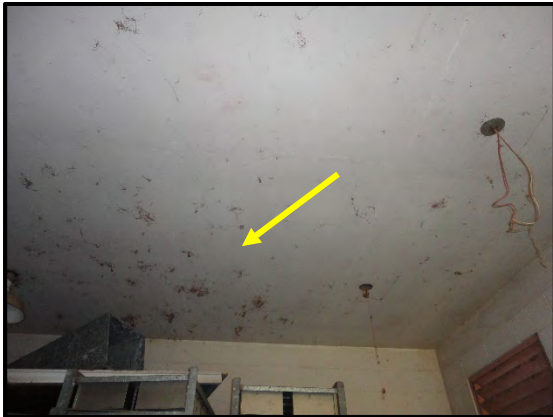
HM ID: 147
Water Shed
Floor 1

Interior
White paint and skim coat on concrete ceiling.

Non-ACM

2819-A-A20A-Composite: ND
2819-A-A20B-Composite: ND
2819-A-A20C: ND

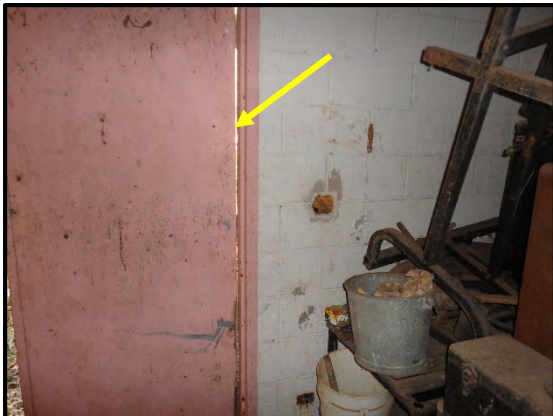
HM ID: 148
Water Shed
Floor 1

Interior
White caulking on metal door frame.

Non-ACM

2819-A-A21A: ND
2819-A-A21B: ND
2819-A-A21C: ND

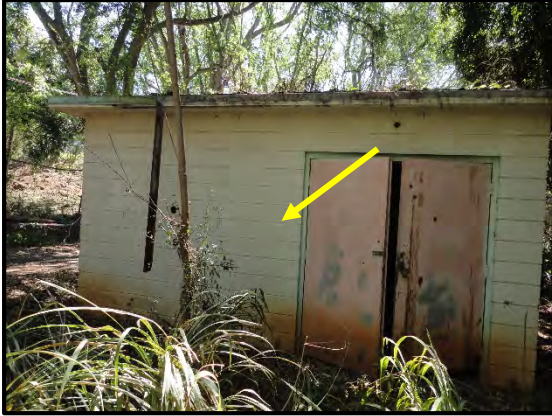
HM ID: 149
Water Shed
Floor 1

Exterior
White paint on concrete block wall.

LCP
2819-A-P29A: 580 mg/kg
2819-A-P29B: 530 mg/kg

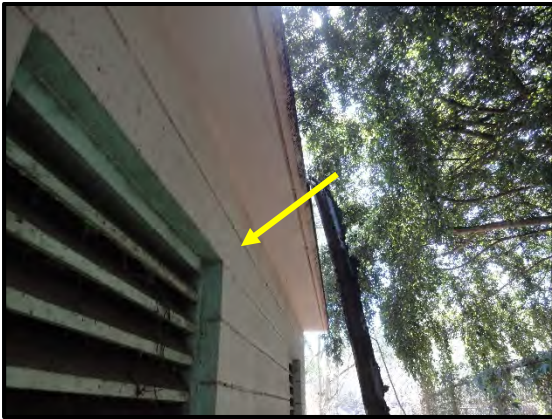
HM ID: 150
Water Shed
Floor 1

Exterior
White paint on concrete wall.

LCP
2819-A-P30A: 510 mg/kg
2819-A-P30B: 460 mg/kg

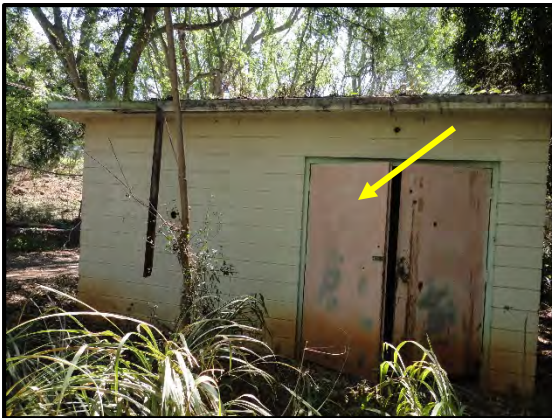
HM ID: 151
Water Shed
Floor 1

Exterior
Pink paint on metal door.

LCP
2819-A-P31A: 1,900 mg/kg
2819-A-P31B: 250 mg/kg

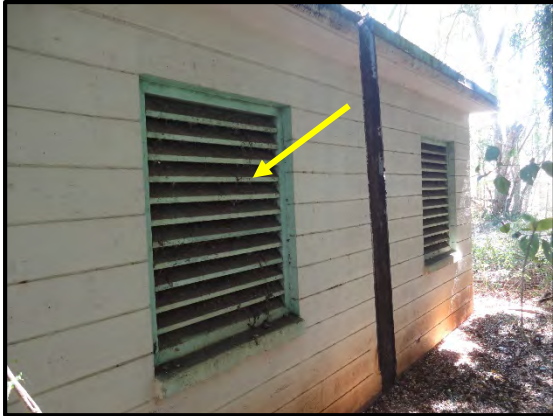
HM ID: 152
Water Shed
Floor 1

Exterior
Light green paint on metal window frame.

LCP
2819-A-P32A: 2,000 mg/kg
2819-A-P32B: 2,000 mg/kg

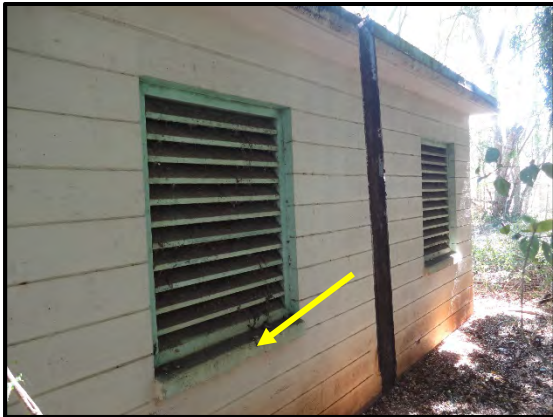
HM ID: 153
Water Shed
Floor 1

Exterior
Light green paint on concrete window ledge.

LCP
2819-A-P33A: 1,000 mg/kg
2819-A-P33B: 900 mg/kg

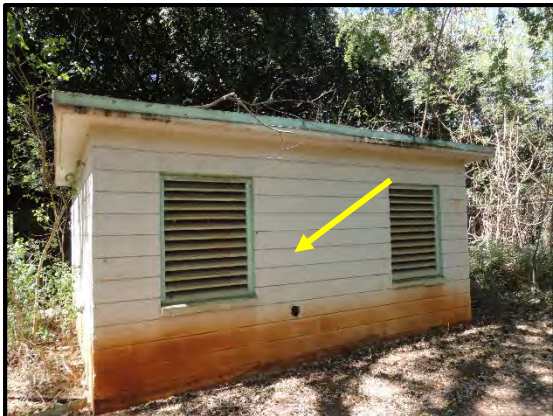
HM ID: 154
Water Shed
Floor 1

Exterior
White paint and skim coat on concrete block wall.

Non-ACM
2819-A-A22A-Composite: ND
2819-A-A22B-Composite: ND
2819-A-A22C-Skim coat/Plaster: ND

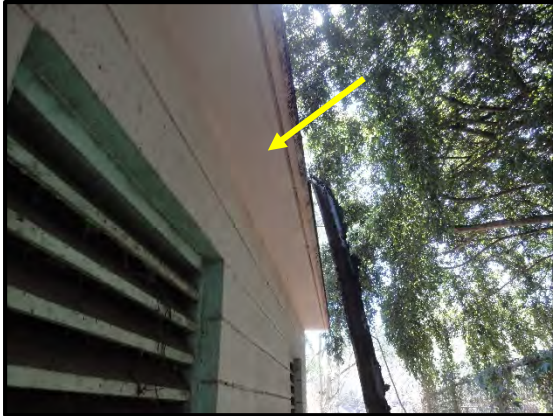
HM ID: 155
Water Shed
Floor 1

Exterior
White paint and skim coat on concrete ceiling.

Non-ACM

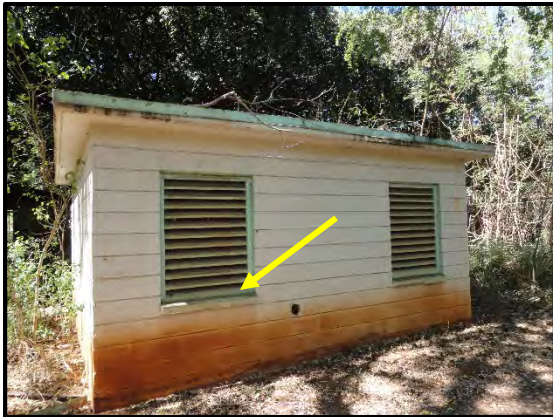
HM ID: 156
Water Shed
Floor 1

Exterior
White caulking on metal window frame.

Non-ACM

2819-A-A24A-Skim coat: ND
2819-A-A24A-Window putty: ND
2819-A-A24B-Skim coat: ND
2819-A-A24B-Window putty: ND
2819-A-A24C-Skim coat: ND
2819-A-A24C-Window putty: ND

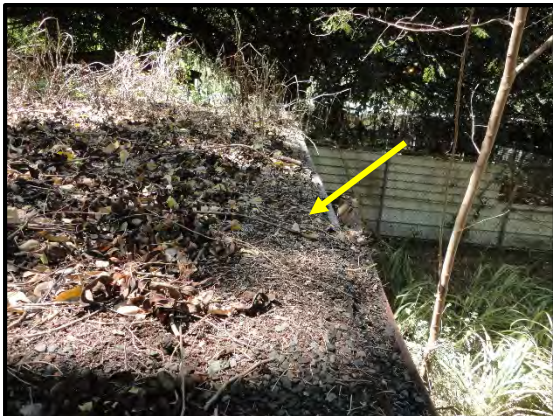
HM ID: 157
Water Shed
Roof

Exterior
Black built-up roofing on concrete roofing system.
