**HAZARDOUS MATERIAL SURVEY REPORT
FOR
PHASE 2 ANIMAL QUARANTINE STATION RELOCATION
HALAWA VALLEY STREET
AIEA, ISLAND OF OAHU 96701**

MNA PROJECT 3048_2

October 6, 2021

MNA Environmental

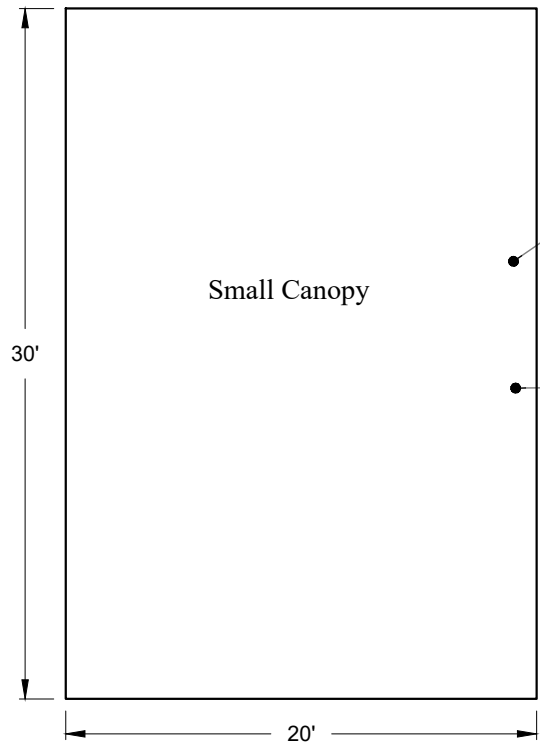
3084-P5A: <38 mg/kg
 3084-P5B: <39 mg/kg
 HM ID: 5 (Beige paint on metal roof)

3084-P6A: <35 mg/kg
 3084-P6B: <36 mg/kg
 HM ID: 6 (Green paint on metal ceiling)

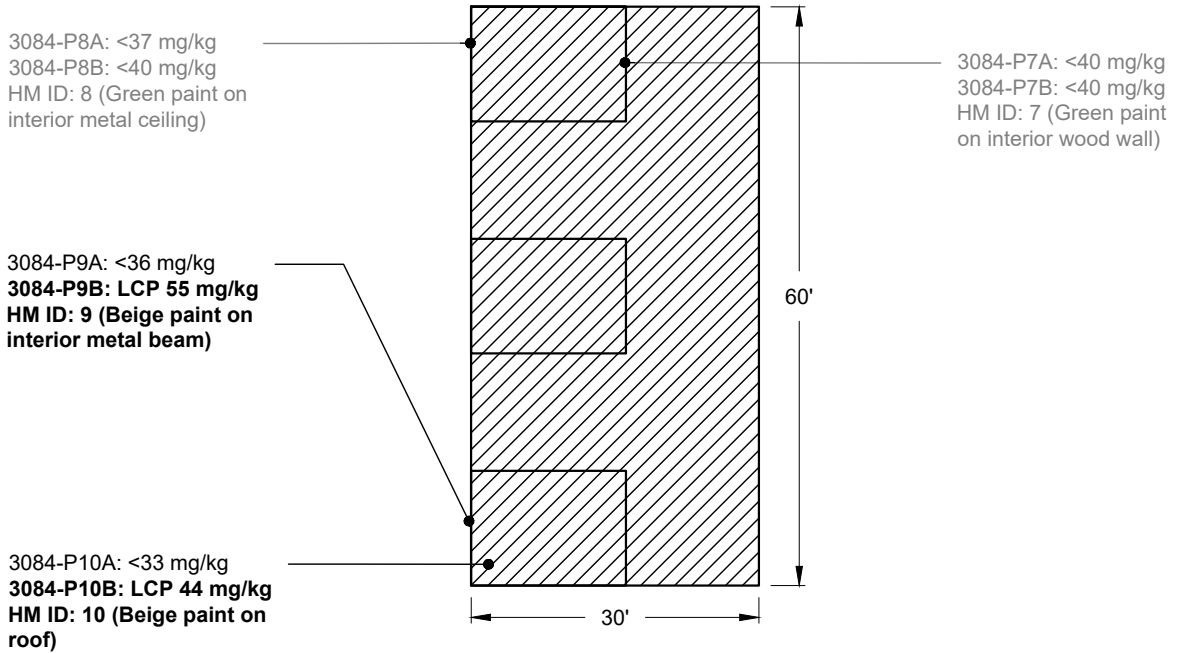
Kennel

HM ID	Location	Color	Substrate	Result (mg/kg)
9	Interior beams and purlins	Beige	Metal	LCP <36 - 55
10	Downspouts, gutter, roof			LCP <33 - 44

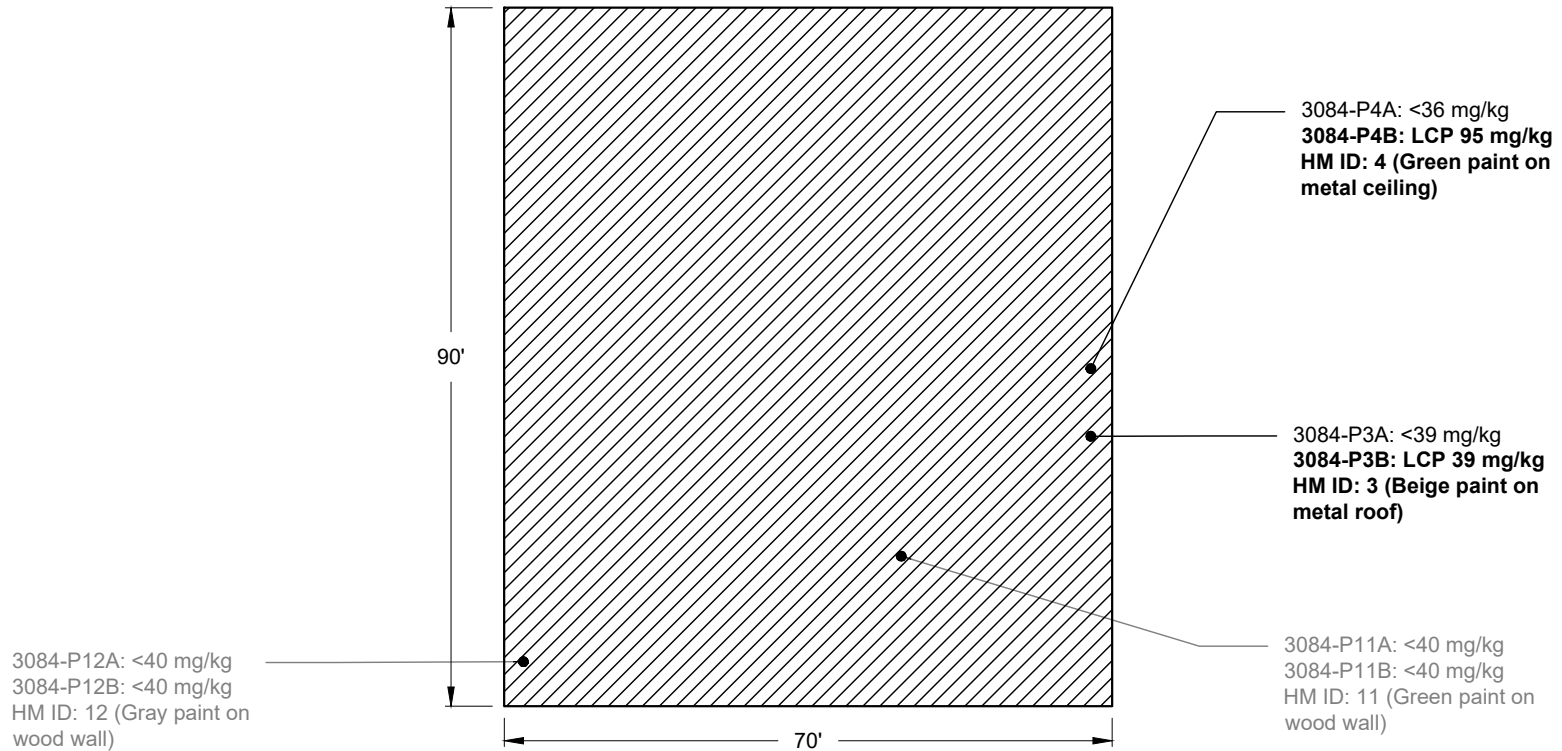
Large Canopy 6
(Typical)

HM ID	Location	Color	Substrate	Result (mg/kg)
3	Beams, purlins, roof, walls	Beige	Metal	LCP <39 - 39
4	Ceiling	Green		LCP <36 - 95

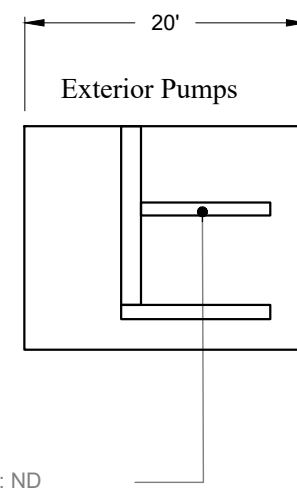
3084-A7A: ND
 3084-A7B: ND
 3084-A7C: ND
 HM ID: 30 (Lt. green
 gasket on metal valve)
