Volume II

Appendix G - Appendix L

Oahu Community Correctional Center

Volume II Appendices

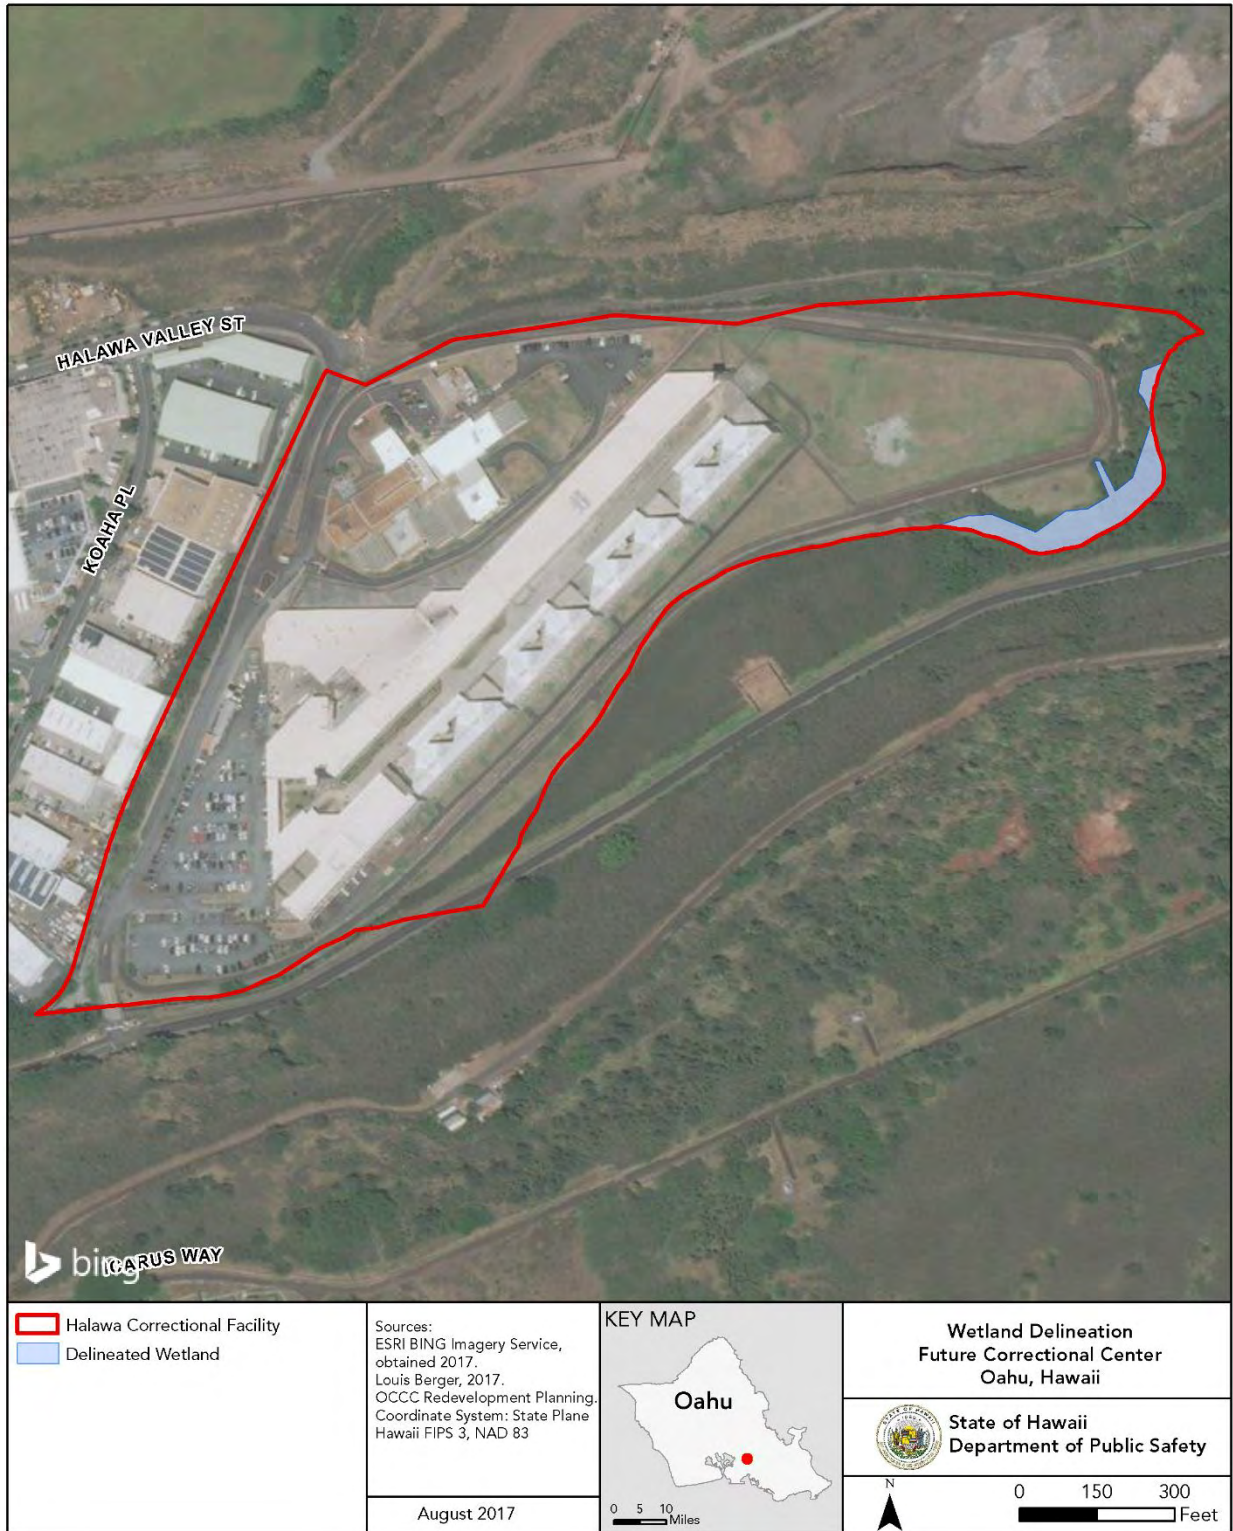
Figure 16: Delineated Wetlands – Halawa Correctional Facility Site

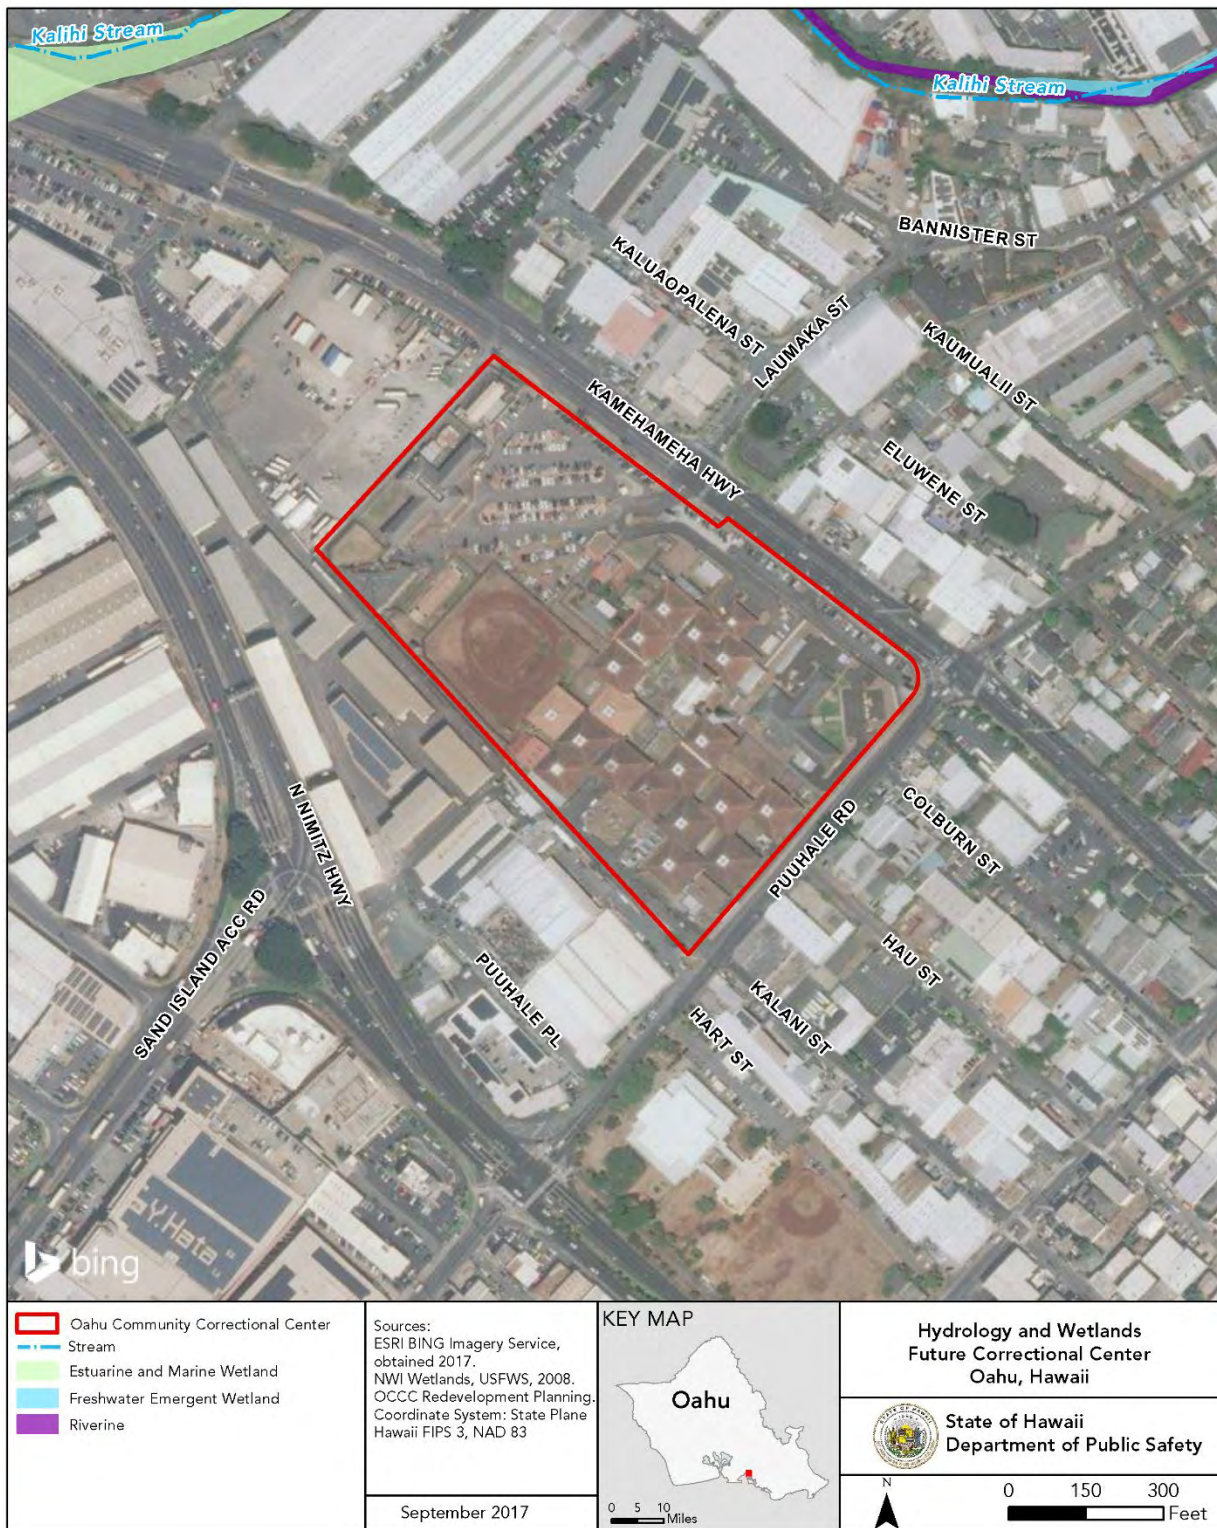
Figure 1: Existing OCCC Hydrology and Wetlands Map

A field survey of the Animal Quarantine Station conducted in June 2017 confirmed that there are no wetlands or OWUS present within the site boundaries. A concrete-lined tributary to South Halawa Stream was observed off-site and adjacent to the eastern site boundary. The streambed was dry at the time of inspection, and no hydrologic connection to the site was evident. A report documenting the desktop and field wetland investigations of the Animal Quarantine Station site is included as Appendix J to the OCCC EIS.

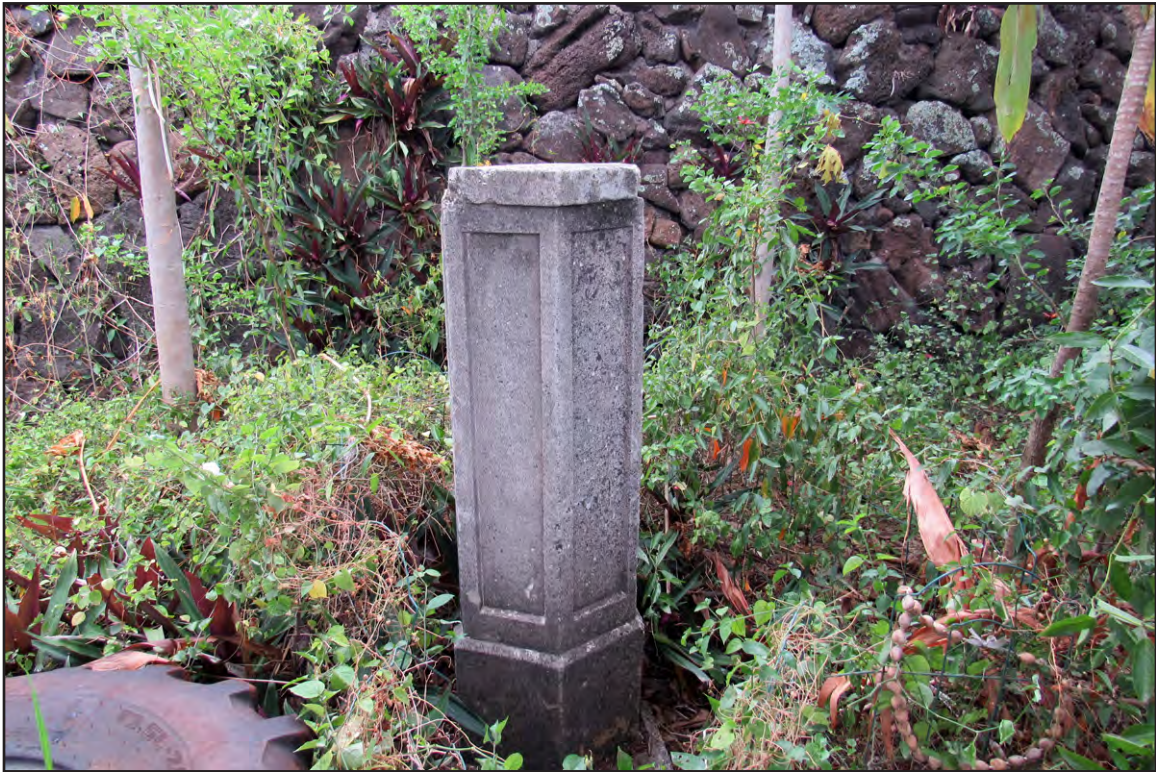
Plate 9: Concrete Pillar Reportedly Moved from a Shinto Shrine to Animal Quarantine Station

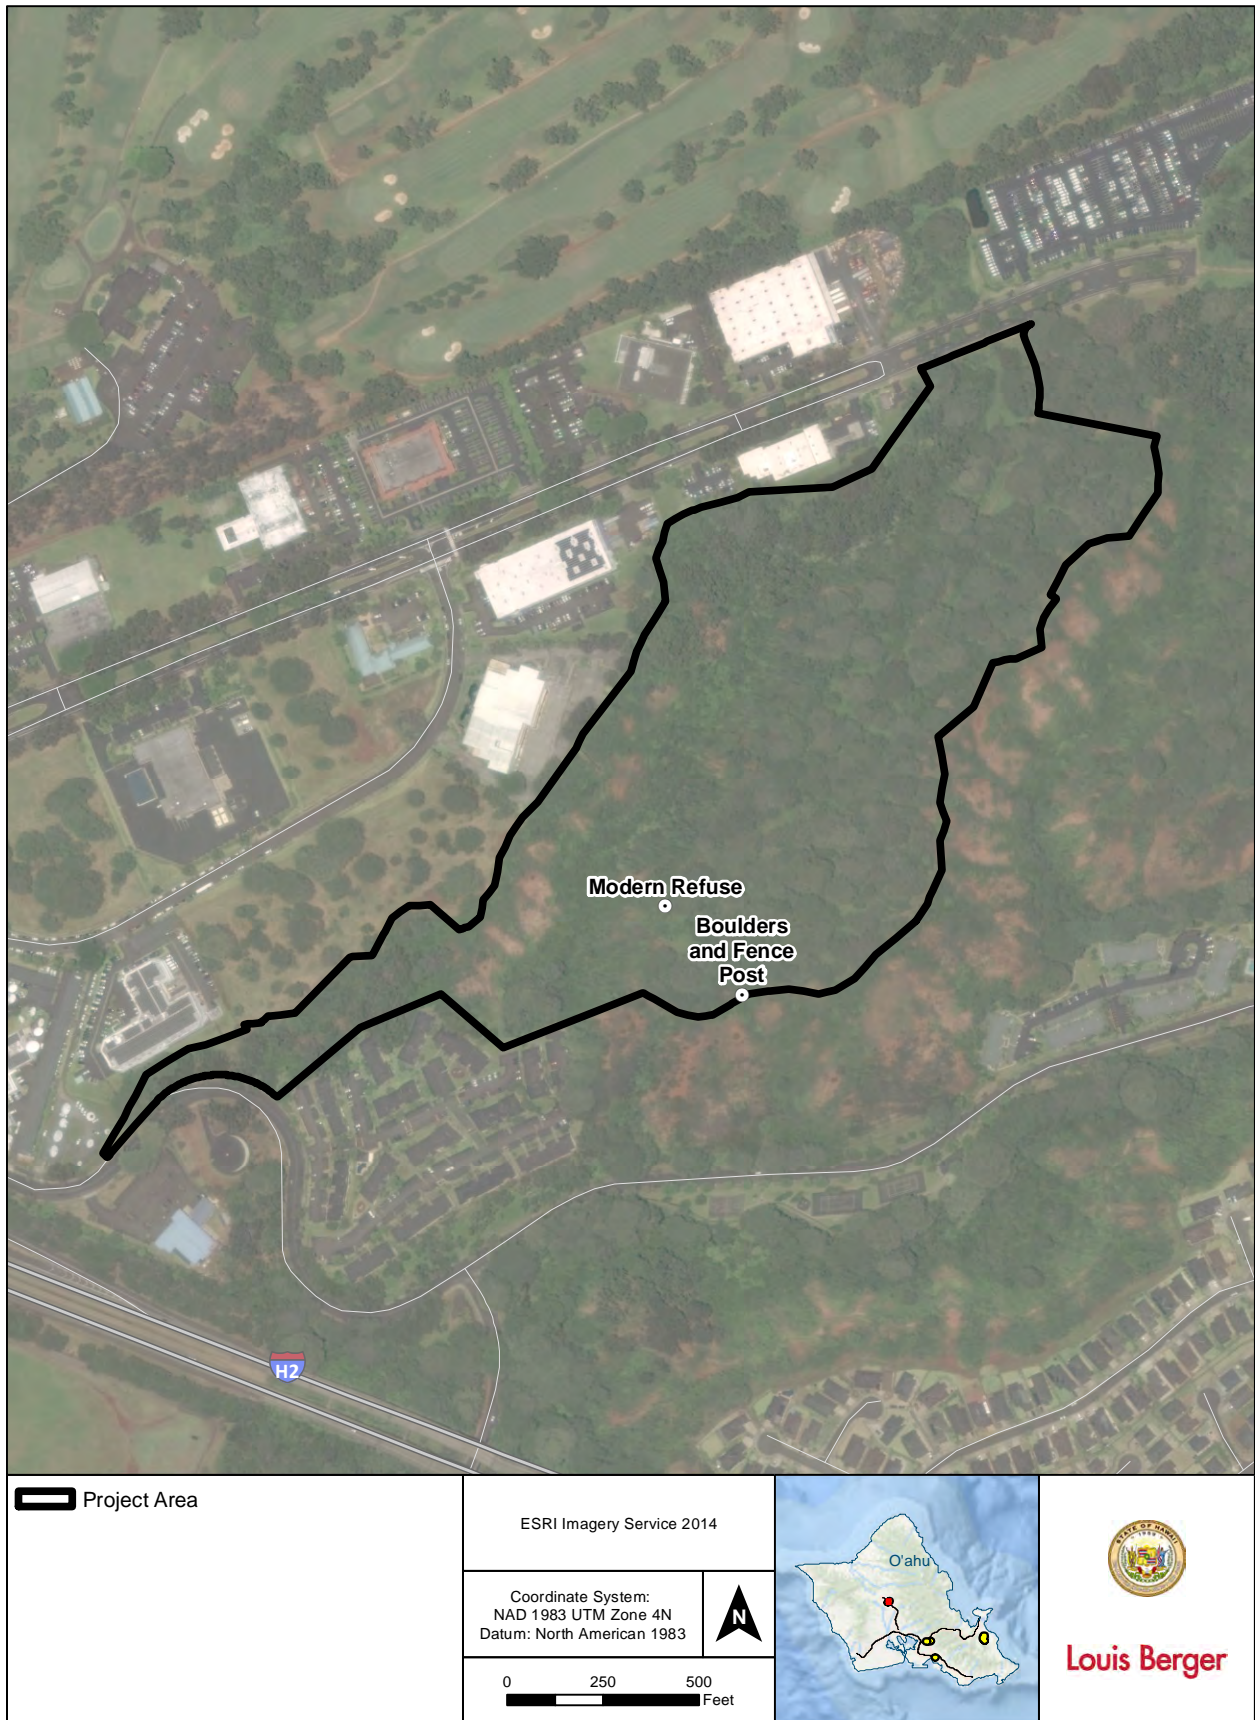
Figure 48: Location of Field Clearing Boulders and Modern Refuse at Mililani Technology Park Lot 17

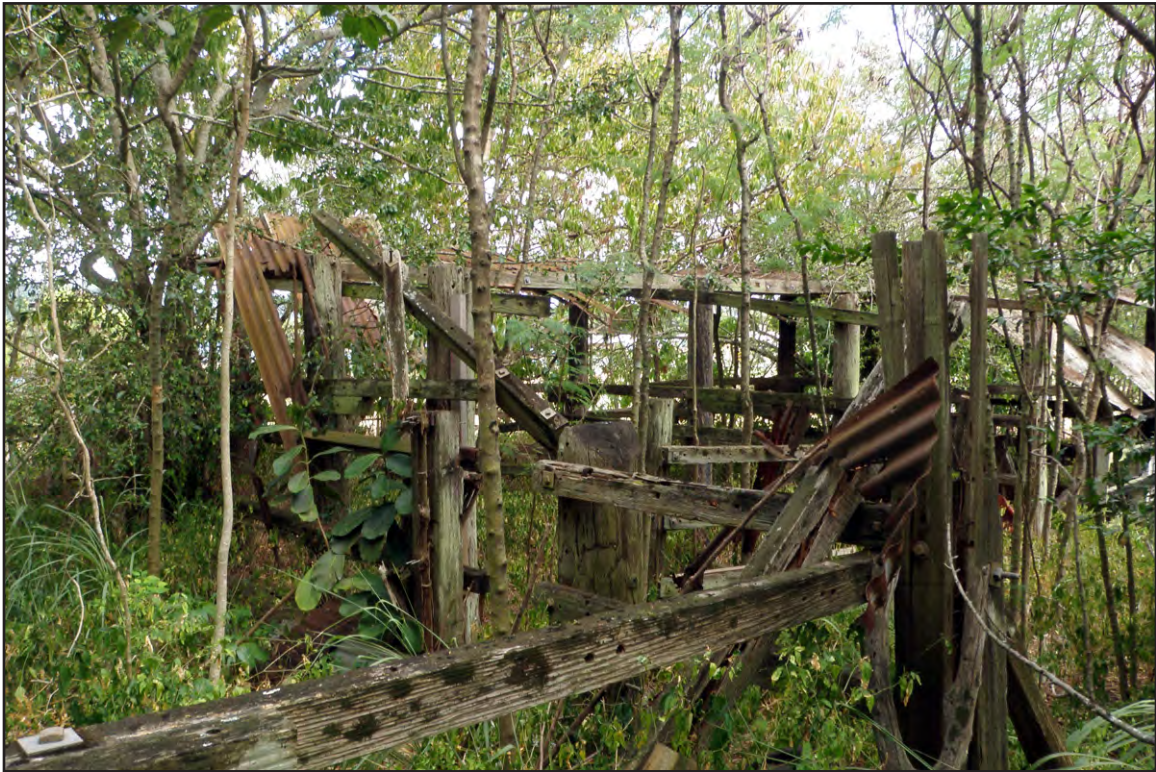
Plate 26: Ruined Stable Structures in Northeast Corner of WCCC Project Area

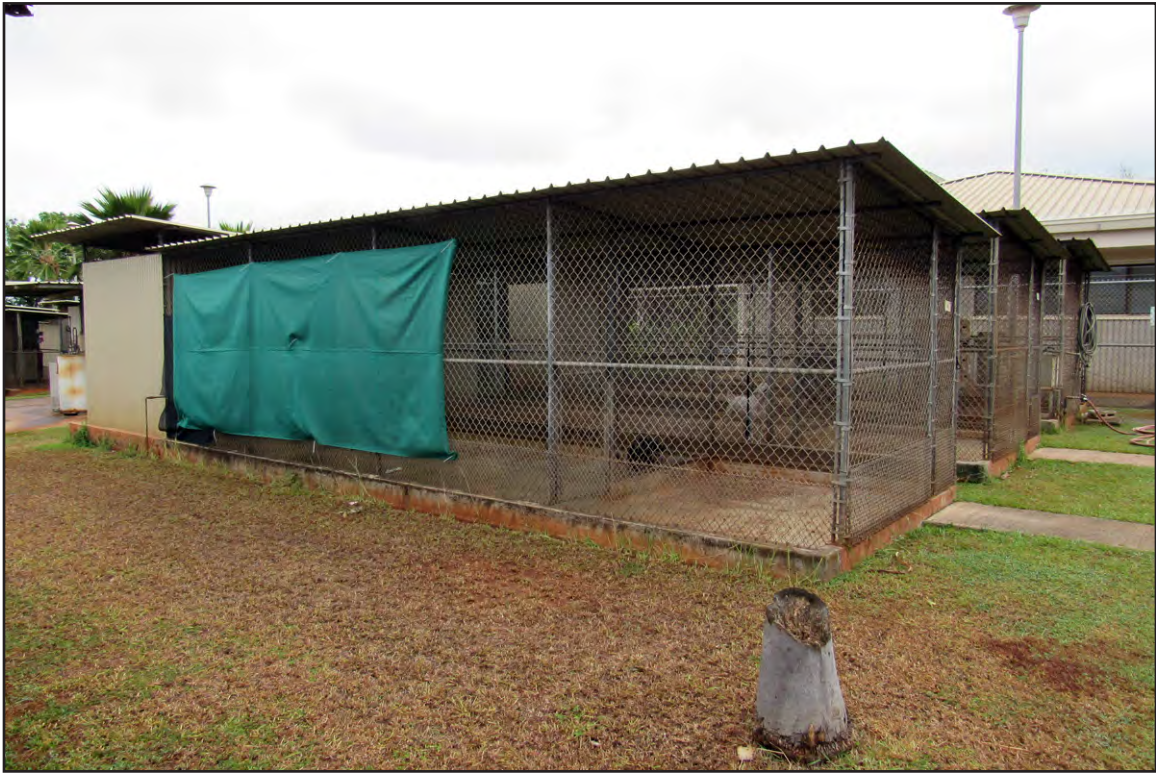
Plate 28: Standard Kennel, Style 1, Animal Quarantine Station

Kennels, Style 1	1970-2000s	Unknown	Chain-link enclosure with a wood or corrugated-metal structure at one end that serves as a shelter. Both shelter and chain-link enclosure are covered with corrugated-metal roofing. There are hundreds of these kennels of varying sizes.
Kennels, Style 2	1970s-2000s	Unknown	Long corrugated-metal shed with chain-link enclosures extending from the open side of the shed, covered with a corrugated metal roofing. There are 7 of this style in use and another 5 that appear inactive.
Cat Kennels	1970s-2000s	Unknown	Corrugated metal building on a concrete foundation with small external pens on both sides. There are approximately 12.
Inactive Kennels	1970-2000s	Unknown	Many of these appear similar to the Style 1 kennels but some are different. The vegetation coverage makes it difficult to determine their exact construction.
